## Nation Partners

## Northern pipeline

## Construction Impact Report

Thursday 23<sup>rd</sup> March 2023

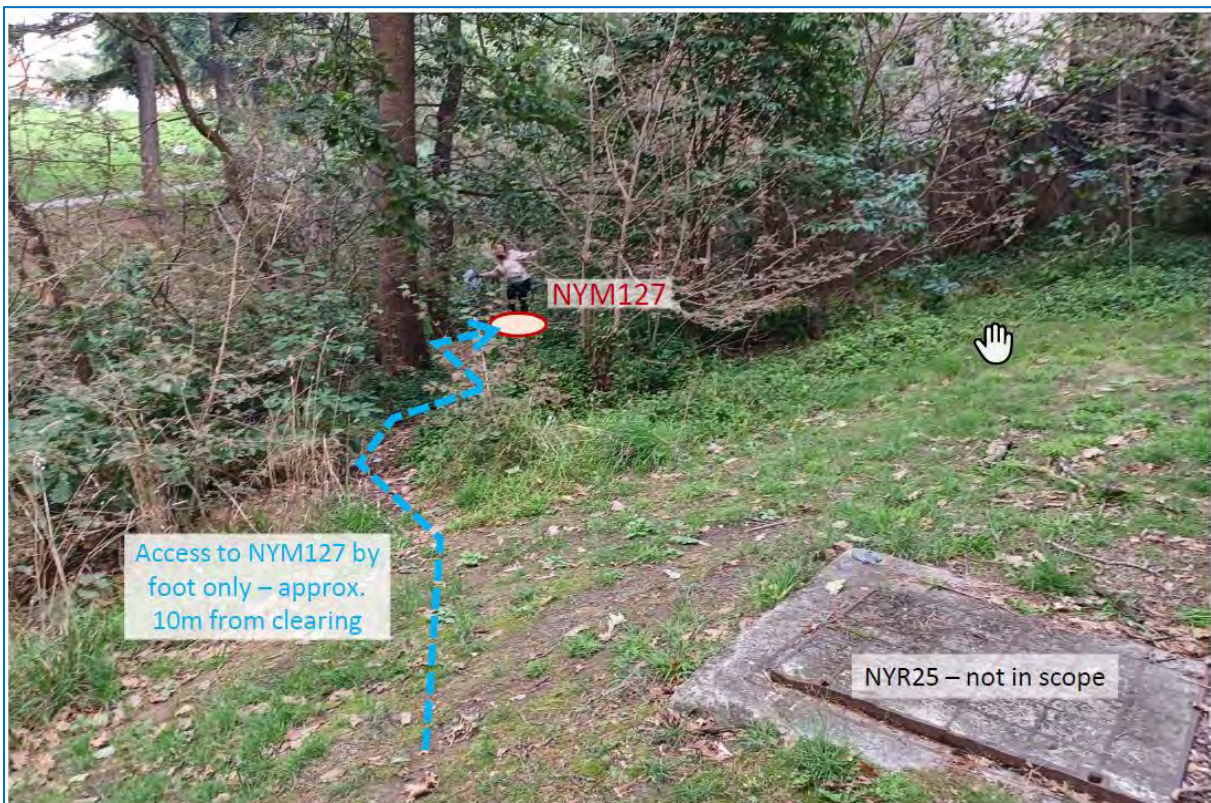
**Figure 3 Access widening and small tree removal to NYM127**

Minor tree pruning (<10cm diameter) will be required for access to this manhole.

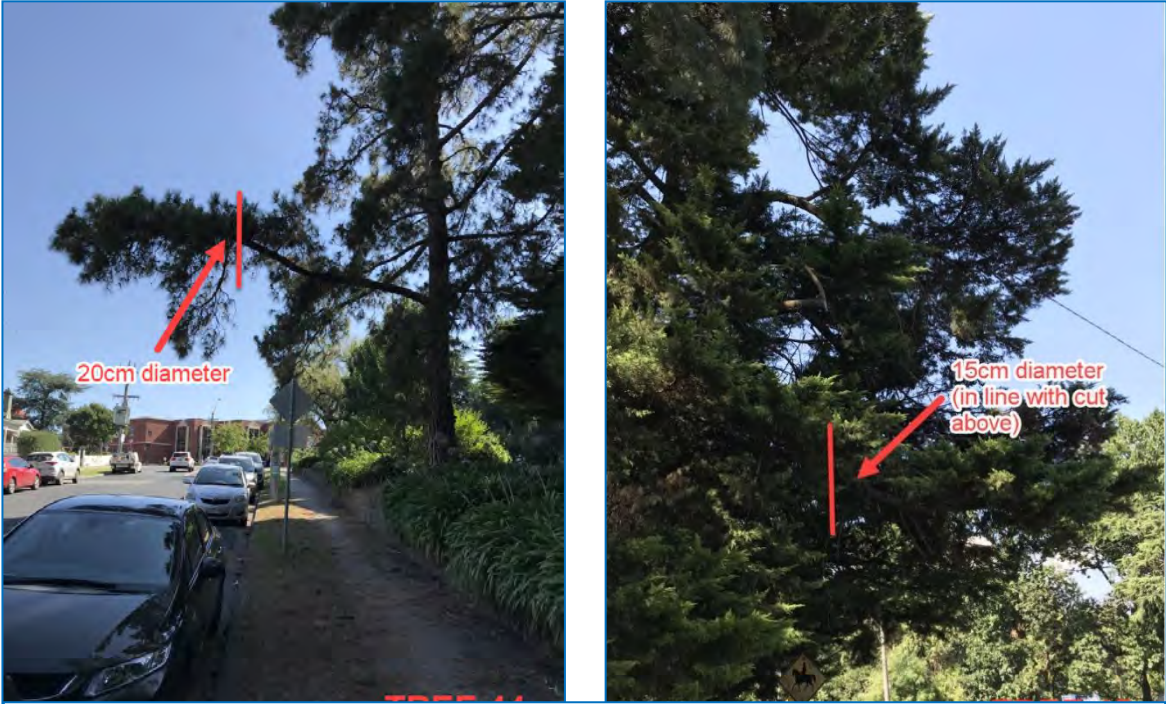
Figure 7 Pruning Tree 44 and Tree 45 (Heidelberg Park set down and parking area (Burgundy Street))

Tree 44 and Tree 45 require pruning to provide clearance:

The removal of these branches from each of these two trees will remove less than 10% of the canopy volume of each individual tree. Provided that the pruning works are undertaken in accordance with *AS 4373 - 2007 Pruning of Amenity Trees*, it will have little or no impact on the health or longevity of the four individual trees (Figure 7).

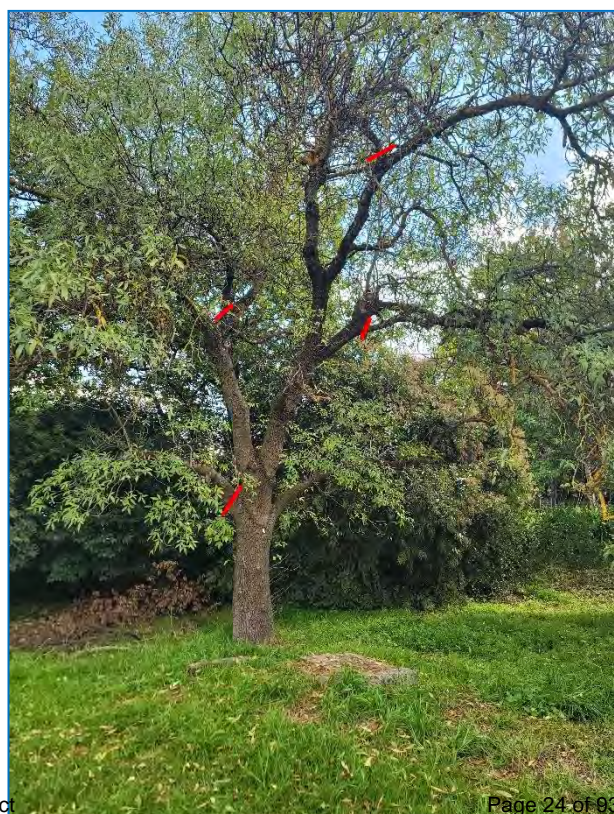
Figure 13 NYM118 Tree 36 pruning requirement

It is understood that no other trees will require pruning at this site.

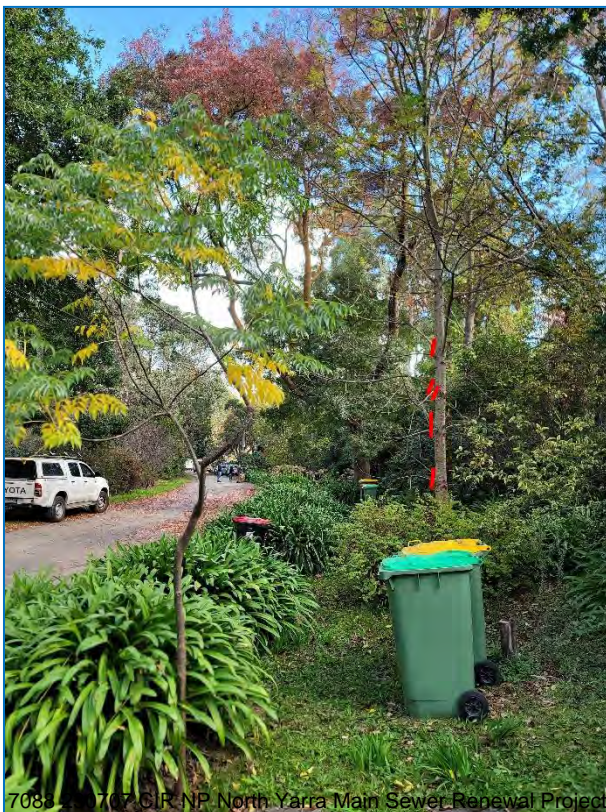
Figure 16 Tree 33 pruning

While this tree is very small and could be readily replaced, it would be preferable that it be preserved at the site.

The possibility of working around this tree should be explored.

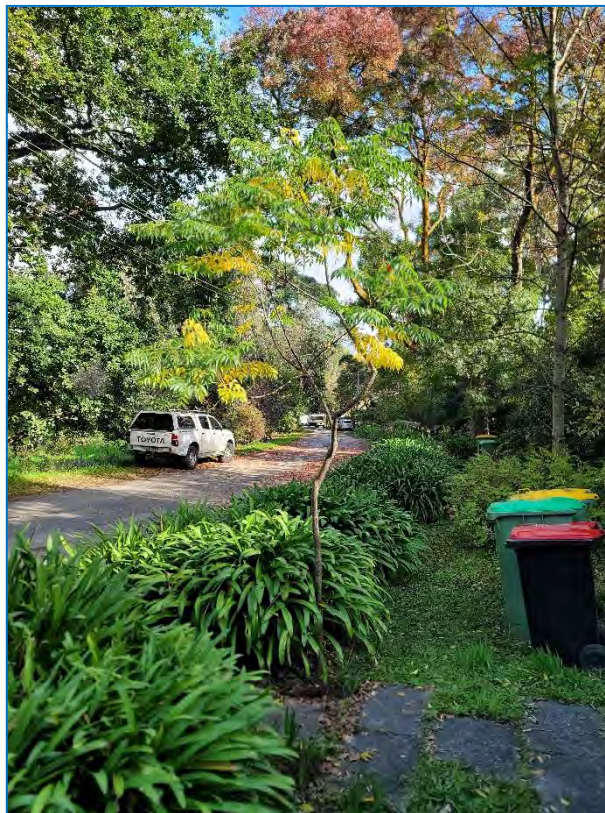
Figure 17 Tree 66 removal

Tree 66 (a *Melia azedarach* with low retention value) (Figure 17) is understood to be required to be removed to facilitate the proposed works. It is understood that the contractors regard this tree as a self seeded specimen although this would seem unlikely.

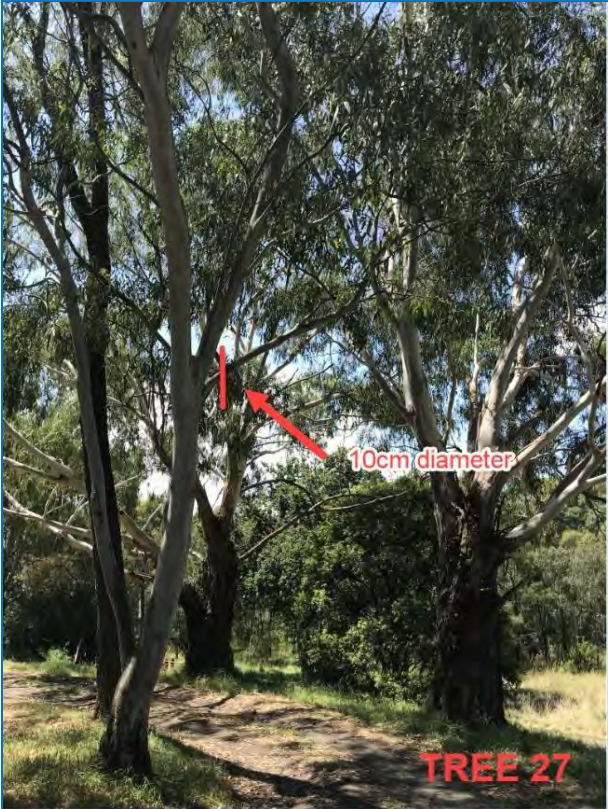
Figure 24 Tree 27 pruning (10cm limb)

It is understood that the proposed works will require the pruning of Trees 24 & 27 at NYM115.

The removal of these branches from each of these three trees will remove less than 10% of the canopy volume of each individual tree. Provided that the pruning works are undertaken in accordance with *AS 4373 - 2007 Pruning of Amenity Trees*, it will have little or no impact on the health or longevity of these three trees.

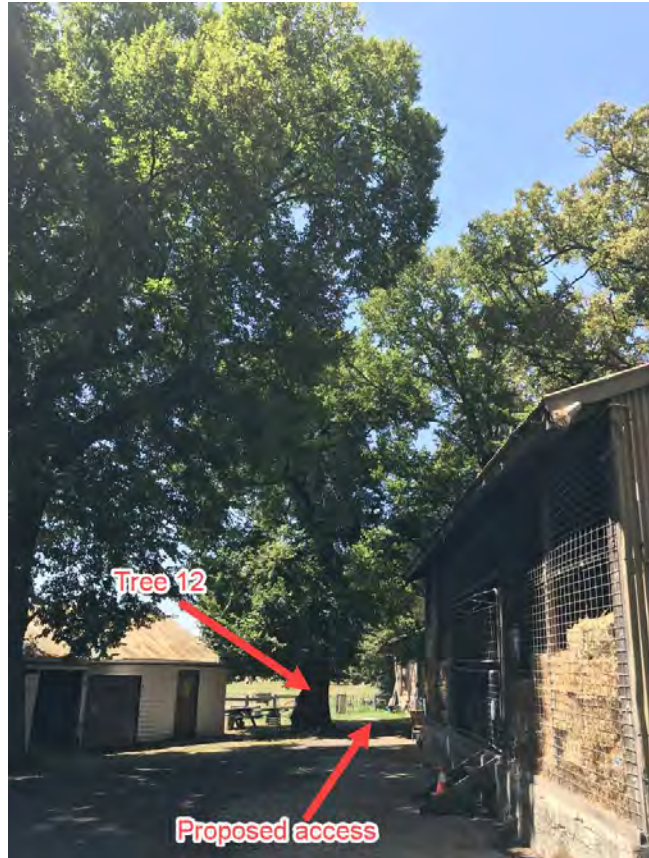
Figure 27 Proposed access adjacent to Tree 12 (NYM 113, NYM113a and NYM114)

without the removal of Tree 12 then it would be preferable to continue the access track from NYM113A directly to the south to NYM 113. While this would require the temporary relocation of the farm fencing for the duration of the works and its reinstatement following the completion of works.

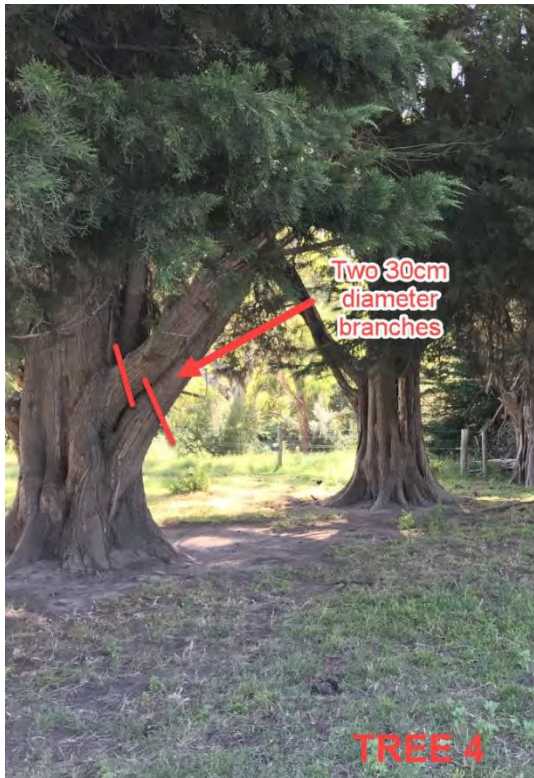
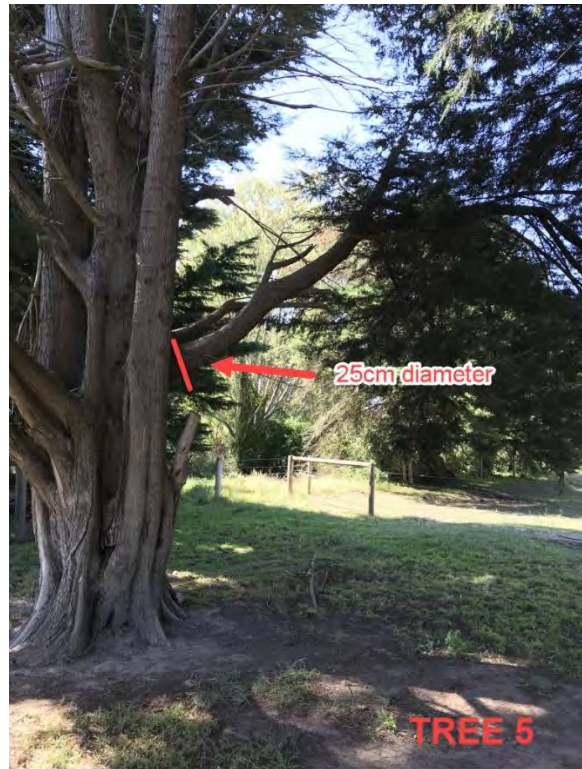
Figure 34 Pruning Tree4 and Tree 5 (NYM1113a)

The removal of these branches from each of these two trees will remove less than 10% of the canopy volume of each individual tree. Provided that the pruning works are undertaken in accordance with *AS 4373 - 2007 Pruning of Amenity Trees*, it will have little or no impact on the health or longevity of the two individual trees.

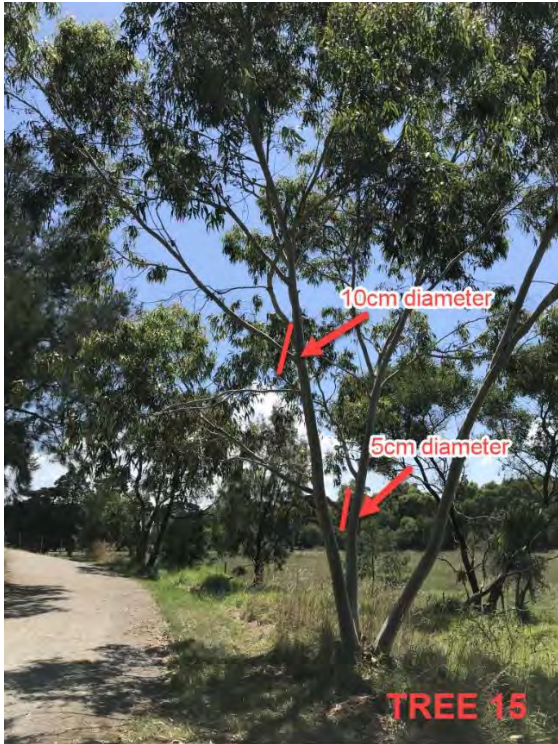
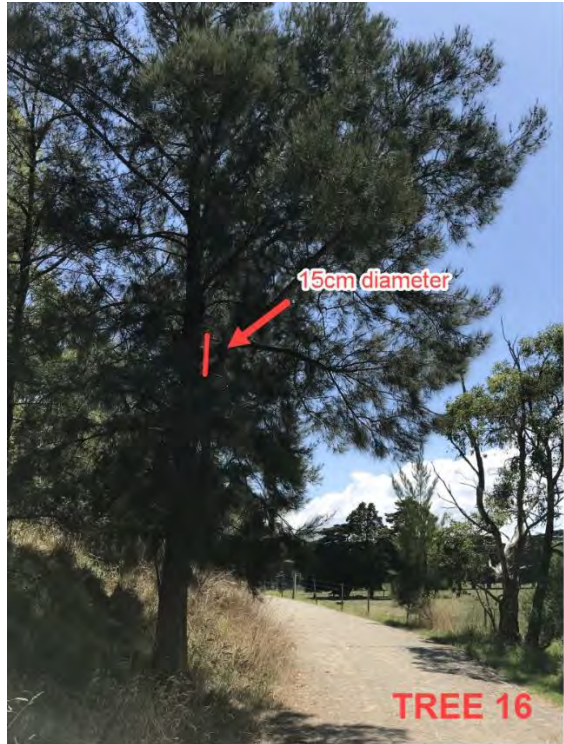
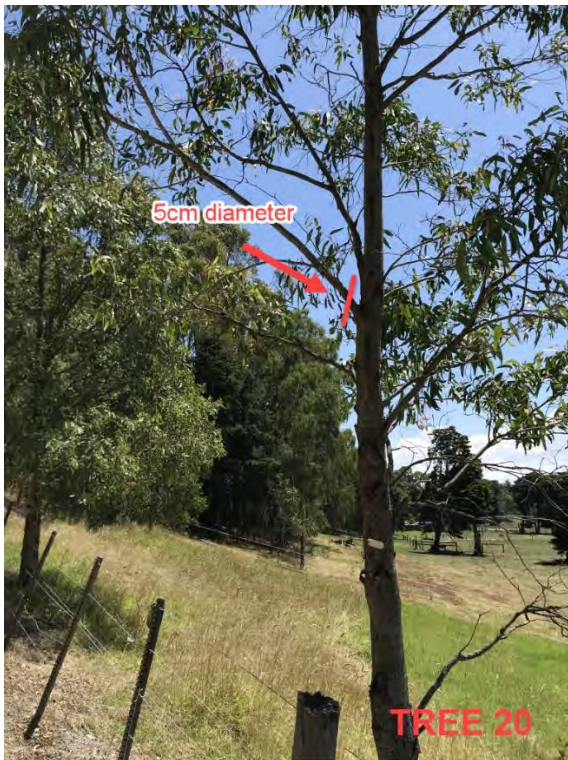
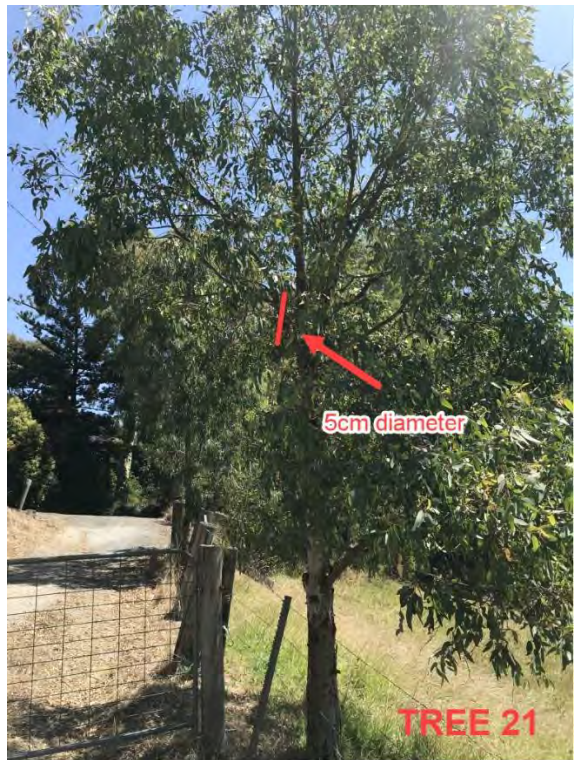
Figure 40 Pruning Trees 15, 16, 20 and 21 (NYM111a and NYM112)

Three trees (Tree 13, 14 and Tree 15) are located within approximately 10m of NYM111a. If additional clearance is required around the manholes, we recommend the retention of tree 15 (a *Corymbia citriodora* with a moderate retention value), and the removal of Tree 13 (an *Acacia melanoxylon* with a low retention value) and Tree 14 (a *Casuarina cunninghamiana* with a low retention value). Tree 15 is a mature 10 metre tall tree with an estimated ULE of 30 to 60 year; while Tree 13 and 14 are both under 6 metres tall. In comparison Trees 13 and 14 provides less amenity value. Refer to Figure 39 Figure 40.
