## Nation Partners

# Northern Sewers Relining Project Southern Section

## Construction Impact Report

**Wednesday 4<sup>th</sup> December 2024**

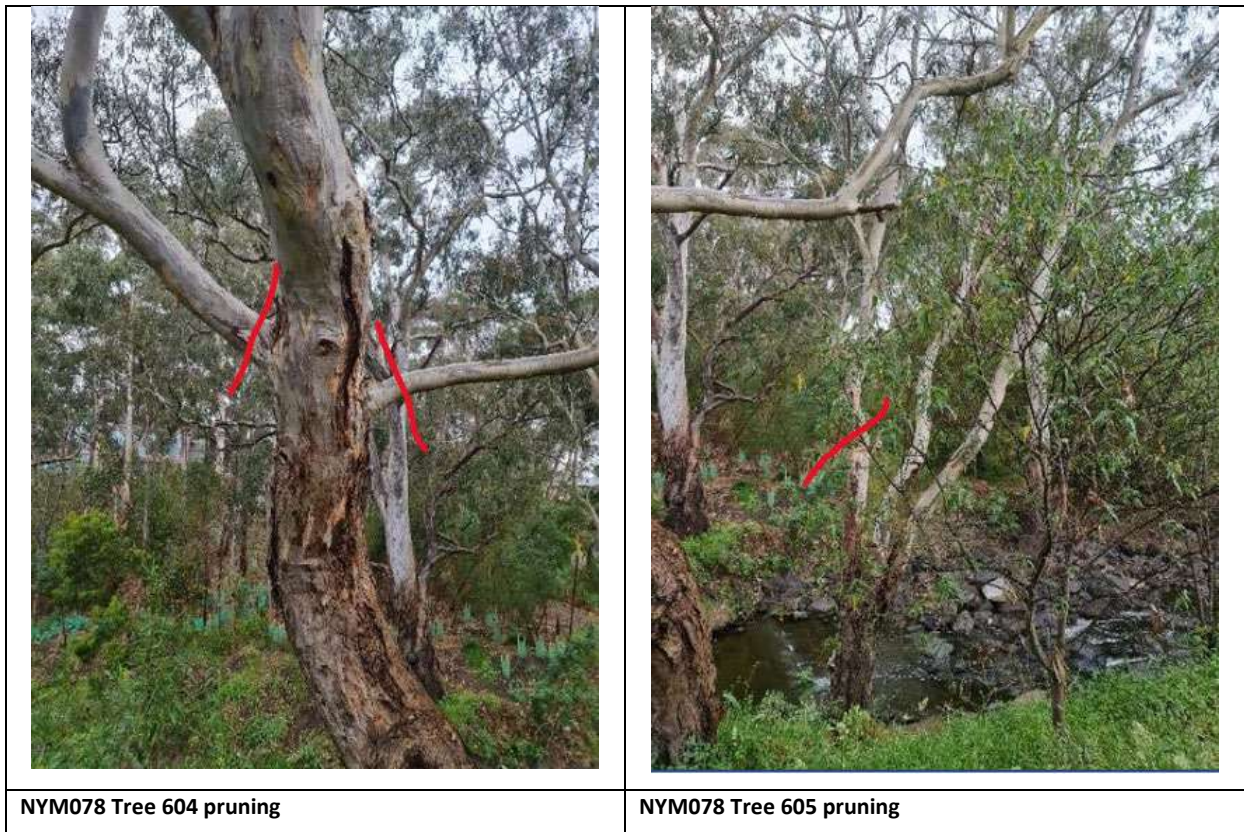
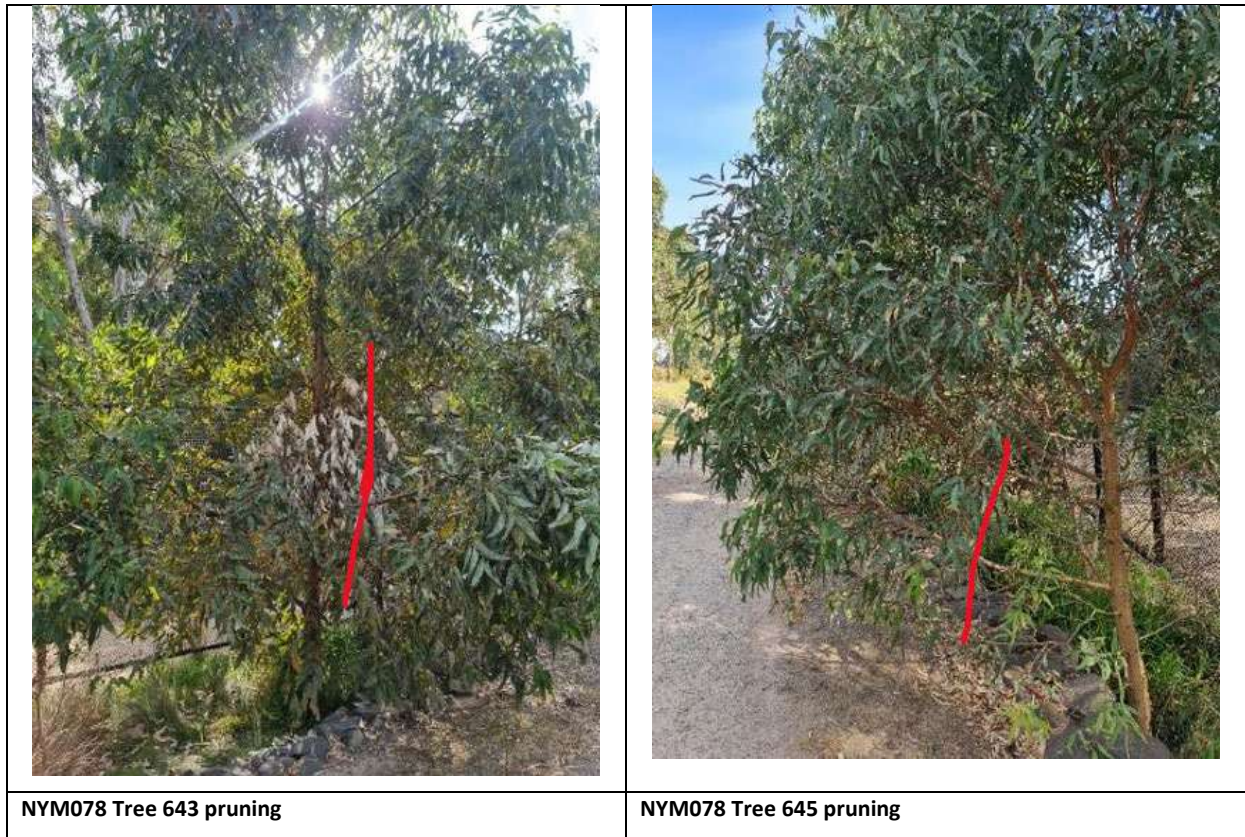
**Figure 2 NYM078 Pruning (City of Yarra)**

The pruning of four Trees (Trees 604, 605, 643 and 645) is required to enable access between this maintenance hole (NYM078) and NYM091 (which is located on the other side of Darebin Creek in the City of Banyule).

The removal of these branches from each of these four trees will remove less than 15% of the canopy volume of each individual tree. Provided that the pruning works are undertaken in accordance with *AS 4373 - 2007 Pruning of Amenity Trees*, it will have little or no impact on the health or longevity of the two individual trees.

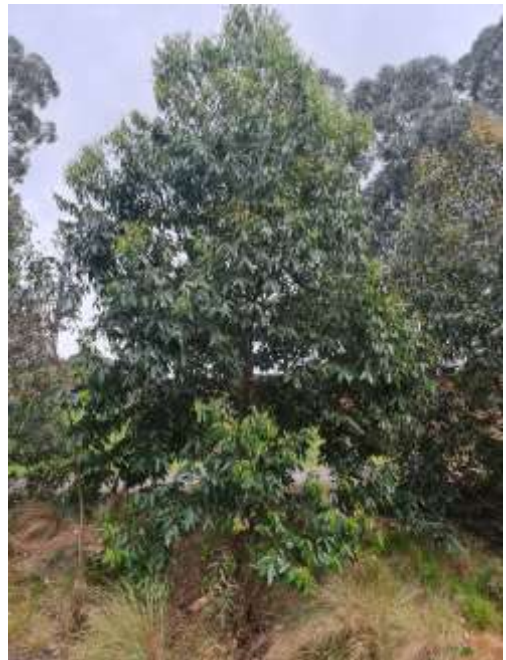
A permit is required to remove Trees 601 and 602.

**Tree ID:** 601  
**Genus / species:** *Eucalyptus botryoides*  
Evergreen Southern Mahogany  
**Height (m):** 7 **Structure:** Good  
**Width (m):** 4 **Health:** Good  
**DBH (cm):** 15 Estimated **Maturity:** Immature  
**Origin:** Victorian **ULE (years):** 30 - 60  
**Retained?:** Removed **Form:** Good  
**Retention Value:** Low  
**Removal / retention reason:** N/A.  
**Amenity value:** Low  
**Works Required:** N/A.

**SRZ (m):** 1.6 **Works priority:** N/A  
**TPZ (m):** 2.0 **Construction Proximity:** 0.1  
**mTPZ (m):**

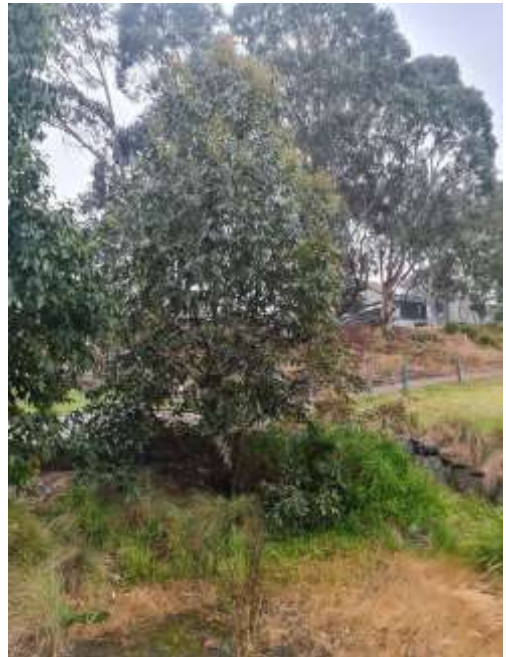
**Tree ID:** 602  
**Genus / species:** *Eucalyptus botryoides*  
Evergreen Southern Mahogany  
**Height (m):** 5 **Structure:** Good  
**Width (m):** 3 **Health:** Good  
**DBH (cm):** 12 Estimated **Maturity:** Immature  
**Origin:** Victorian **ULE (years):** 30 - 60  
**Retained?:** Removed **Form:** Good  
**Retention Value:** Low  
**Removal / retention reason:** N/A.  
**Amenity value:** Low  
**Works Required:** N/A.

**SRZ (m):** 1.6 **Works priority:** N/A  
**TPZ (m):** 2.0 **Construction Proximity:** 0.1  
**mTPZ (m):**

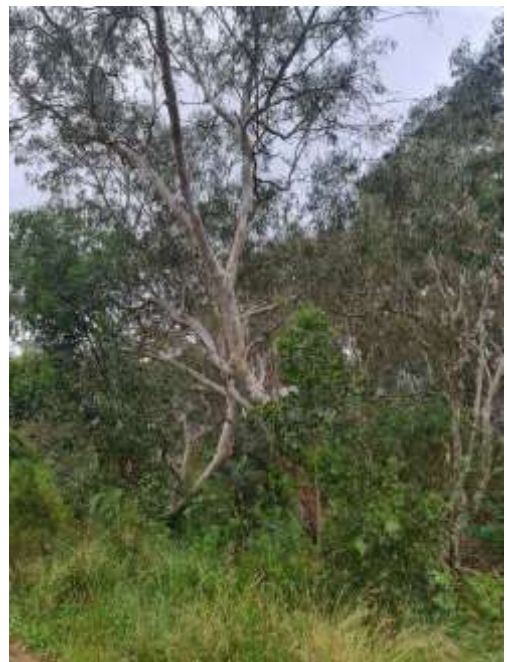
**Tree ID:** 604

**Height (m):** 17                      **Structure:** Fair  
**Width (m):** 15                      **Health:** Fair  
**DBH (cm):** 74      Measured **Maturity:** Mature  
**Origin:** Australian              **ULE (years):** > 60  
**Retained?:** Retained              **Form:** Fair  
**Retention Value:** Very high  
**Removal / retention reason:** N/A.  
**Amenity value:** High  
**Works Required:** Canopy lift.

**SRZ (m):** 3                      **Works priority:** Very low  
**TPZ (m):** 8.9              **Construction Proximity:** 0.1  
**mTPZ (m):**

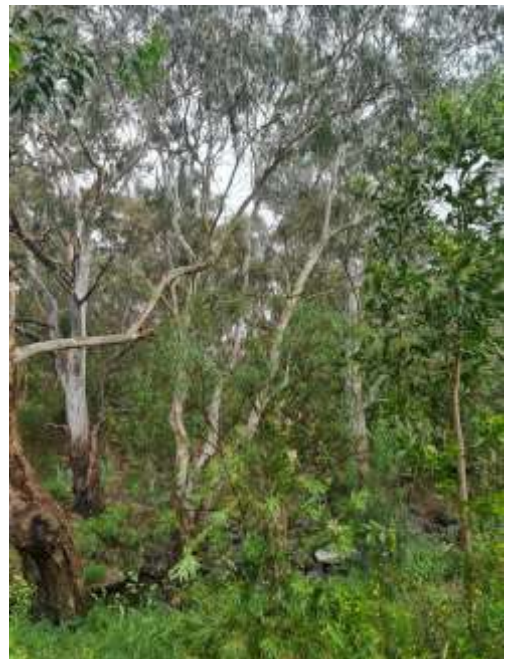
**Tree ID:** 605

**Height (m):** 14                      **Structure:** Fair  
**Width (m):** 10                      **Health:** Fair  
**DBH (cm):** 40      Measured **Maturity:** Mature  
**Origin:** Australian              **ULE (years):** > 60  
**Retained?:** Retained              **Form:** Fair  
**Retention Value:** High  
**Removal / retention reason:** N/A.  
**Amenity value:** Moderate  
**Works Required:** Canopy lift.

**SRZ (m):** 2.4                      **Works priority:** Very low  
**TPZ (m):** 4.8              **Construction Proximity:** 0.1  
**mTPZ (m):**

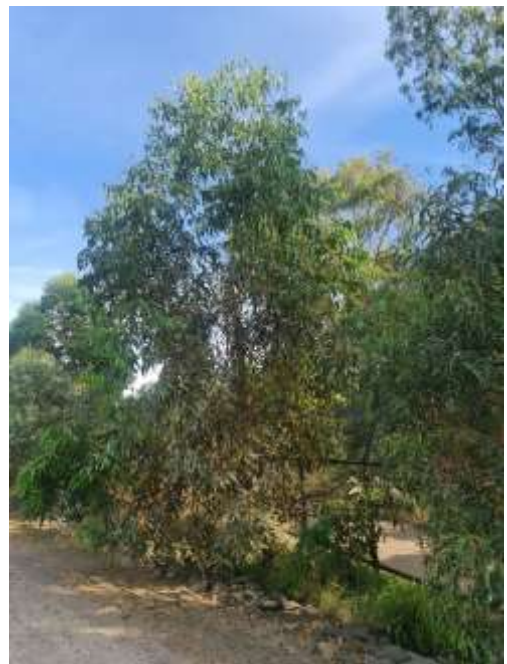
**Tree ID:** 643

<b>Height (m):</b> 8	<b>Structure:</b> Good
<b>Width (m):</b> 5	<b>Health:</b> Good
<b>DBH (cm):</b> 13 Measured	<b>Maturity:</b> Immature
<b>Origin:</b> Victorian	<b>ULE (years):</b> 30 - 60
<b>Retained?:</b> Retained	<b>Form:</b> Good
<b>Retention Value:</b>	Low
<b>Removal / retention reason:</b>	N/A.
<b>Amenity value:</b>	Low
<b>Works Required:</b>	Canopy lift.

<b>SRZ (m):</b> 1.6	<b>Works priority:</b>	Very low
<b>TPZ (m):</b> 2.0	<b>Construction Proximity:</b>	0.1
<b>mTPZ (m):</b>
