ARBORICULTURAL IMPACT ASSESSMENT

MT EVELYN WATER TREATMENT PLANT

SEPTEMBER 2023

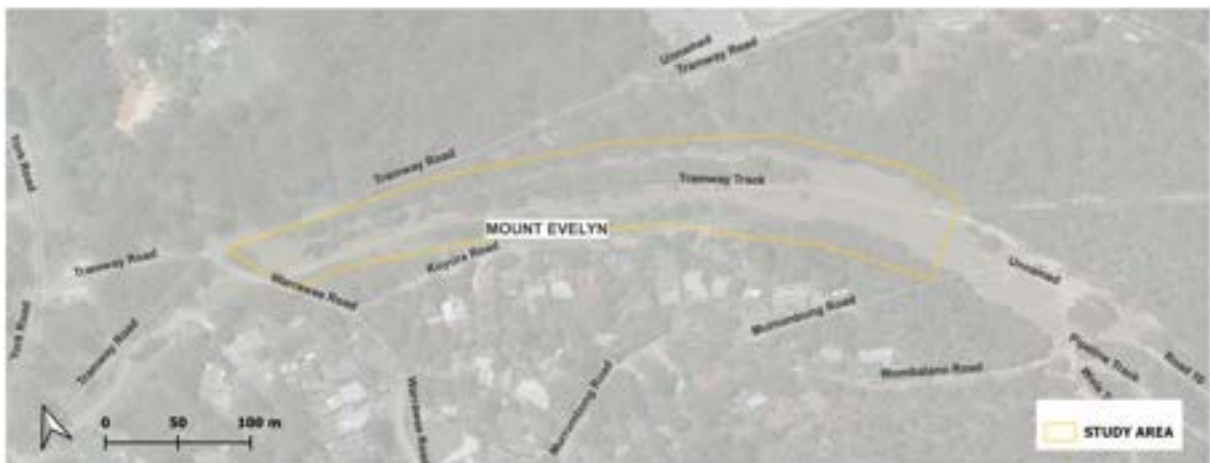
FIGURE 1 STUDY AREA

1.2.1 The study area is a linear portion of land along the western end of Tramway Track, Mt Evelyn, terminating at Tramway Road.

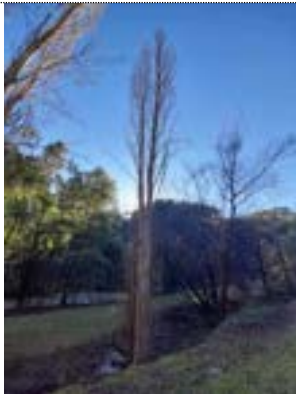
<p>TREE: 3</p>	<p><i>Populus nigra var. italica</i>, Lombardy Poplar. Arboricultural value: None</p>		
<p>Encroachment:</p>	<p>100.0 (SRZ)</p>	<p>Impact for Power:</p>	
	<p>Remove for drain and site civil works</p>		
<p>Impact:</p>	<p>Remove</p>

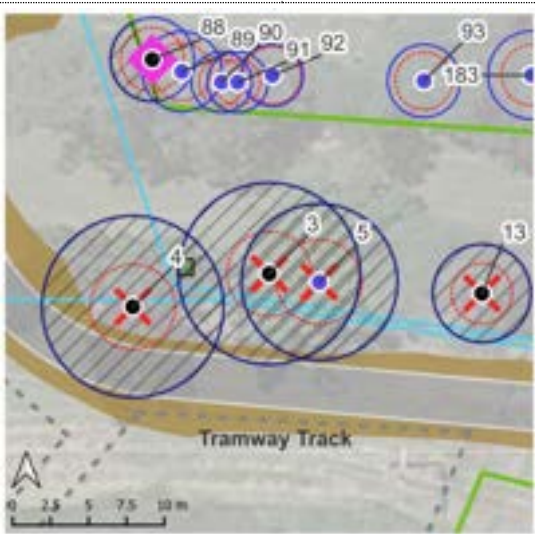
<p>TREE: 4</p>	<p><i>Populus nigra var. italica</i>, Lombardy Poplar. Arboricultural value: None</p>		
<p>Encroachment:</p>	<p>100.0 (SRZ)</p>	<p>Impact for Power:</p>	
	<p>Remove for drain and site civil works</p>		
<p>Impact:</p>	<p>Remove</p>

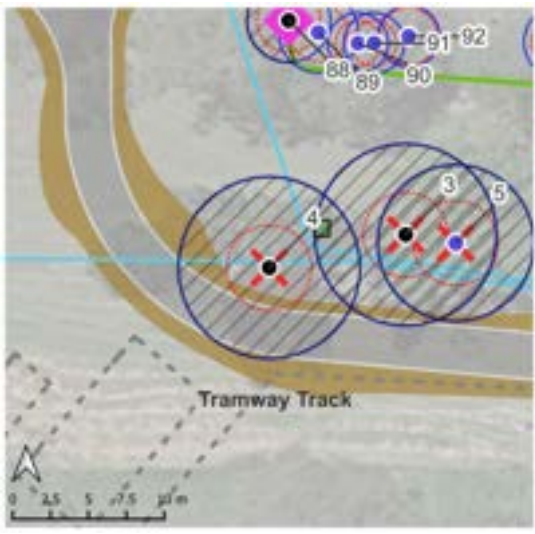
TREE: 5	<i>Salix x reichardtii</i> , Pussy Willow. Arboricultural value: Low		
Encroachment:	100.0 (SRZ)	Impact for Power:	
	Remove for drain and site civil works		
Impact:	Remove

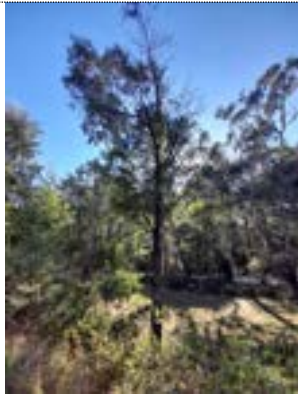
TREE: 7	<i>Acacia dealbata</i> , Silver Wattle. Arboricultural value: Low		
Encroachment:	17.0	Impact for Power:	
	Install ground protection for temporary construction access		
Impact:	Retain with mitigation measures

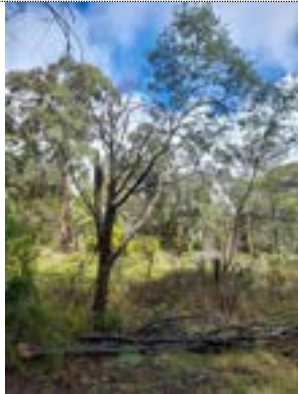
TREE: 14	<i>Acacia dealbata</i> , Silver Wattle. Arboricultural value: Low		
Encroachment:	5.5	Impact for Power:	
	Minor encroachment		
Impact:	Minor encroachment only

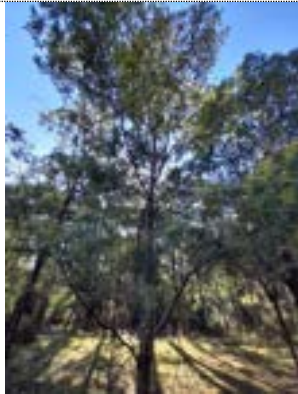
TREE: 16	<i>Acacia dealbata</i> , Silver Wattle. Arboricultural value: Moderate		
Encroachment:	.2	Impact for Power:	
	Minor encroachment		
Impact:	Minor encroachment only

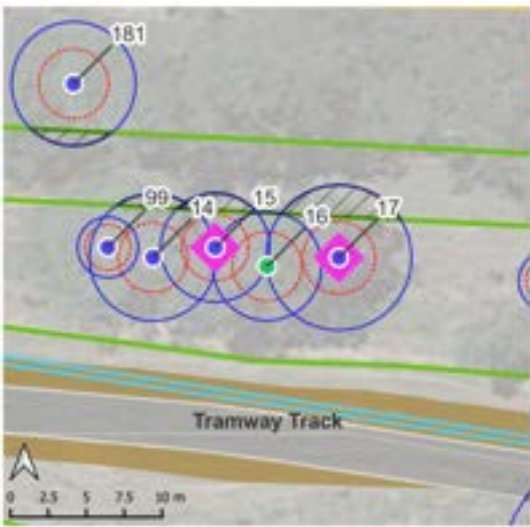
TREE: 17	<i>Acacia dealbata</i> , Silver Wattle. Arboricultural value: Low		
Encroachment:	16.1	Impact for Power:	
	Install ground protection for temporary construction access		
Impact:	Retain with mitigation measures

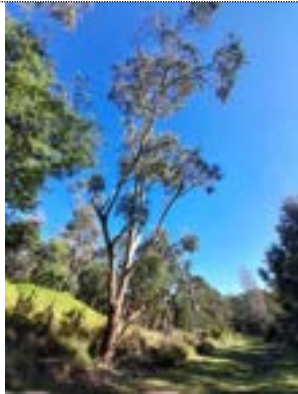
TREE: 18	<i>Eucalyptus ovata</i> , Swamp Gum. Arboricultural value: Moderate		
Encroachment:	26.6	Impact for Power:	
	Tree too close to civil and entry road construction		
Impact:	Remove

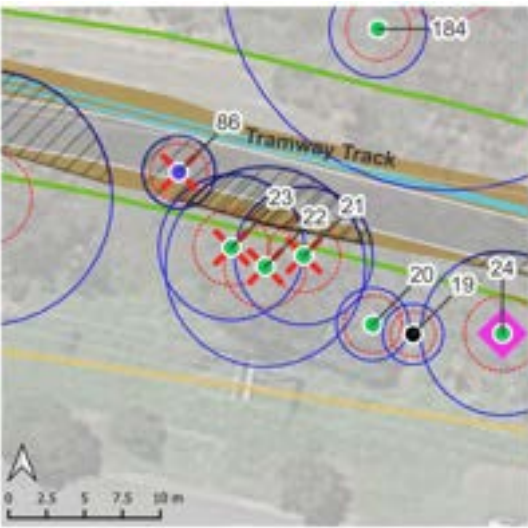
TREE: 23	<i>Eucalyptus ovata</i> , Swamp Gum. Arboricultural value: Moderate		
Encroachment:	22.9 (SRZ)	Impact for Power:	
	Tree too close to civil and entry road construction		
Impact:	Remove

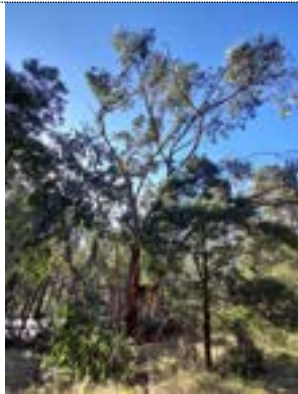
TREE: 32	<i>Eucalyptus obliqua</i> , Messmate. Arboricultural value: Moderate		
Encroachment:	18.1	Impact for Power:	
	Install ground protection for temporary construction access		
Impact:	Retain with mitigation measures

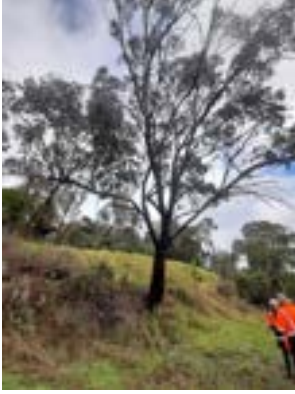
TREE: 46	<i>Eucalyptus ovata</i> , Swamp Gum. Arboricultural value: Moderate		
Encroachment:	7.8	Impact for Power:	
	Minor encroachment		
Impact:	Minor encroachment only

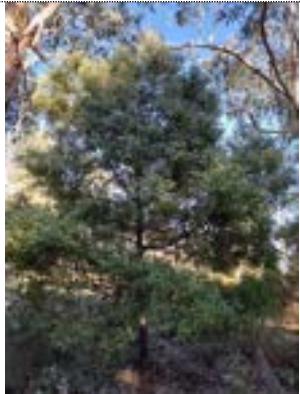
TREE: 49	<i>Acacia melanoxylon</i> , Blackwood. Arboricultural value: Low		
Encroachment:	100.0 (SRZ)	Impact for Power:	
	Remove for upgrade to site drainage		
Impact:	Remove

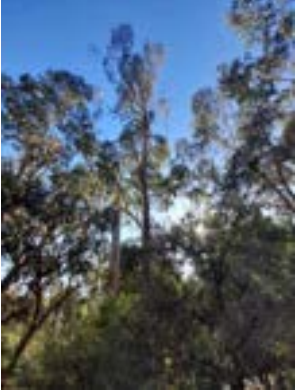
TREE: 54	<i>Eucalyptus ovata</i> , Swamp Gum. Arboricultural value: Moderate		
Encroachment:	-	Impact for Power:	Poor structure. Remove for new power line
Impact:	Remove for powerline

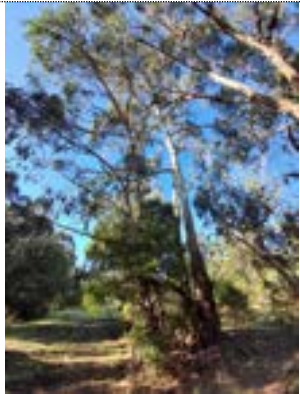
TREE: 55	<i>Eucalyptus ovata</i> , Swamp Gum. Arboricultural value: Moderate		
Encroachment:	.7	Impact for Power:	Heavy reduction pruning (lopping) required for new powerline
Impact:	Lop

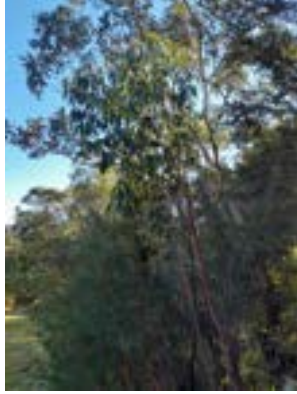
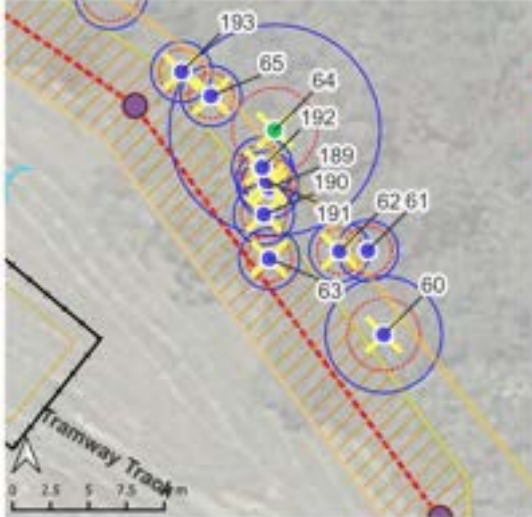
TREE: 63	<i>Eucalyptus ovata</i> , Swamp Gum. Arboricultural value: Low		
Encroachment:	-	Impact for Power:	Within / too close to new powerline
Impact:	Remove for powerline

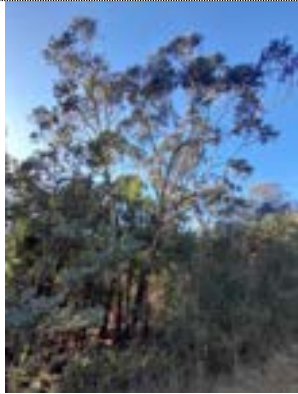
TREE: 64	<i>Eucalyptus ovata</i> , Swamp Gum. Arboricultural value: Moderate		
Encroachment:	-	Impact for Power:	Within / too close to new powerline
Impact:	Remove for powerline

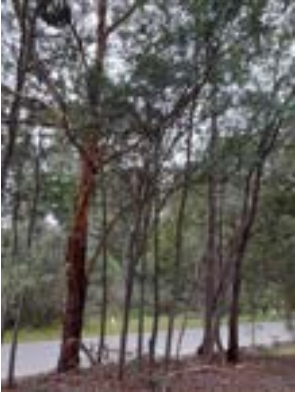
TREE: 90	<i>Acacia dealbata</i> , Silver Wattle. Arboricultural value: Low		
Encroachment:	.9	Impact for Power:	
	Minor encroachment		
Impact:	Minor encroachment only

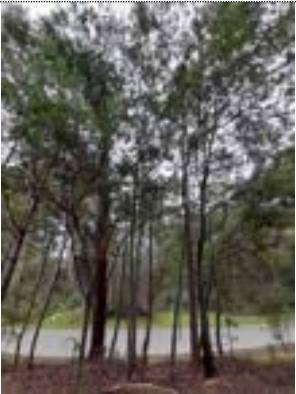
TREE: 91	<i>Acacia dealbata</i> , Silver Wattle. Arboricultural value: Low		
Encroachment:	.3	Impact for Power:	
	Minor encroachment		
Impact:	Minor encroachment only

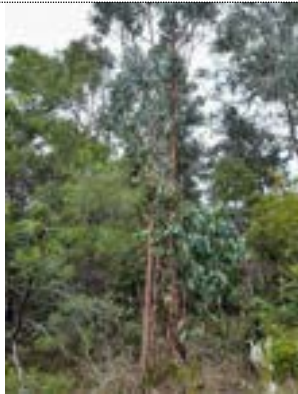
<p>TREE: 103</p> <ul style="list-style-type: none"> ✗ Remove - Construction ✗ Remove - Power ◆ Retain with mitigation

TREE: 103	<i>Eucalyptus ovata</i> , Swamp Gum. Arboricultural value: Low		
Encroachment:	41.7 (SRZ)	Impact for Power:	
	Remove for new drainage works from existing swale		
Impact:	Remove

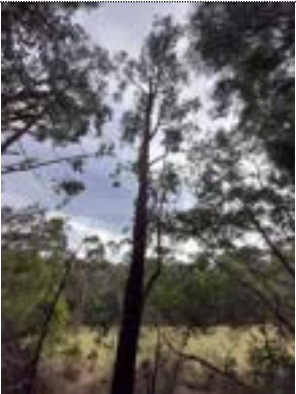
TREE: 104	<i>Eucalyptus obliqua</i> , Messmate. Arboricultural value: Moderate		
Encroachment:	23.6 (SRZ)	Impact for Power:	
	Remove for new drainage works from existing swale		
Impact:	Remove

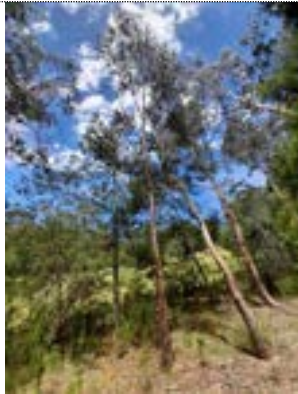
<p>TREE: 115</p> <ul style="list-style-type: none"> ✗ Remove - Construction ✗ Remove - Power ◆ Retain with mitigation

TREE: 115	<i>Eucalyptus ovata</i> , Swamp Gum. Arboricultural value: Moderate		
Encroachment:	100.0	Impact for Power:	
	Remove for dosing shed works and fence construction		
Impact:	Remove

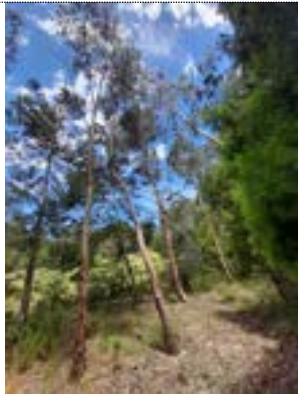
<p>TREE: 116</p> <ul style="list-style-type: none"> ✗ Remove - Construction ✗ Remove - Power ◆ Retain with mitigation

TREE: 116	<i>Eucalyptus ovata</i> , Swamp Gum. Arboricultural value: Moderate		
Encroachment:	100.0 (SRZ)	Impact for Power:	
	Remove for dosing shed works and fence construction		
Impact:	Remove

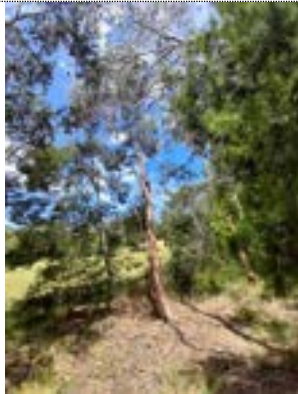
TREE: 118	<i>Eucalyptus ovata</i> , Swamp Gum. Arboricultural value: Moderate		
Encroachment:	99.9 (SRZ)	Impact for Power:	
	In construction footprint		
Impact:	Remove

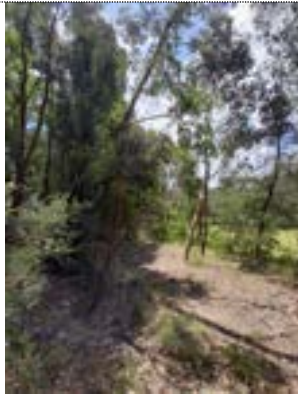
TREE: 119	<i>Eucalyptus ovata</i> , Swamp Gum. Arboricultural value: Low		
Encroachment:	100.0	Impact for Power:	
	Remove for dosing shed works and fence construction		
Impact:	Remove

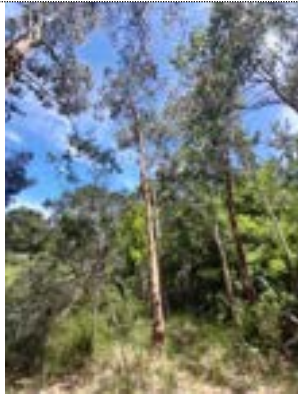
<p>TREE: 123</p> <ul style="list-style-type: none"> ✗ Remove - Construction ★ Remove - Power ◆ Retain with mitigation

TREE: 123	<i>Eucalyptus goniocalyx</i> , Long-leaved Box. Arboricultural value: Moderate		
Encroachment:	100.0 (SRZ)	Impact for Power:	
	Remove for dosing shed works and fence construction		
Impact:	Remove

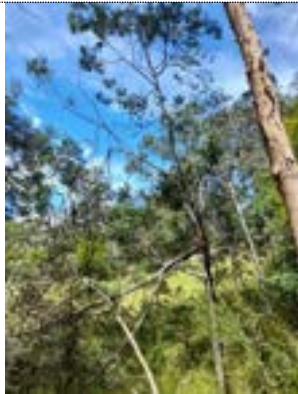
<p>TREE: 131</p> <ul style="list-style-type: none"> ✗ Remove - Construction ★ Remove - Power ◆ Retain with mitigation

TREE: 131	<i>Acacia dealbata</i> , Silver Wattle. Arboricultural value: Low		
Encroachment:	100.0 (SRZ)	Impact for Power:	
	Remove for dosing shed works and fence construction		
Impact:	Remove

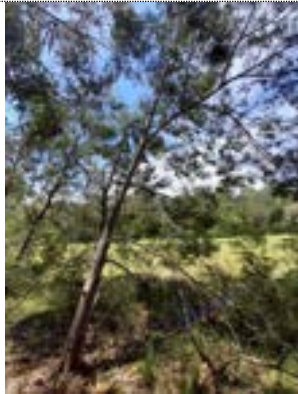
TREE: 132	<i>Acacia dealbata</i> , Silver Wattle. Arboricultural value: Low		
Encroachment:	100.0 (SRZ)	Impact for Power:	
	In construction footprint		
Impact:	Remove

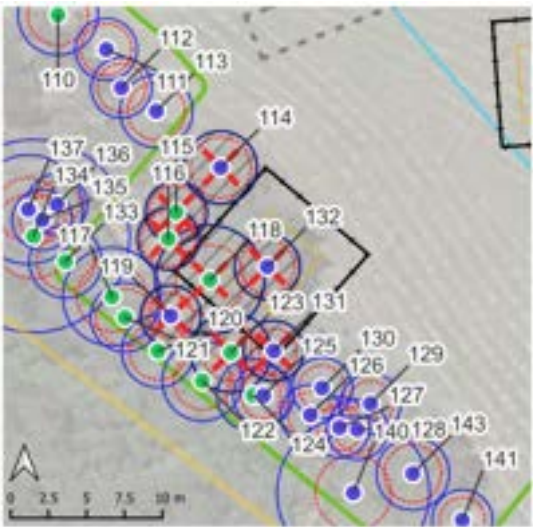
TREE: 138	<i>Acacia dealbata</i> , Silver Wattle. Arboricultural value: Low		
Encroachment:	12.6 (SRZ)	Impact for Power:	
	Remove for new drainage works from existing swale		
Impact:	Remove

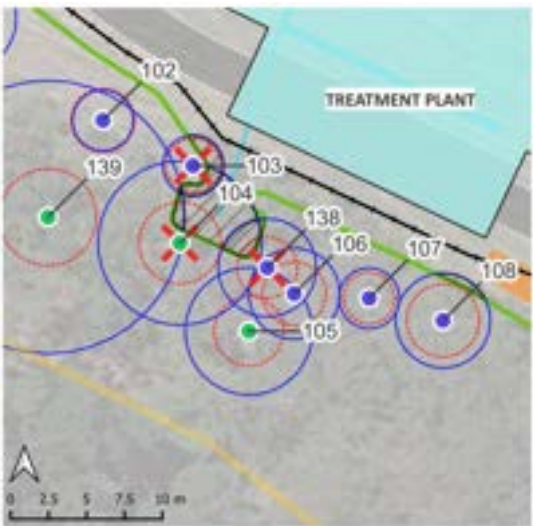
TREE: 139	<i>Eucalyptus obliqua</i> , Messmate. Arboricultural value: Moderate		
Encroachment:	.5	Impact for Power:	
	Minor encroachment		
Impact:	Minor encroachment only

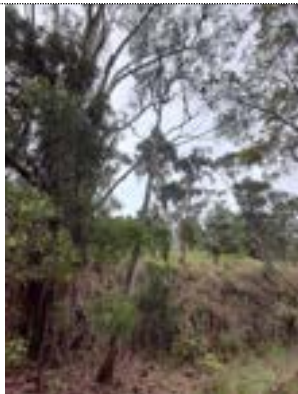
<p>TREE: 151</p> <ul style="list-style-type: none"> ✗ Remove - Construction ★ Remove - Power ◆ Retain with mitigation

TREE: 151	<i>Eucalyptus ovata</i> , Swamp Gum. Arboricultural value: Moderate		
Encroachment:	2.9	Impact for Power:	
	Minor encroachment		
Impact:	Minor encroachment only

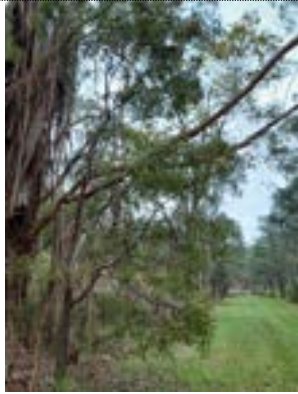
TREE: 152	<i>Acacia melanoxylon</i> , Blackwood. Arboricultural value: Low		
Encroachment:	33.1 (SRZ)	Impact for Power:	
	Install ground protection for temporary construction access		
Impact:	Retain with mitigation measures

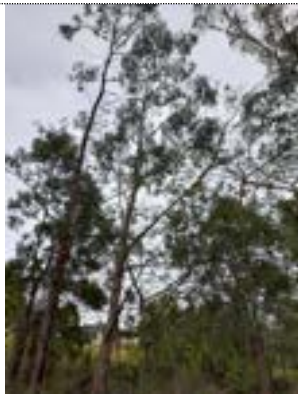
<p>TREE: 157</p> <ul style="list-style-type: none"> ✗ Remove - Construction ✗ Remove - Power ◆ Retain with mitigation

TREE: 157	<i>Eucalyptus ovata</i> , Swamp Gum. Arboricultural value: Moderate		
Encroachment:	5.8	Impact for Power:	
	Minor encroachment		
Impact:	Minor encroachment only

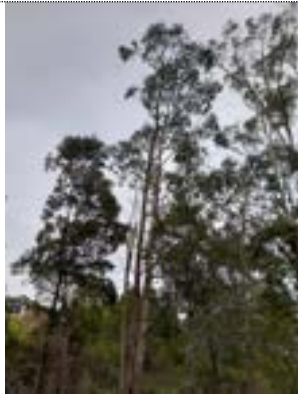
<p>TREE: 158</p> <ul style="list-style-type: none"> ✗ Remove - Construction ✖ Remove - Power ◆ Retain with mitigation

TREE: 158	<i>Eucalyptus ovata</i> , Swamp Gum. Arboricultural value: Moderate		
Encroachment:	6.9	Impact for Power:	
	Temporary access only through TPZ		
Impact:	Minor encroachment only

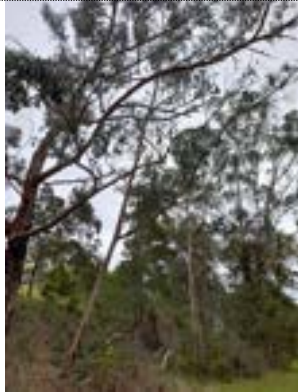
TREE: 160	<i>Eucalyptus ovata</i> , Swamp Gum. Arboricultural value: Moderate		
Encroachment:	6.7 (SRZ)	Impact for Power:	
	Install ground protection for temporary construction access		
Impact:	Retain with mitigation measures

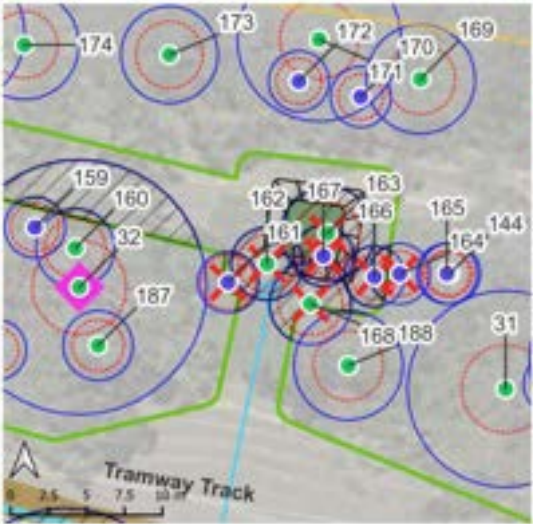
TREE: 163	<i>Eucalyptus ovata</i> , Swamp Gum. Arboricultural value: Moderate		
Encroachment:	100 (SRZ)	Impact for Power:	
	In flow meter footprint		
Impact:	Remove

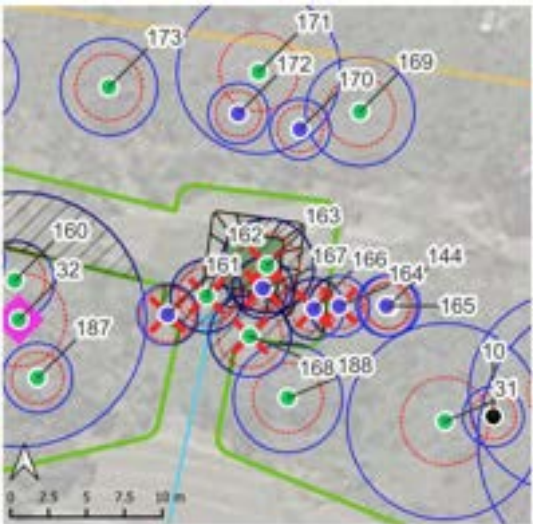
TREE: 164	<i>Acacia melanoxylon</i> , Blackwood. Arboricultural value: Low		
Encroachment:	24.4 (SRZ)	Impact for Power:	
	Remove for construction access to Flow meter		
Impact:	Remove

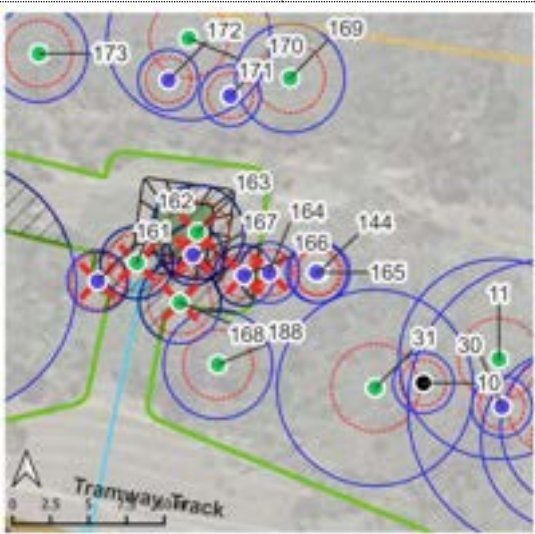
TREE: 166	<i>Acacia melanoxylon</i> , Blackwood. Arboricultural value: Low		
Encroachment:	74.5 (SRZ)	Impact for Power:	
	Remove for construction access to Flow meter		
Impact:	Remove

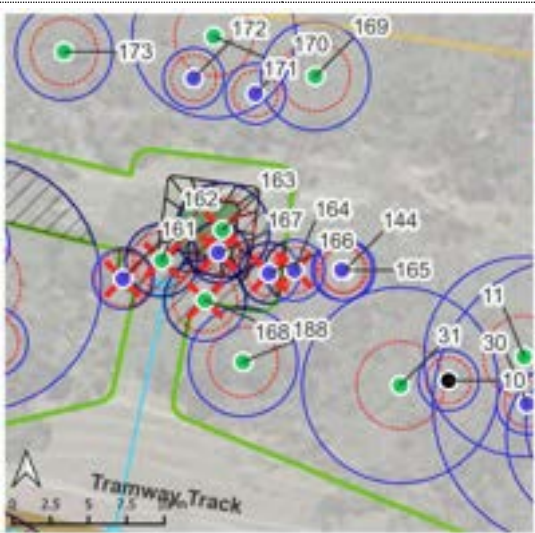
TREE: 167	<i>Acacia melanoxylon</i> , Blackwood. Arboricultural value: Low		
Encroachment:	100.0 (SRZ)	Impact for Power:	
	In flow meter footprint		
Impact:	Remove

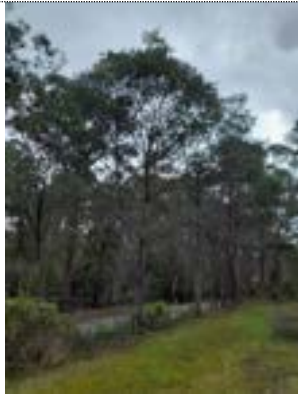
TREE: 181	<i>Acacia dealbata</i> , Silver Wattle. Arboricultural value: Low		
Encroachment:	6.9	Impact for Power:	
	Temporary access only through TPZ		
Impact:	Minor encroachment only

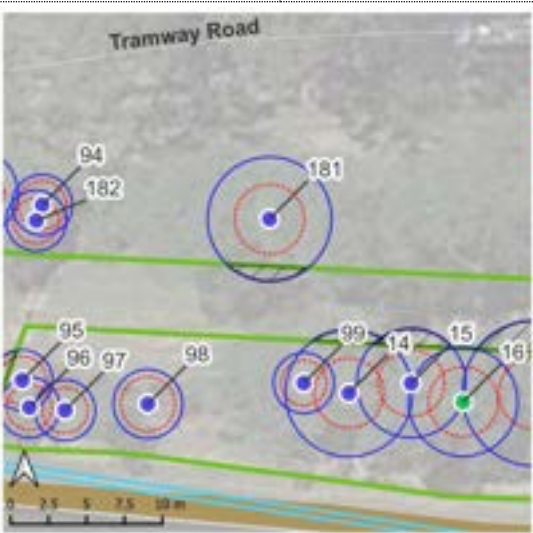
TREE: 188	<i>Acacia melanoxylon</i> , Blackwood. Arboricultural value: Moderate		
Encroachment:	.3	Impact for Power:	
	Minor encroachment		
Impact:	Minor encroachment only

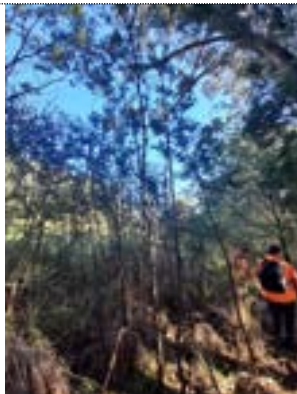
<p>TREE: 190</p> <ul style="list-style-type: none"> ✗ Remove - Construction ★ Remove - Power ● Retain with mitigation

TREE: 190	<i>Acacia dealbata</i> , Silver Wattle. Arboricultural value: Low		
Encroachment:	-	Impact for Power:	Within / too close to new powerline
Impact:	Remove for powerline

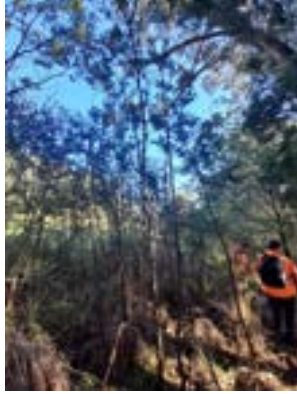
<p>TREE: 192</p> <ul style="list-style-type: none"> ✖ Remove - Construction ★ Remove - Power ● Retain with mitigation

TREE: 192	<i>Acacia dealbata</i> , Silver Wattle. Arboricultural value: Low		
Encroachment:	-	Impact for Power:	Within / too close to new powerline
Impact:	Remove for powerline

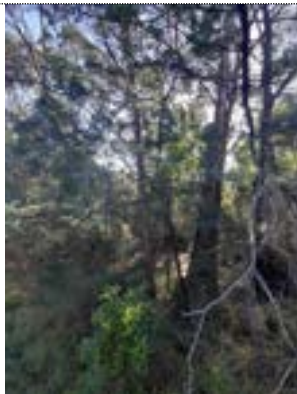
<p>TREE: 194</p> <ul style="list-style-type: none"> ✗ Remove - Construction ✗ Remove - Power ◆ Retain with mitigation

TREE: 194	<i>Acacia dealbata</i> , Silver Wattle. Arboricultural value: Low		
Encroachment:	-	Impact for Power:	Within / too close to new powerline
Impact:	Remove for powerline

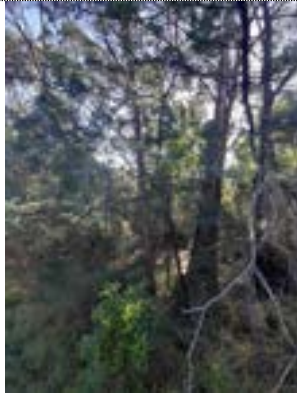
TREE: 195	<i>Acacia dealbata</i> , Silver Wattle. Arboricultural value: Low		
Encroachment:	-	Impact for Power:	Within / too close to new powerline
Impact:	Remove for powerline

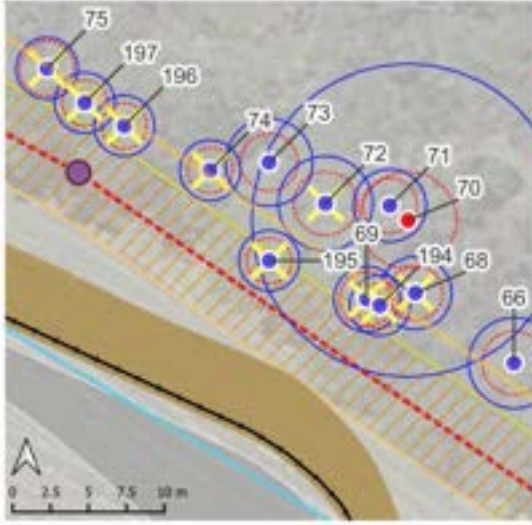
TREE: 196	<i>Eucalyptus ovata</i> , Swamp Gum. Arboricultural value: Low		
Encroachment:	-	Impact for Power:	Within / too close to new powerline
Impact:	Remove for powerline

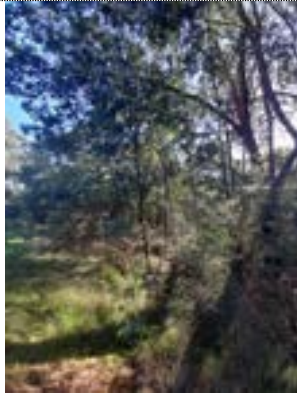
<p>TREE: 197</p> <ul style="list-style-type: none"> ✖ Remove - Construction ★ Remove - Power ◆ Retain with mitigation

TREE: 197	<i>Eucalyptus ovata</i> , Swamp Gum. Arboricultural value: Low		
Encroachment:	-	Impact for Power:	Within / too close to new powerline
Impact:	Remove for powerline

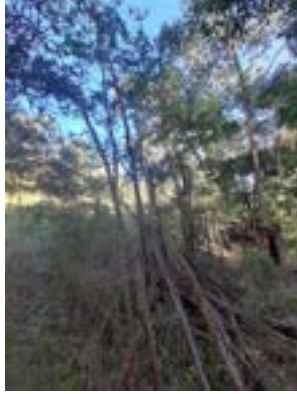
<p>TREE: 198</p> <ul style="list-style-type: none"> ✖ Remove - Construction ★ Remove - Power ◆ Retain with mitigation

TREE: 198	<i>Acacia dealbata</i> , Silver Wattle. Arboricultural value: Low		
Encroachment:	-	Impact for Power:	Within / too close to new powerline
Impact:	Remove for powerline

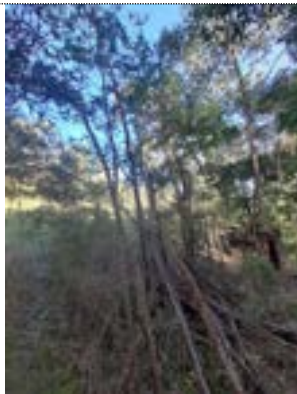
TREE: 200	<i>Acacia dealbata</i> , Silver Wattle. Arboricultural value: Low		
Encroachment:	-	Impact for Power:	Within / too close to new powerline
Impact:	Remove for powerline

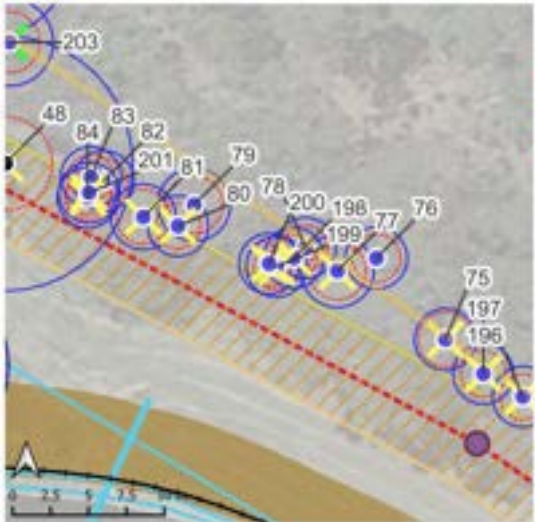
TREE: 201	<i>Acacia melanoxylon</i> , Blackwood. Arboricultural value: Low		
Encroachment:	-	Impact for Power:	Within / too close to new powerline
Impact:	Remove for powerline

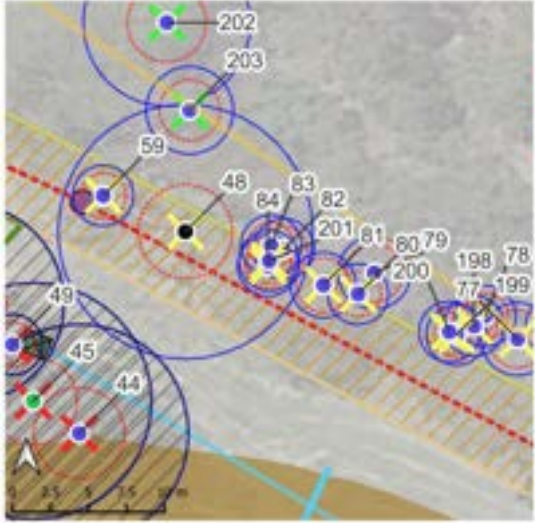
TREE: 202	<i>Eucalyptus ovata</i> , Swamp Gum. Arboricultural value: Low		
Encroachment:	-	Impact for Power:	Grows out from adjacent land. Lop for powerline
Impact:	Lop

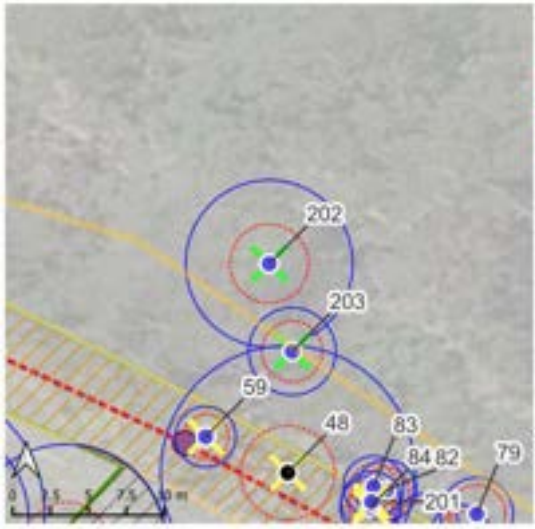
TREE: 203	<i>Eucalyptus ovata</i> , Swamp Gum. Arboricultural value: Low		
Encroachment:	-	Impact for Power:	Grows out from adjacent land. Lop for powerline
Impact:	Lop

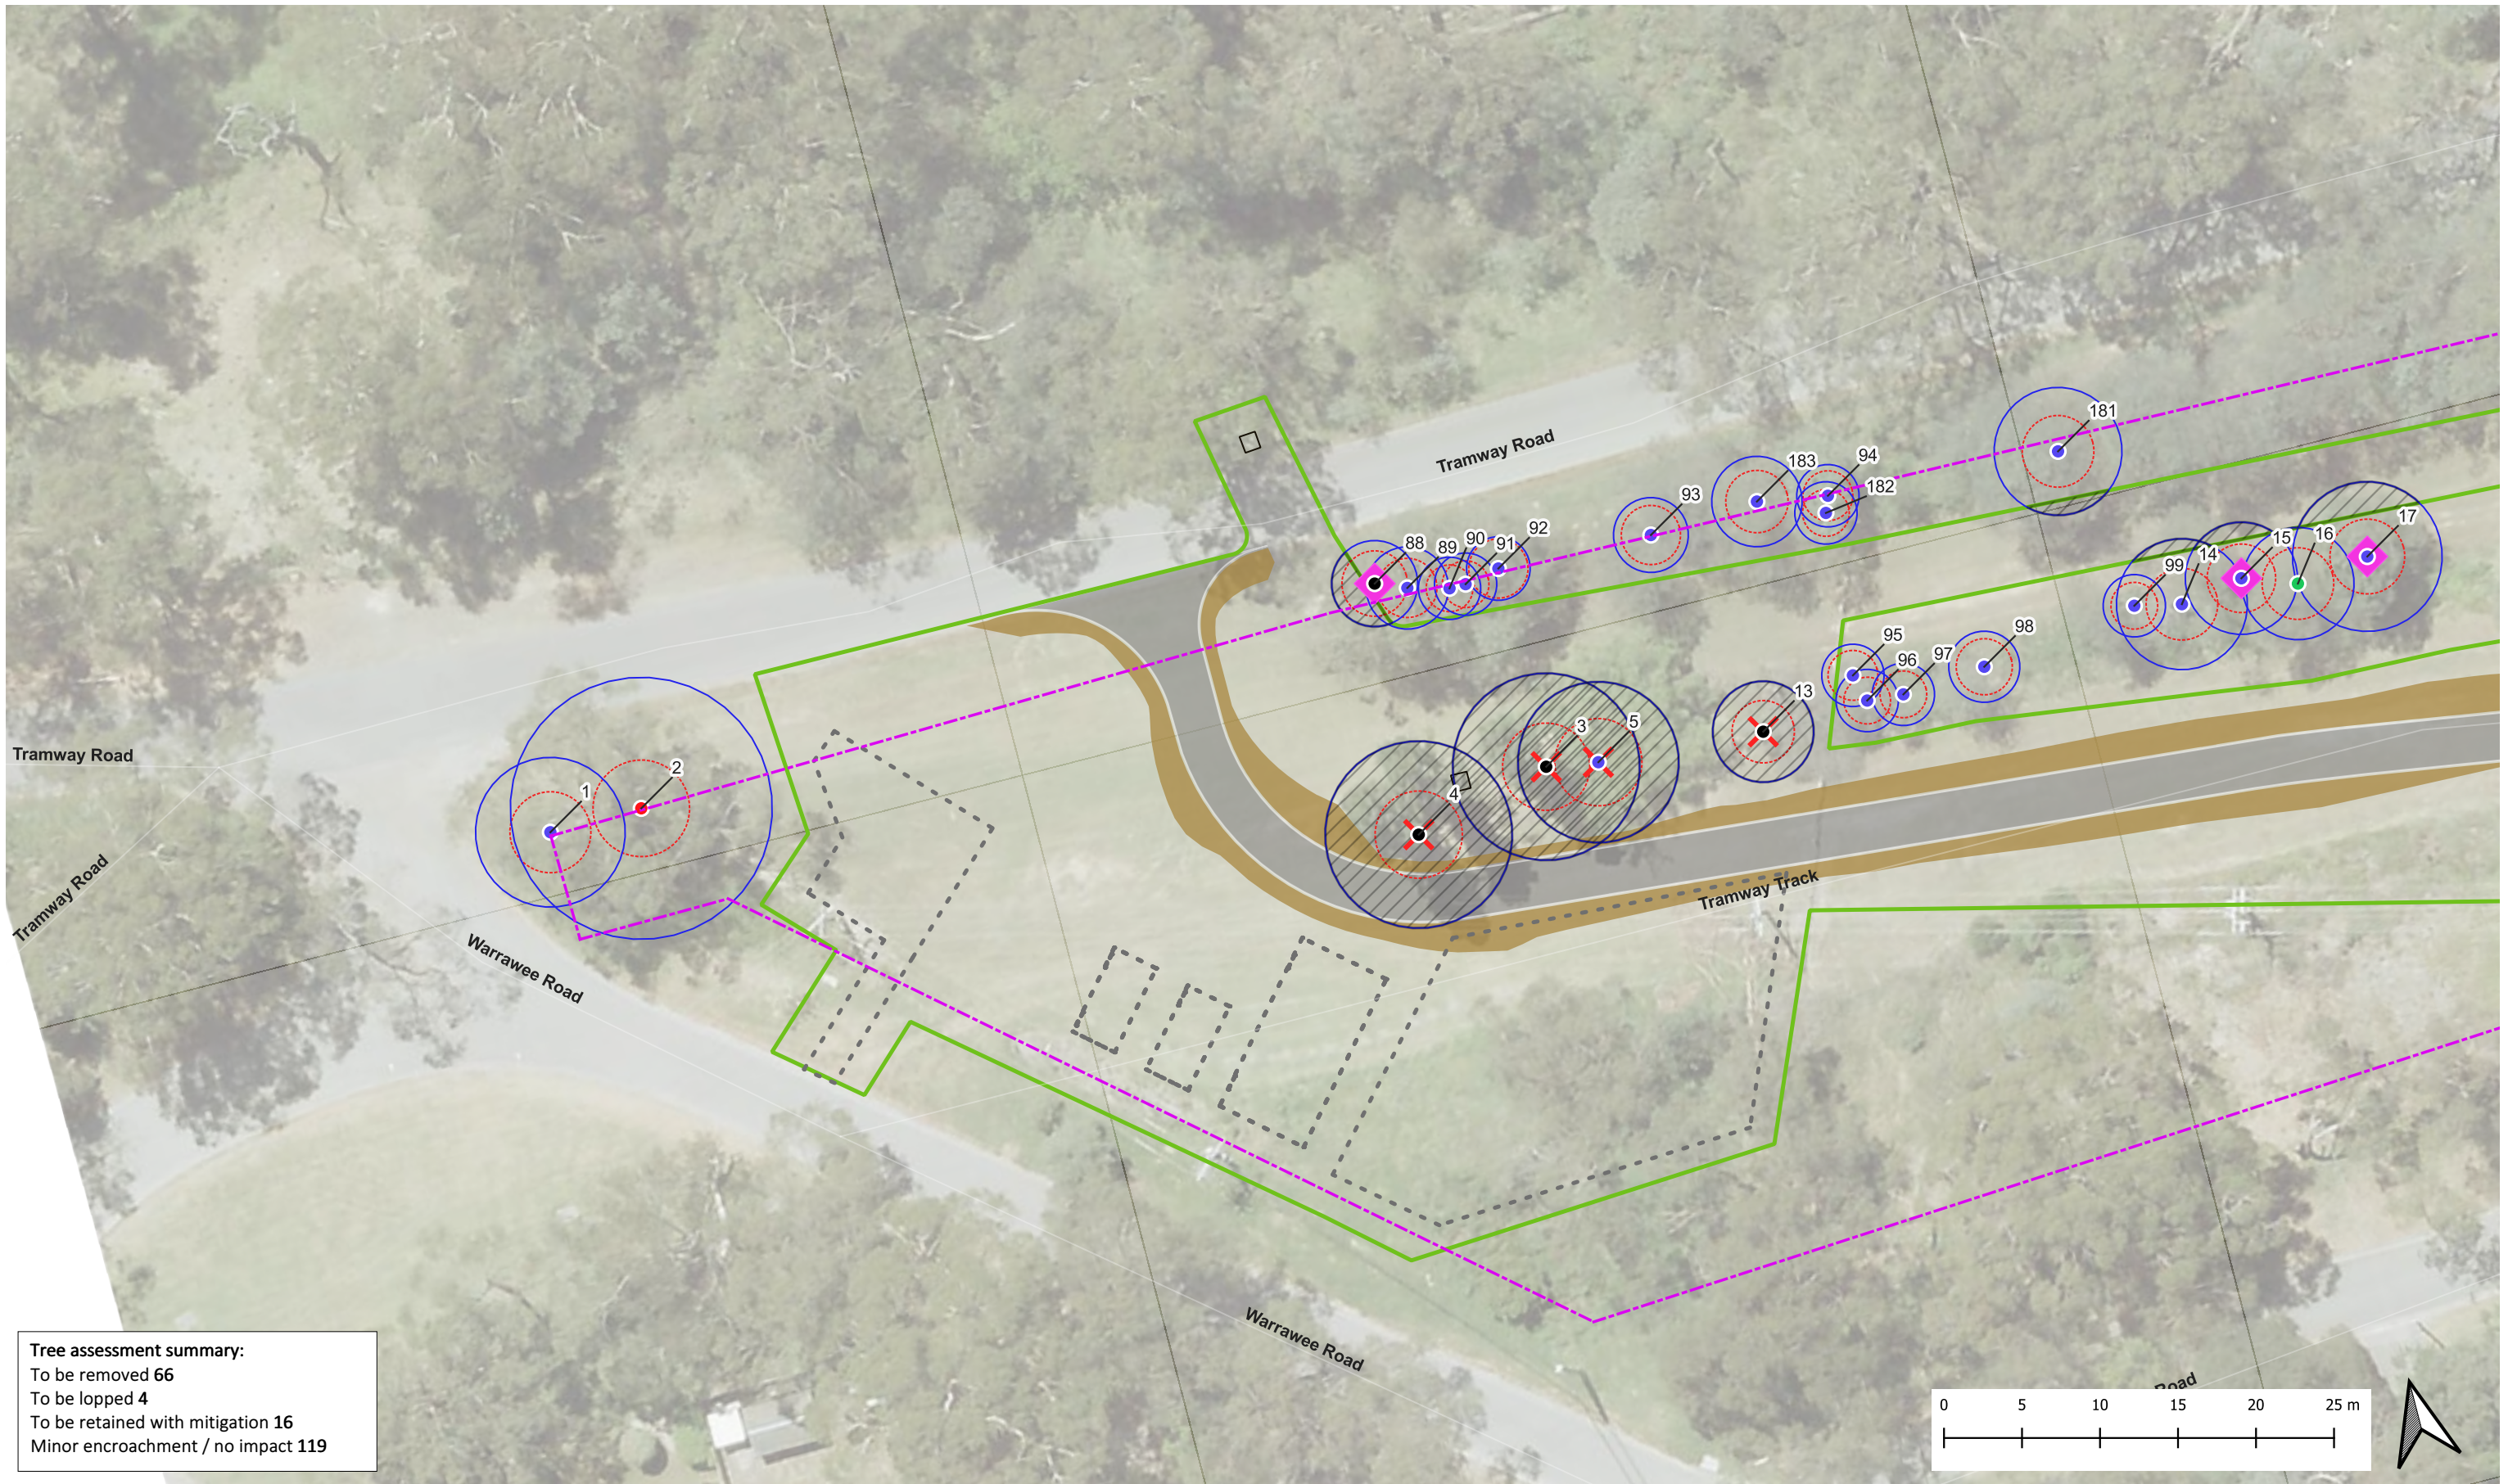
Tree assessment summary:
 To be removed 66
 To be lopped 4
 To be retained with mitigation 16
 Minor encroachment / no impact 119

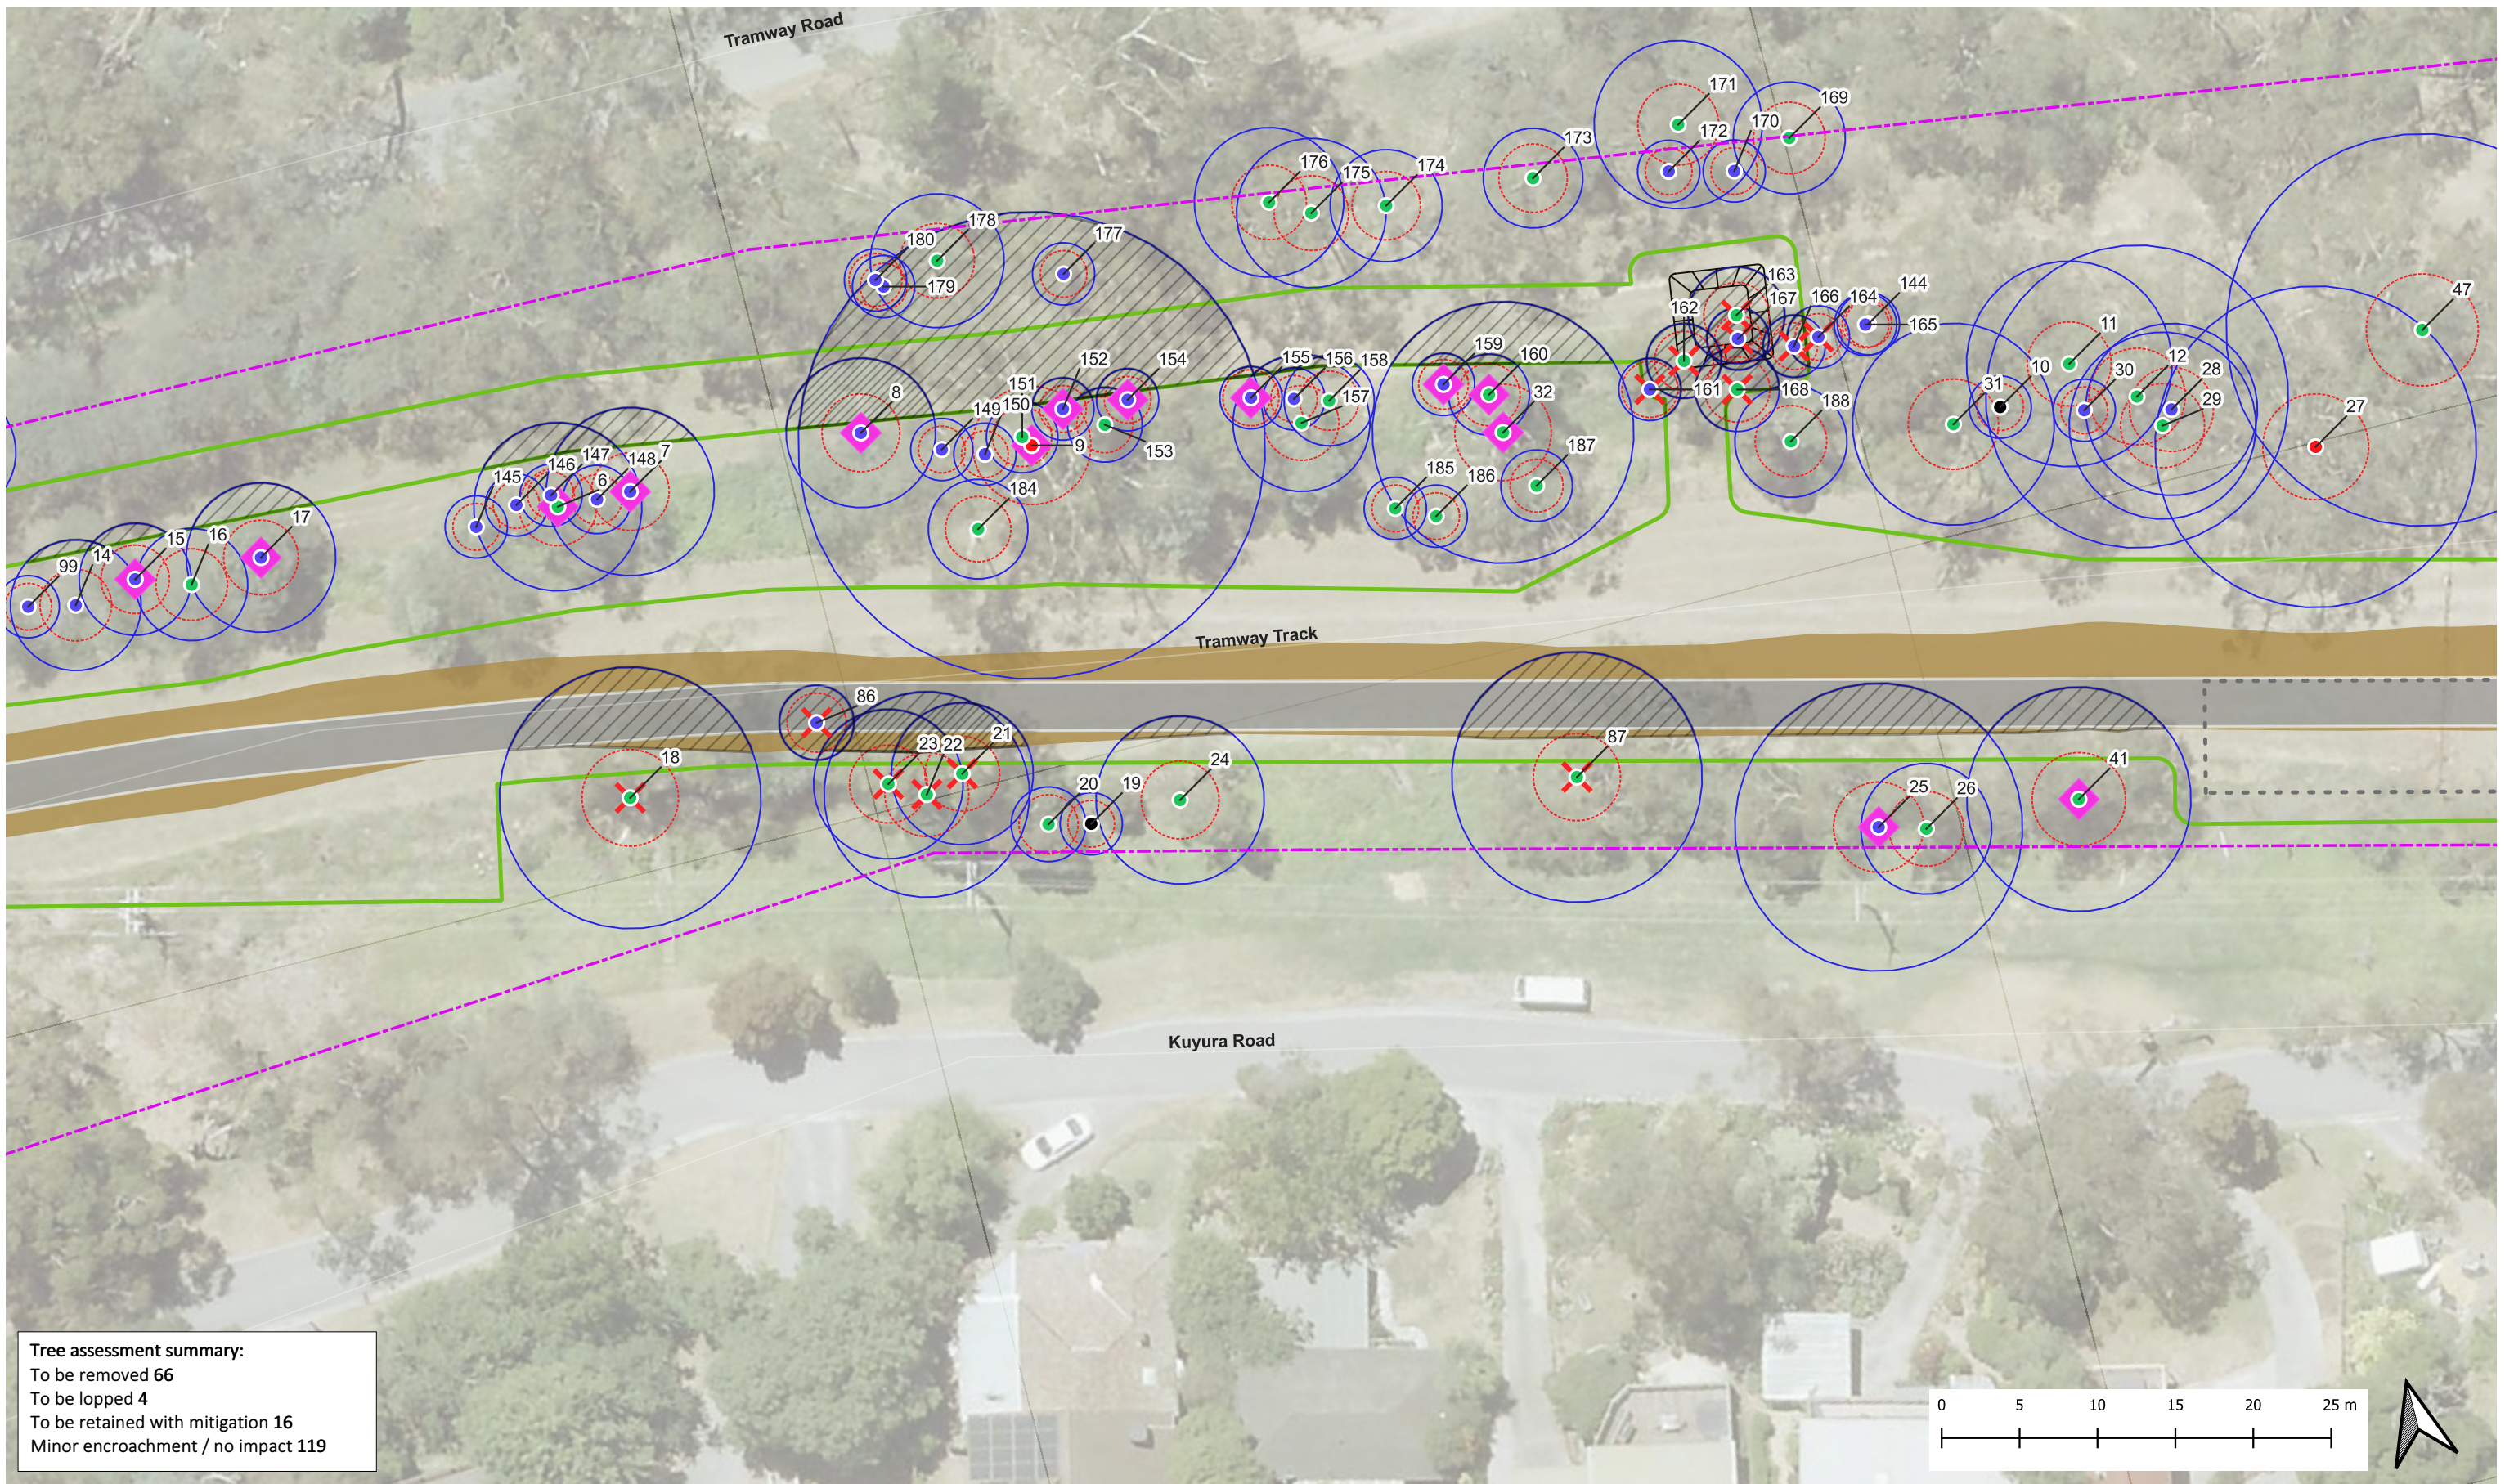
Tree assessment summary:
 To be removed 66
 To be lopped 4
 To be retained with mitigation 16
 Minor encroachment / no impact 119
