ARBORICULTURAL IMPACT ASSESSMENT

MT EVELYN WATER TREATMENT PLANT

SEPTEMBER 2023

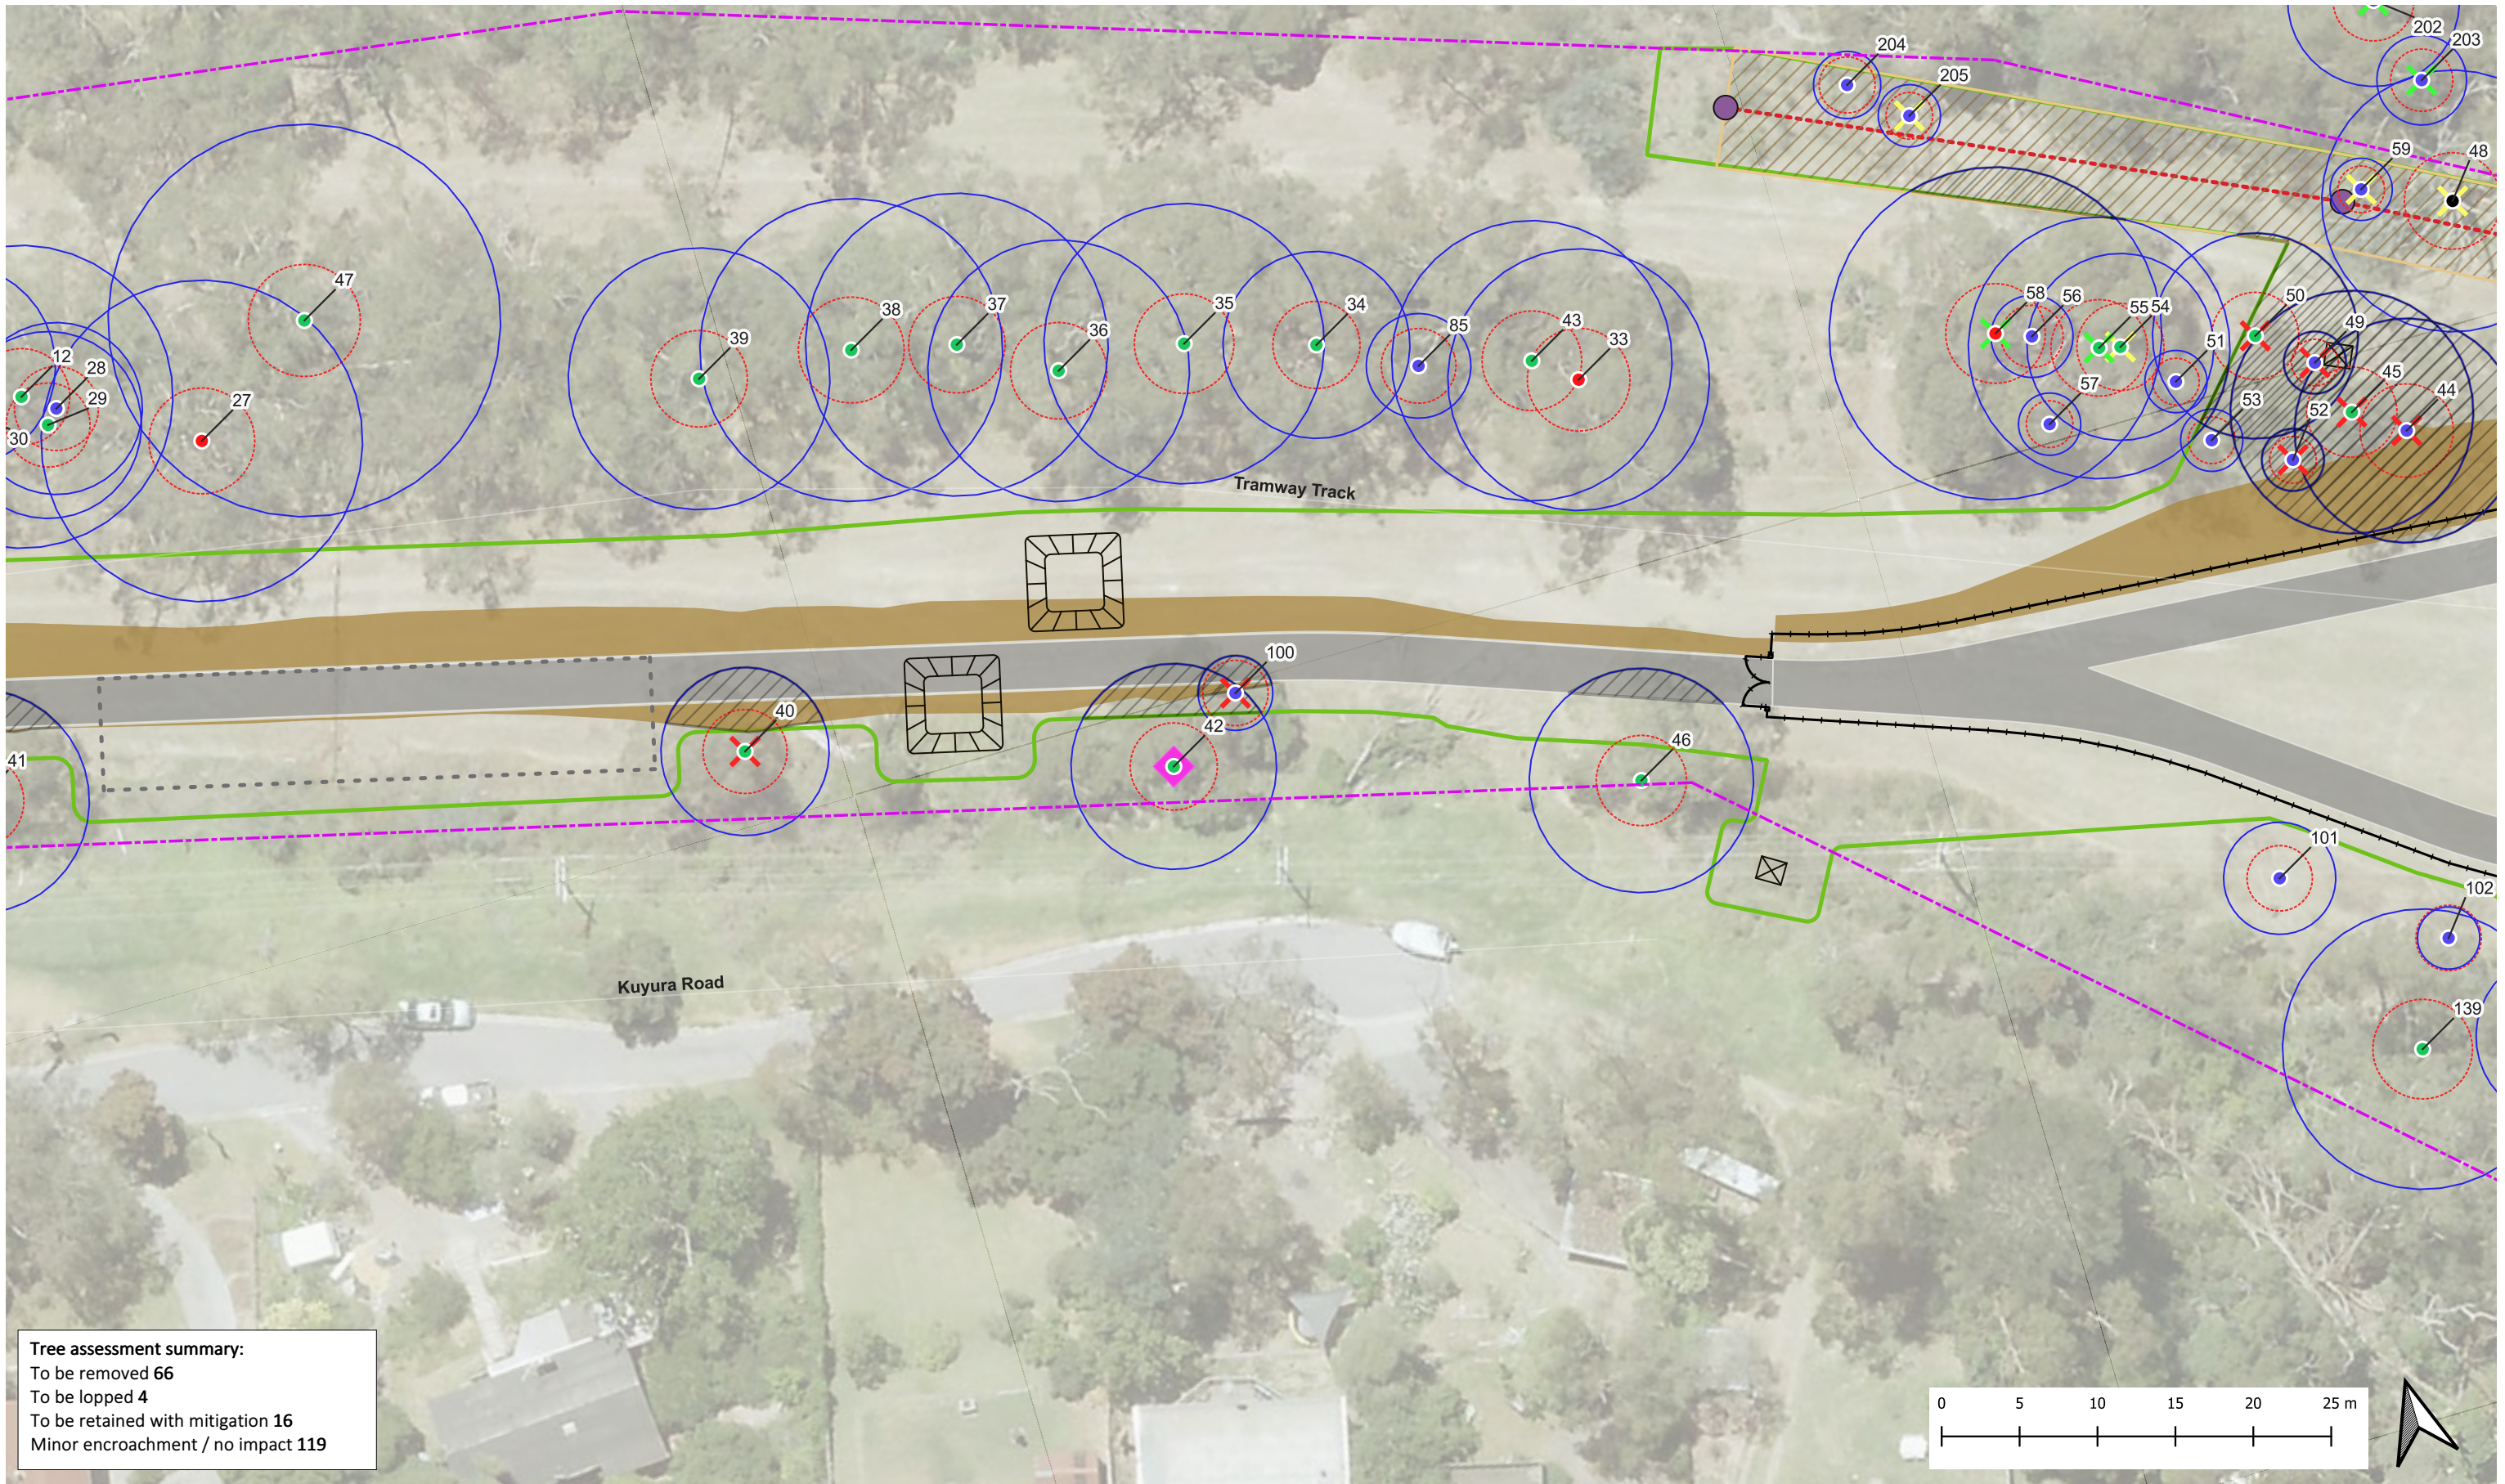
MT EVELYN WATER TREATMENT PLANT
TREE LOCATION PLAN 3 - 4

- 3.4.1 A high voltage power line currently crosses the open tramway track reserve. Realignment of the overhead powerline is required to clear the proposed treatment plant footprint. The realignment is shown on the plan at Section 6.0.
- 3.4.2 A total of thirty-five trees have been identified that will require removal (31 trees) or significant crown reduction (4 trees) (lopping) to maintain statutory distances from the new power line easement, and to mitigate against the risk of tree failure across the powerline.
- 3.4.3 Twenty-three trees that require removal or lopping for the overhead power realignment within the Melbourne Water pipe track reserve are listed in Table 3-5, with twelve impacted trees outside the reserve listed in Table 3-6.
