# Enhancing the Ecological Health of Western Port

Mangrove Planting for Coastal Stabilisation 2010-2013  
Final Report

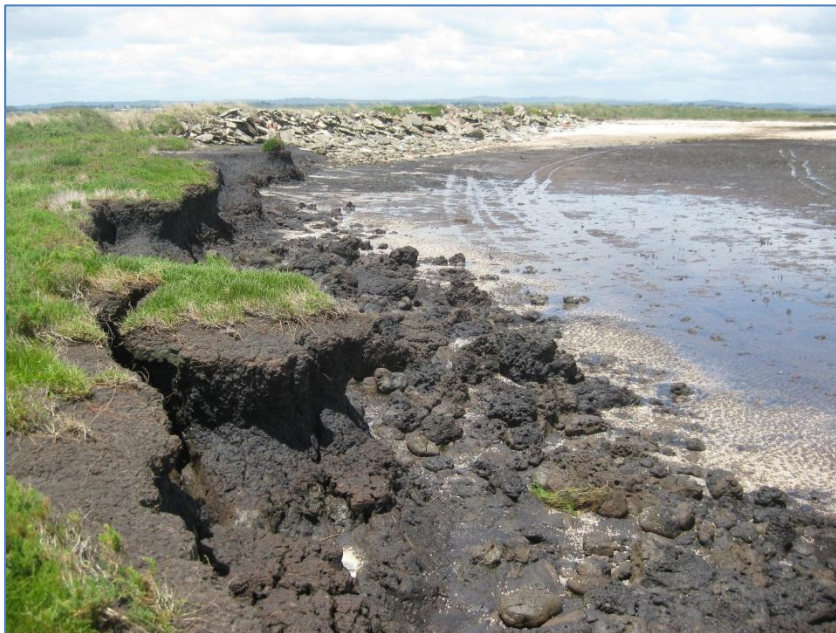
**Figure 2: Example of erosion occurring along Lang Lang Coast in foreground with landholder attempts at stabilisation with concrete rubble in background.**

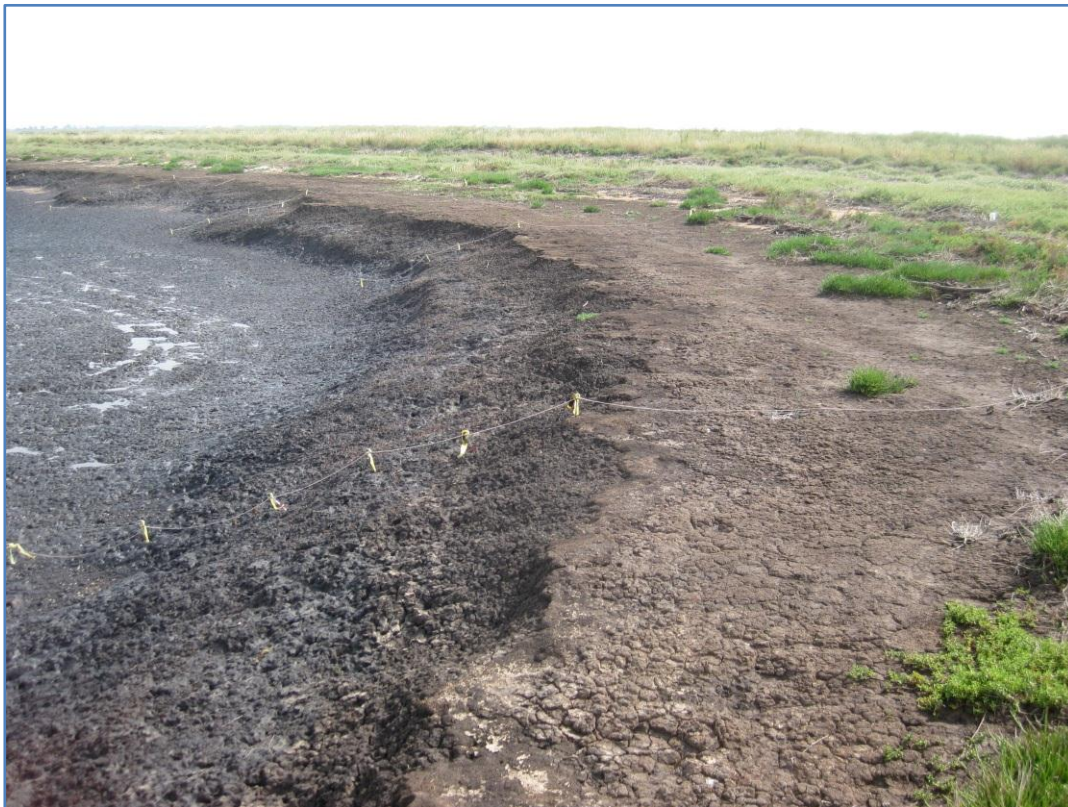
**Figure 5: Erosion monitoring (erosion pins arranged in a series of transects across erosion profile) being undertaken by Tomkins and McLachlan.**

Tomkins and McLachlan are also monitoring erosion in one of the eroding coves over 12 months (November 2012 to November 2013) to answer questions about erosion rates and processes (see figure 5). Some preliminary results from their investigation indicate that erosion is occurring in all parts of the eroding cliff's profile (i.e. on the horizontal parts as well as the vertical parts) and that erosion is most rapid on the most vertical faces of the eroding cliff as well as on the headlands of the crenulated shoreline. They are due to present their findings to Melbourne Water in 2014.

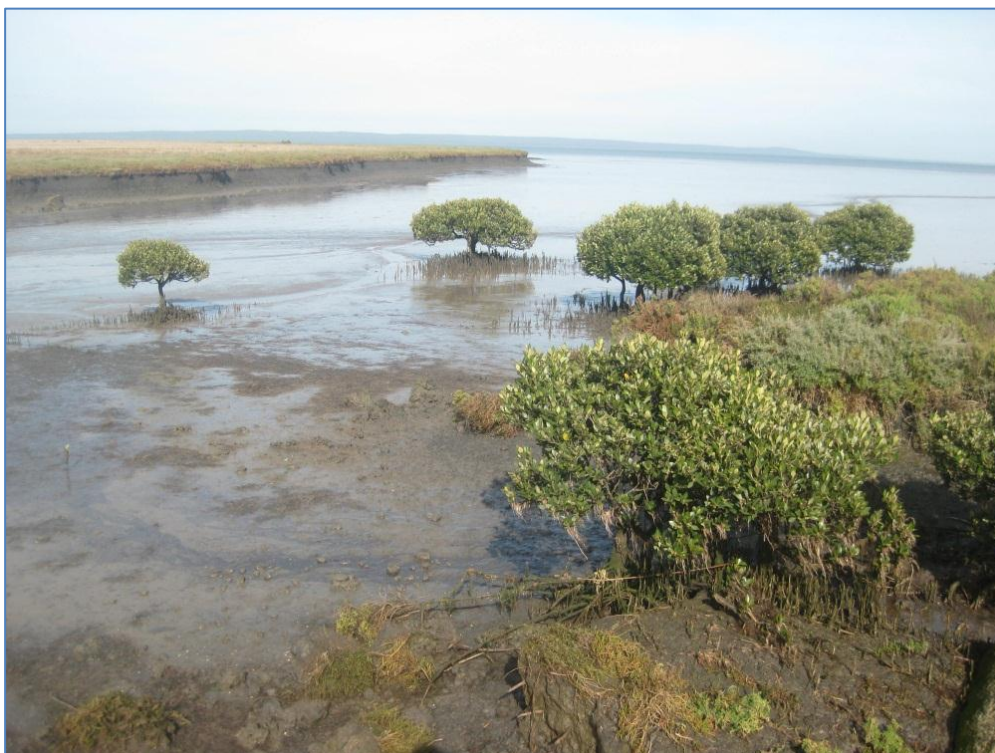
**Figure 7: Mature mangroves at the mouth of the Monomeith Drain**

The Lang Lang coastal mudflats are almost devoid of vegetation with only small mangroves found occasionally. There are however, a few mature mangroves found in more physically protected areas in the mouths of the Lang Lang River, Monomeith Drain and Yallock Outfall (see figure 7).

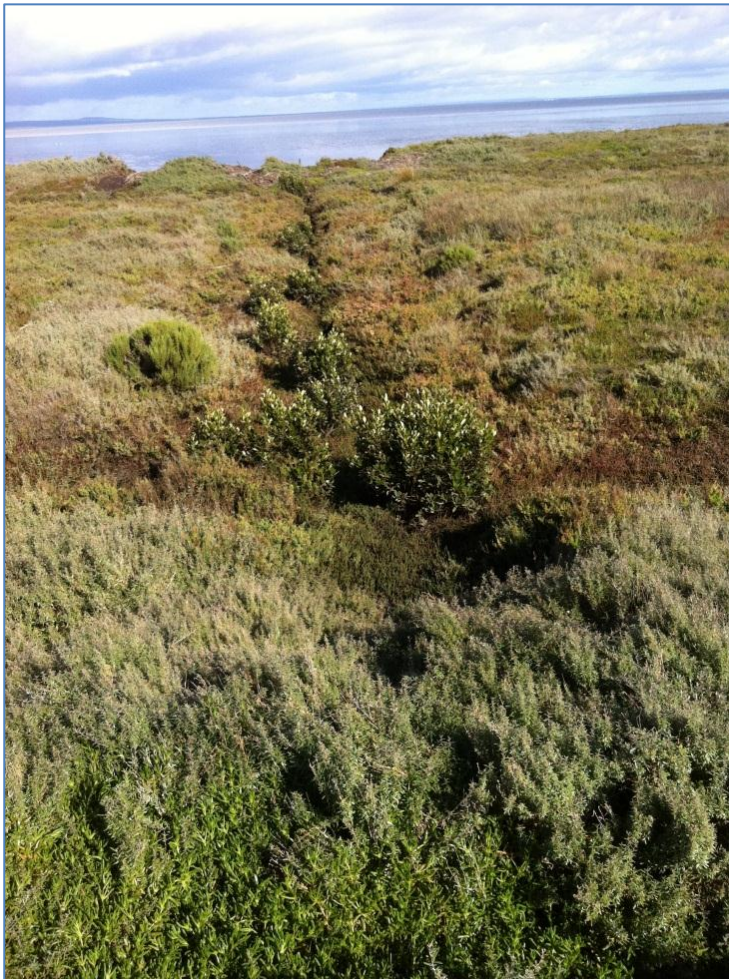
**Figure 8: Naturally recruited mangroves in saltmarsh drainage line**

Some naturally occurring mangroves can also be found in the drainage lines that flow through saltmarsh on the landward side of the eroding cliff (see Figure 8). These naturally occurring mangroves, along with observations of large numbers of propagules (seeds) beached along the Lang Lang coast indicates that natural mangrove regeneration in the area is unlikely to be limited by inadequate supply of propagules. However, *Avicennia* propagules require a period of low-energy water movement to enable root penetration into the soil and subsequent establishment (Balke et al., 2011). Given the Lang Lang coast's exposure to a long wave fetch (discussed below) it seems that mangroves are less likely to establish on the higher energy mudflats than the areas that are more protected from wave energy e.g. drain mouths or saltmarsh drainage lines.

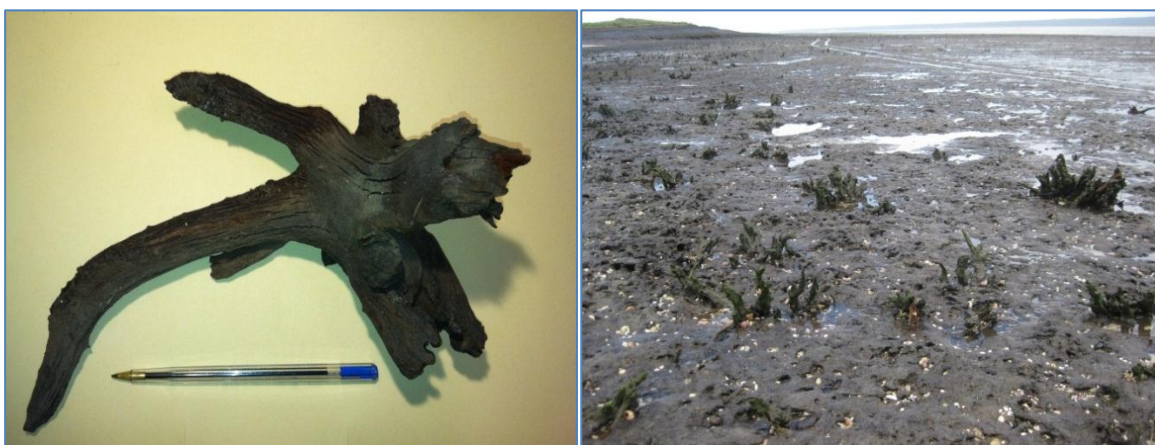
**Figure 9: 10,000 year old mangrove root (left) and site where roots are located along the Lang Lang coast (right).**

Although it appears that mangroves have not existed along the Lang Lang coastline since European colonisation (Smythe, 1842), tree roots can be found protruding from the eroding cliff and mudflat surface (see figure 9). The clustered arrangement of roots indicates that they are the remains of a former

forest at that location. A sample of the roots was sent to the National Herbarium of Victoria for identification and it was confirmed through examination of preserved vascular tissue that they are *Avicennia* roots (Cantrill, 2012). A sample was subsequently sent to the Australian Nuclear Science and Technology Organisation (ANSTO) for radiocarbon dating that estimated that they are 9,695 years old +/- 50yrs. (ANSTO, 2012). Sea-levels at this time were likely to be much lower than they are today and this information may be useful for local geological studies. However, while interesting, the prehistoric existence of mangroves along the Lang Lang coast does not really tell us much about whether they will survive here today.

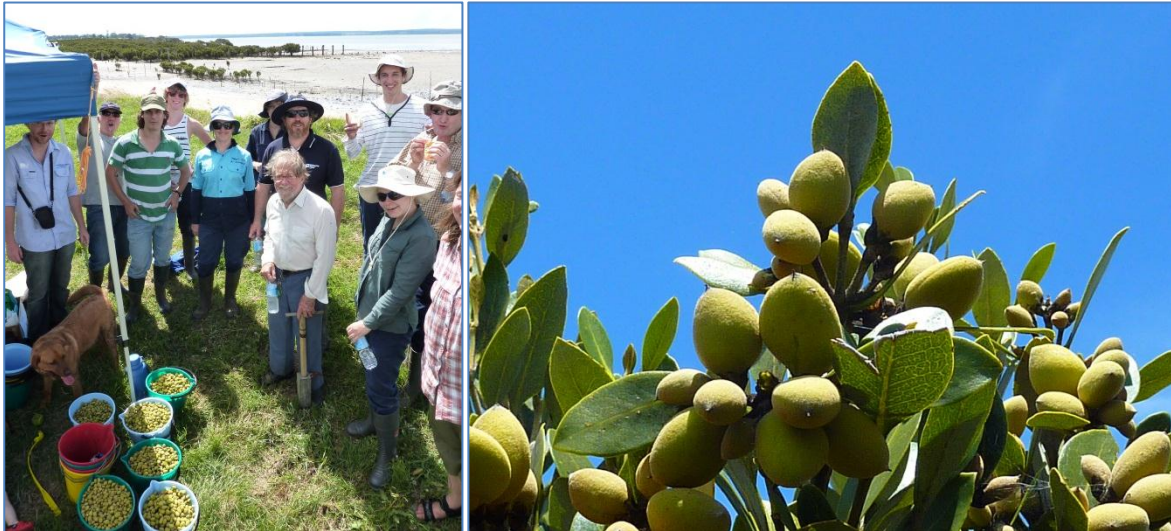
**Figure 10: Propagule collection – volunteer collectors (left) and *A. marina* propagules on a tree (right).**

Collection of mangrove propagules for seedling propagation was generally undertaken by picking ripe propagules from trees. Propagule collection activities were often undertaken with help of volunteers (see Figure 10) who were told that ripe propagules were generally more easily detached from the tree and were identified by a change in colour from greenish to pale yellow and by cracks that may appear on the seedcoat (Hong, 1996). Seed collection started early in the season (beginning of December) with the assumption that earlier collection would allow a longer period of seedling growth in the nursery leading to larger seedlings for planting the following winter.

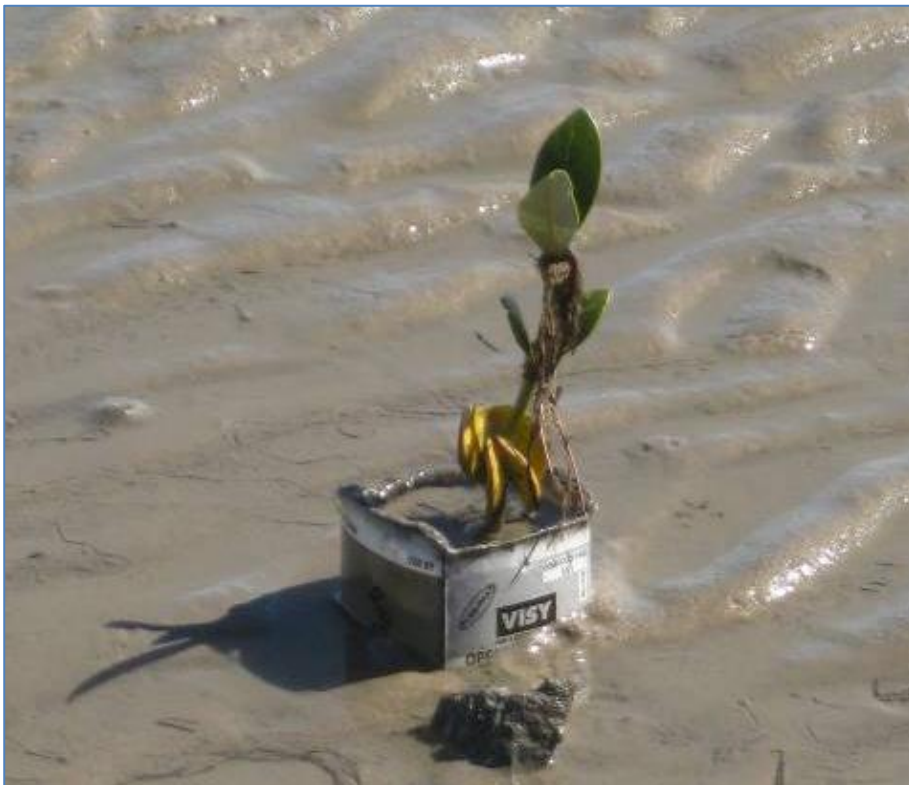
**Figure 12: Mangrove seedling raised in 600ml milk carton planted directly into mud**

The seedling-raising technique originally developed by the WPSP involves planting propagules directly into 600ml milk cartons filled to ~5cm from the top with soil. The milk cartons are a convenient and cheap container that is biodegradable and thought to provide extra stability for young mangroves planted in the mudflats (see Figure 12). This stability is the result of the suction formed by the contact between the waxed side of the carton and the mud. A hole is drilled through the sides of the cartons to allow for root growth and water circulation before being filled with soil. Due to concerns about the cartons resulting in seedlings becoming 'root bound', the nursery investigated alternative containers during the 2012/13 growing season.

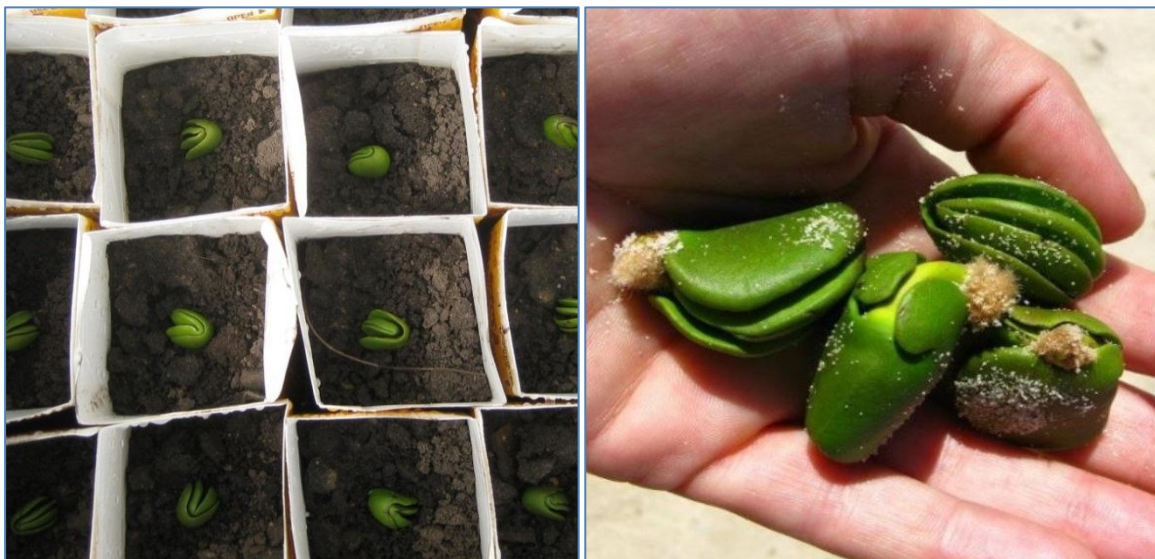
**Figure 13: Mangrove propagules sown in soil filled milk cartons (left) and dehisced propagules showing radicles with hairy tip which should be on the lower side when sown.**

Once the cartons have been filled, a single dehisced propagule is sown in each carton. Propagules are carefully pushed into the soil until they are about one third buried (see figure 13). The radicle (root structure), which is visible on the dehisced propagule (see figure 13), should be pointing downwards when sown to improve root establishment. WSPSP have also allowed propagules to develop roots and shoots in trays of moist seagrass wrack before transferring the seedlings into the cartons. Care must be taken not to damage the delicate root structures when re-potting (Ealey, 2011).

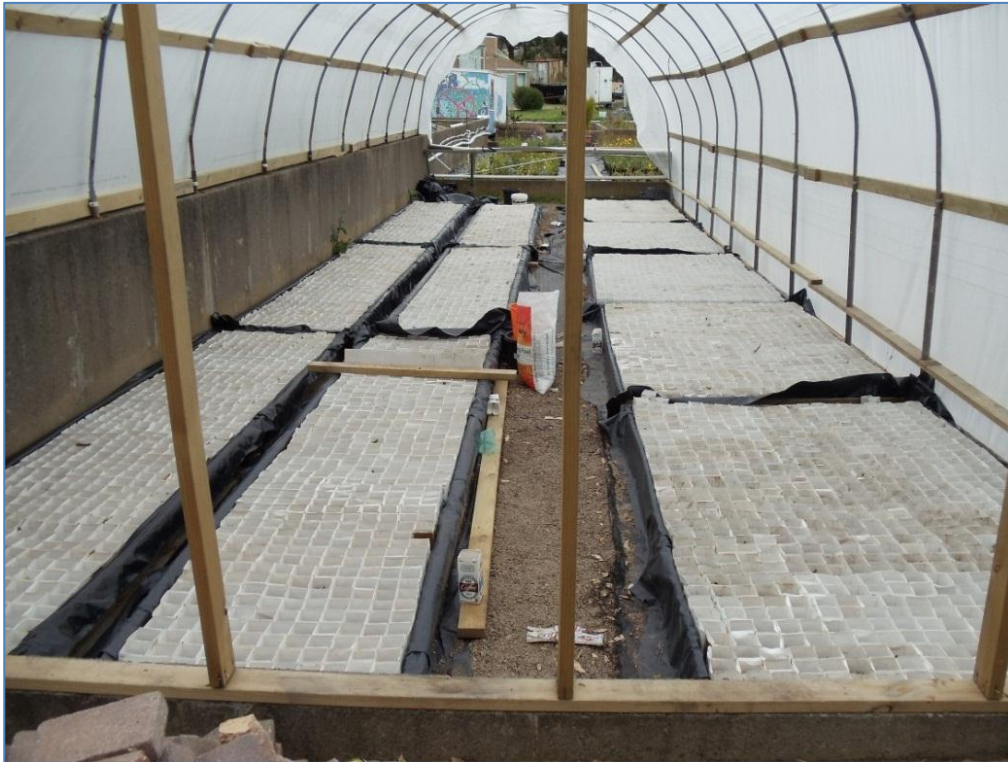
**Figure 14: Old system of seedling storage. Plastic lined timber frames.**

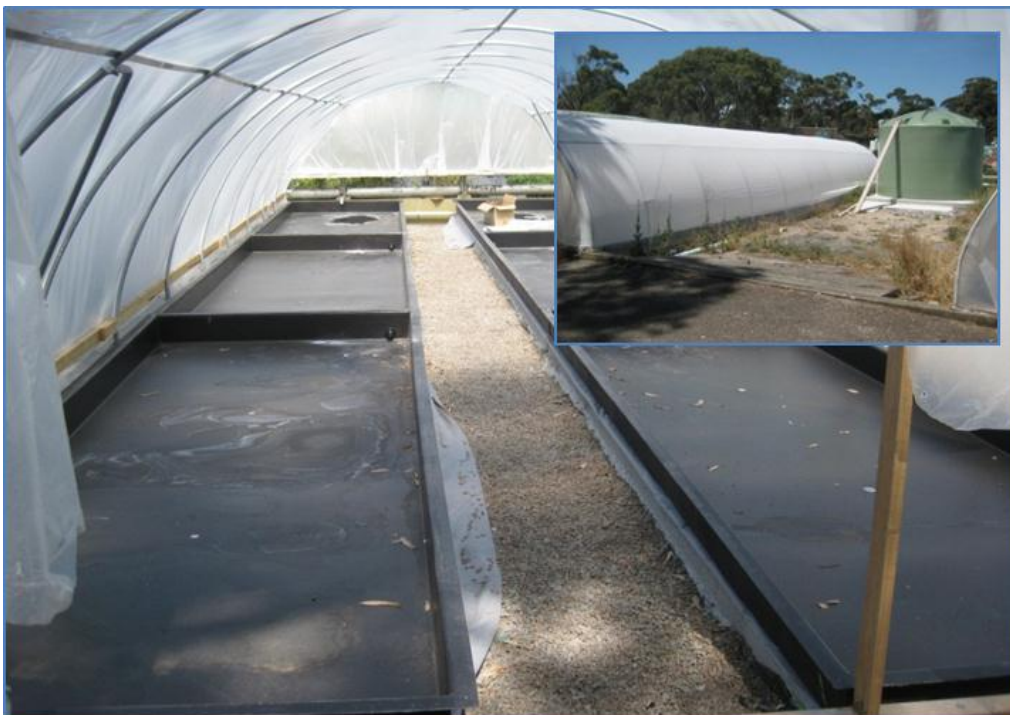
**Figure 15: Tidal mangrove seedling storage system (central storage tank shown in inlay)**

kept at a stable salinity is stored in a central tank and pumped into a series of fibreglass baths (Figure 15). The baths are filled and drained on a daily cycle to mimic a diurnal tidal regime.

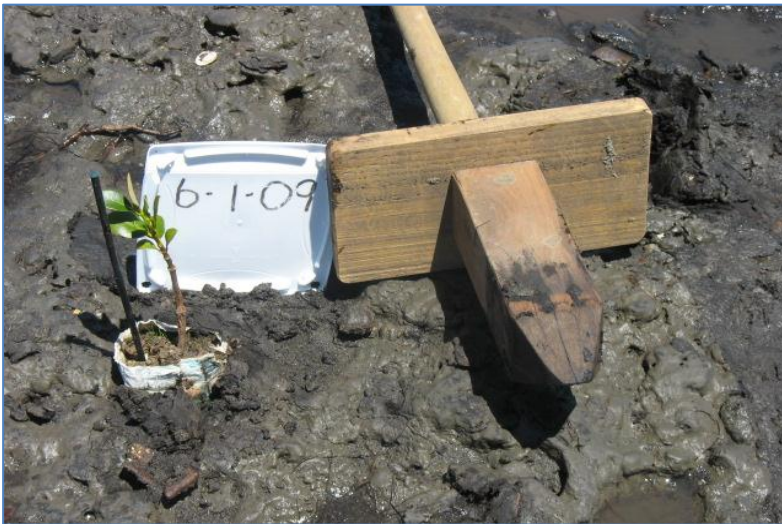
**Figure 18: Mangrove planting tool (Photo: Tim Ealey).**

Nursery grown seedlings were transported to the planting site and planted using the methods developed by the WPSP. This involves using a purpose built tool (Figure 18) that punches a hole in the mud about the same size as a milk carton. The carton slips straight into the tight-fitting hole and is held in place by the suction (see Section 3). Before inserting the seedling, the bottom flaps of the carton are folded up to allow downward root growth. The addition of a stake was seen as a way to improve stability of the plant, however observations have indicated that it may not be needed (i.e. suction in mud is sufficient) and may even damage the root system when inserted. Before planting, the tops of the milk cartons are stapled together (see figure 19) so that movement of the seedling by wave action is minimised.

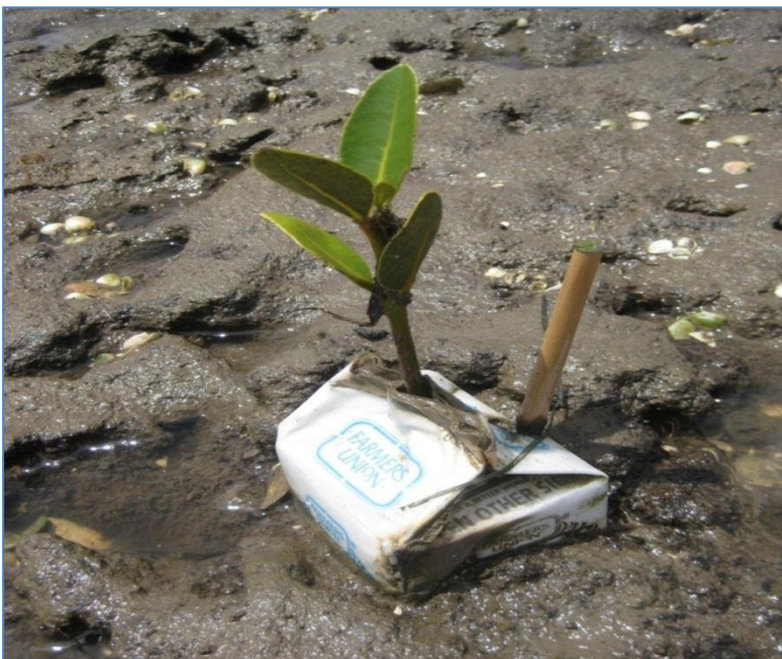
**Figure 19: Planted mangrove seedling with top of milk carton stapled.**

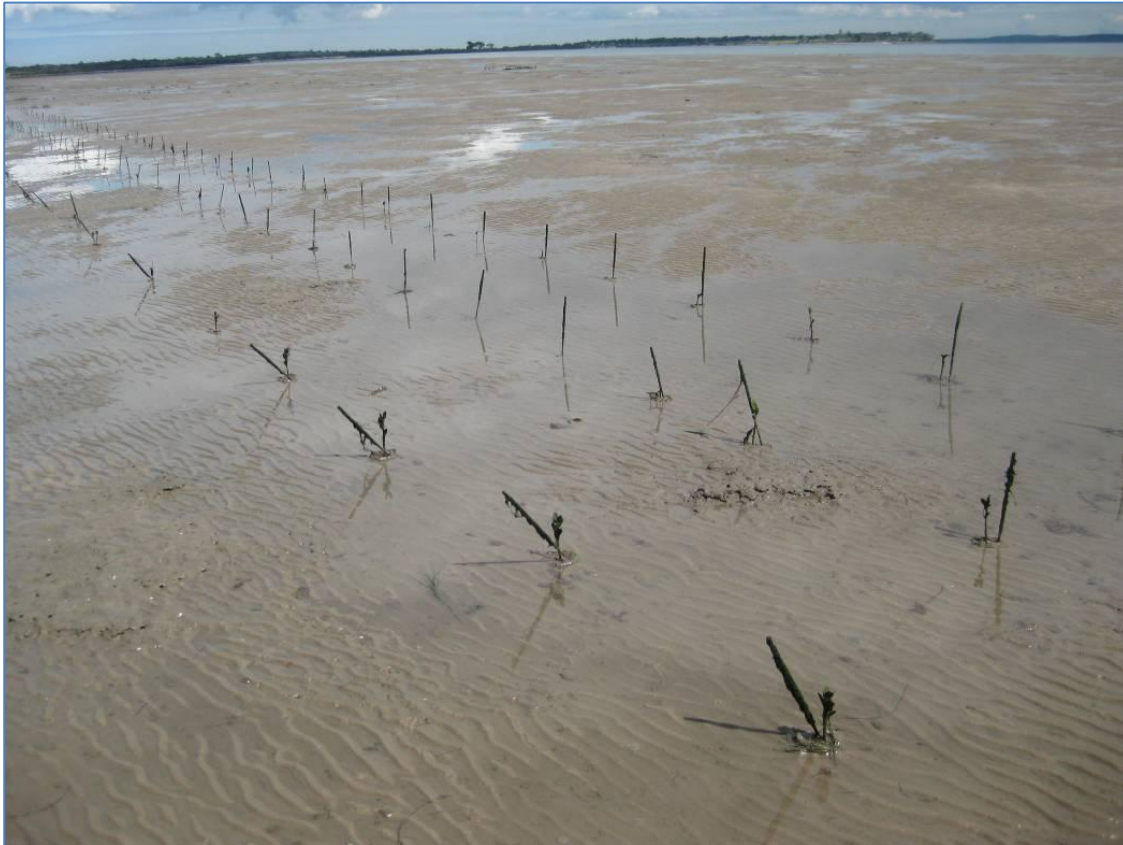
**Figure 20: Mangrove seedlings planted in three rows at around 1m spacing at Grantville**

Given the aim of mangrove planting along the Lang Lang coast was to establish a protective barrier for the eroding coastline, the WPSP arranged their seedlings in a continuous belt along the shore consisting of two or three rows of seedlings planted around 1m apart (1 seedling/m<sup>2</sup>) (see figure 20). This spacing was based on observation of older plantings done at the same spacing which now have a continuous canopy and do not appear to have competition problems (Ealey, 2010).

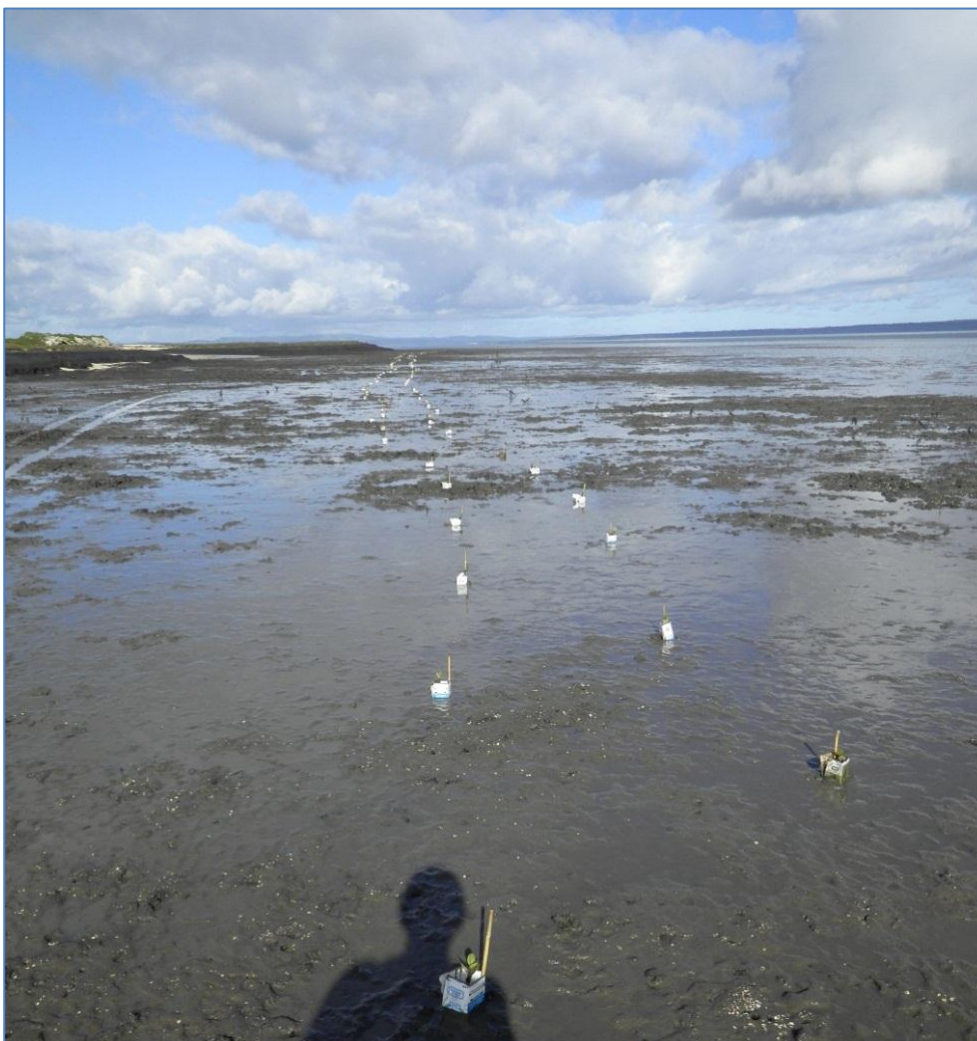
**Figure 23: Mangrove planting in 2011. Two rows of seedlings spaced 1m apart.**

Seedlings were generally planted in the bench area of the coastline (see section 2.2) as this area provided the most stable substrate for planting. However, as discussed in section 2.2, the bench was not always available and attempts were made to plant some seedlings in the unconsolidated sediments, especially when a continuous belt of plants was the focus of the planting strategy. Figures 21 and 22 show the planting extent for each year of the project. In 2010/11, 9,000 seedlings were planted along about 3.5km of the eroding coastline. Planting started near the mouth of the Lang Lang River and plants were generally arranged in two or three rows, planted approximately 1m apart (see figure 23).

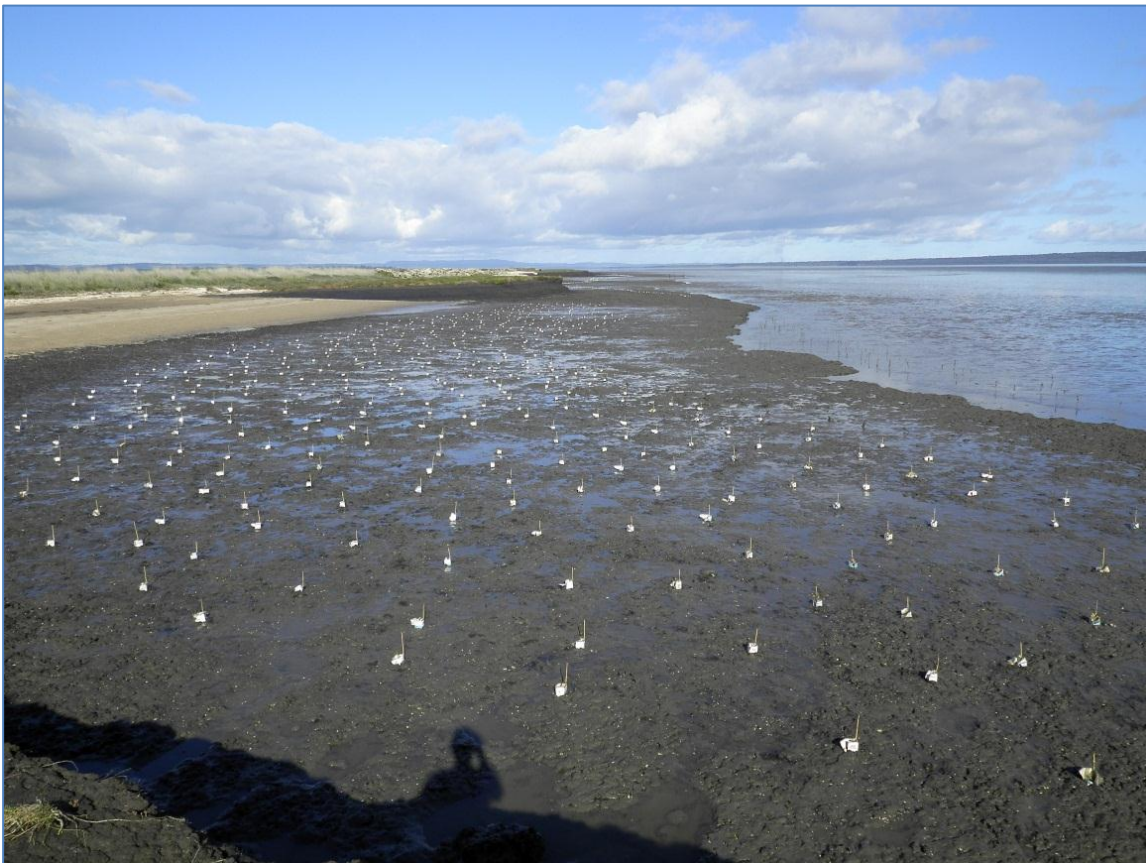
**Figure 24: Wider belt of planting in protective cove planted in 2012.**

Given the survival rates in 2011, planting in 2012 focussed on more intensively planting in protected coves (see Figure 24). Planting began in May and finished in June 2012 and survival counts were undertaken in late October 2012. Overall survival was only 19% and while this is a lower result than the first year of planting, there were still strong indications that survival rates were better in coves where there was protection from waves. Monitoring in 2012 also revealed that survival was especially high at the northern ends of zones 1 and 4 where the jutting shoreline seems to provide protection from wind and waves from the north-west. Additionally, survival was much higher where seedlings had been planted behind the remains of an old pipe outlet

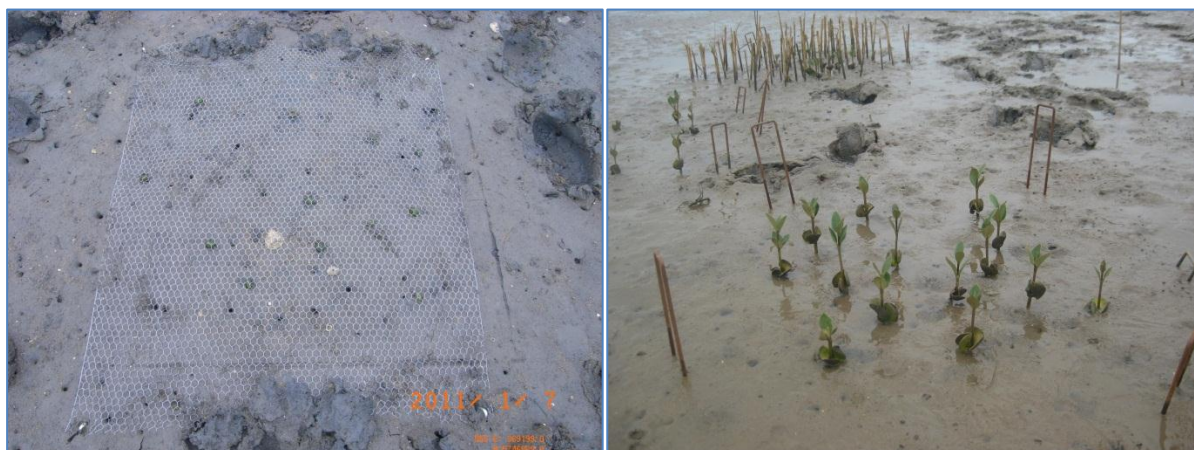
**Figure 25: Direct seeding. Wire mesh covering newly planted propagules (left) and seedlings after 2 months (mesh removed).**

The trial included pegging some bird wire mesh over the planted propagules to prevent them from being washed out by tidal movement (see figure 25). This mesh deteriorates quite rapidly and needs to be removed around 1-2 months after planting to avoid seedlings being damaged by flapping pieces of wire.

Removal of the mesh also prevents seedlings becoming deformed due to their attempt to grow through the mesh.

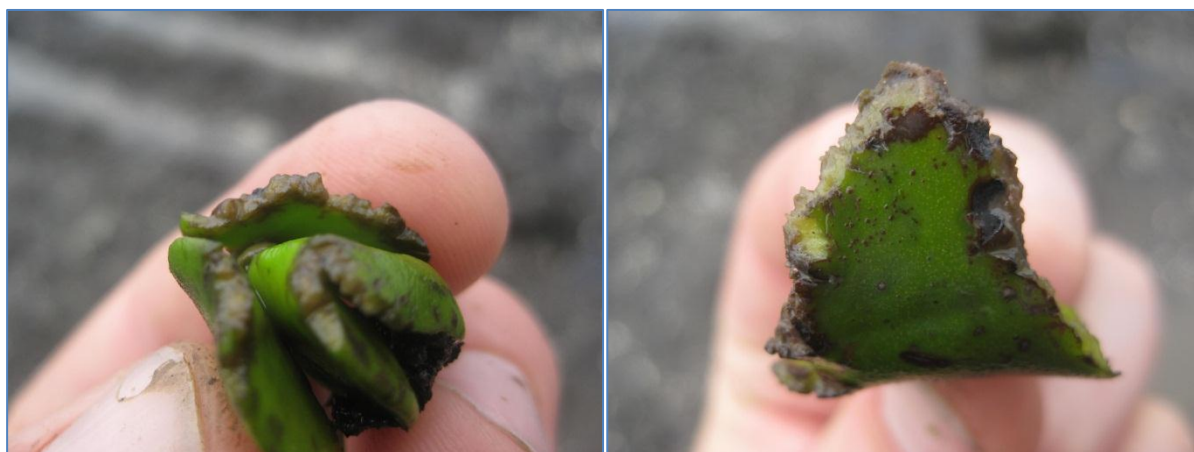
**Figure 26: Damage to mangrove propagules suspected to be caused by crabs**

The success of the trial led to the decision to introduce the direct seeding method to the Lang Lang site more broadly. In summer 2011/12, 2,000m<sup>2</sup> of direct seeding was planned, half of which occurred before Christmas 2011. On return to the site for the completion of the direct seeding in January 2012 almost zero seed survival was observed. It appeared that the propagules had been consumed by crabs as a number of propagule fragments were found with suspected chew markings (see Figure 26).

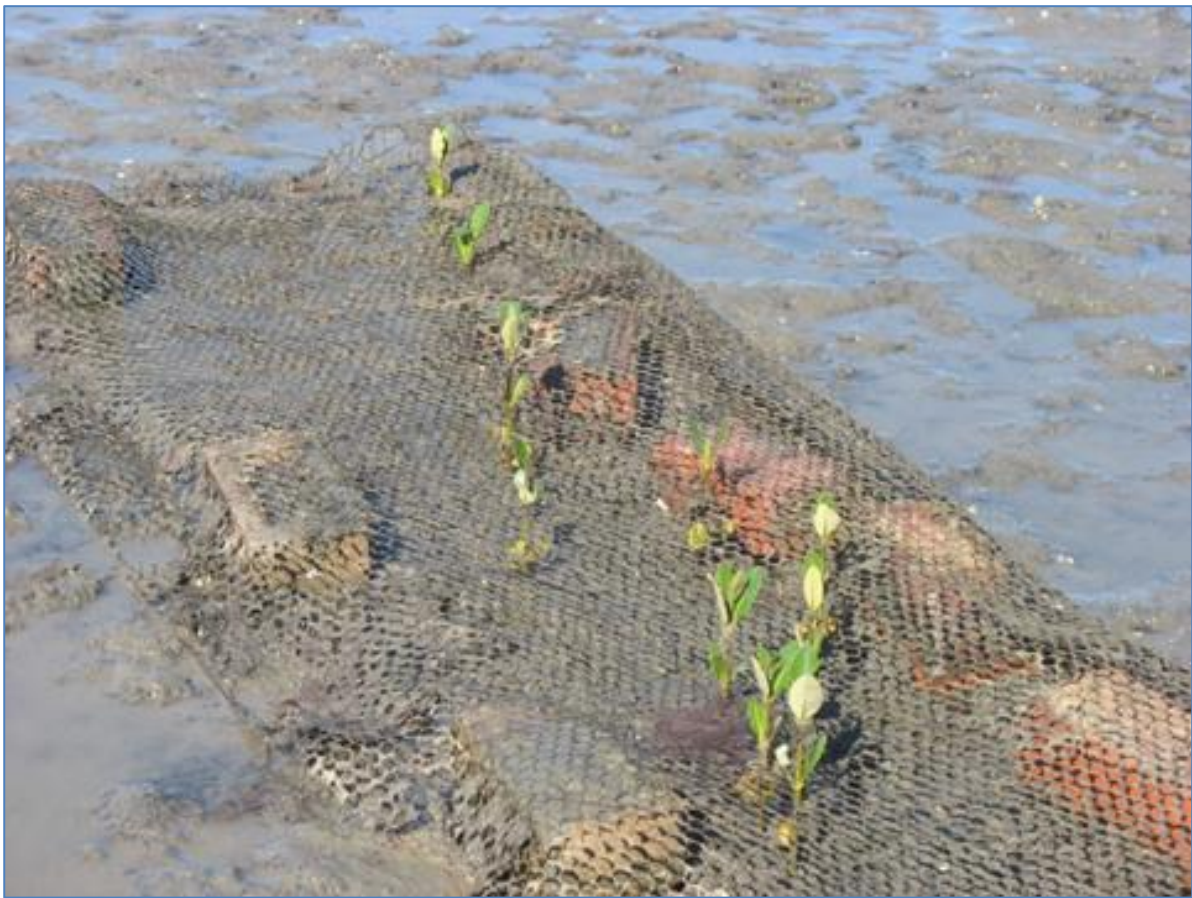
**Figure 27: Crab prevention measure. Mesh is kept above the surface of the mud to prevent crabs from chewing propagules from above the wire.**

Another possibility for the mass failure of seeding was under-ripe propagules, as further direct seeding during January had better success. The extra direct seeding in January was accompanied by some crab prevention measures (see Figure 27). This was briefly successful but the seedlings that had managed to

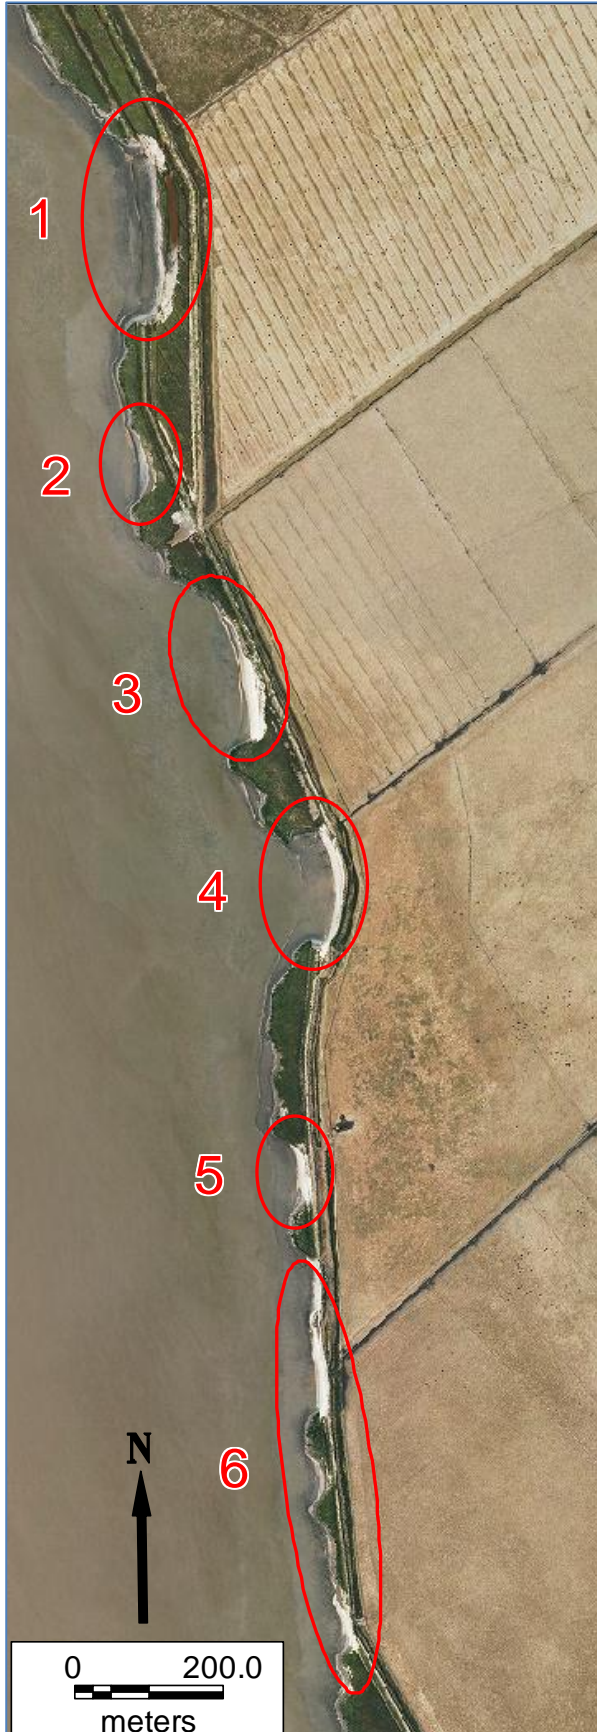
Figure 28: Planting Zones along Lang Lang Coast

Figure 28 shows a section of the Lang Lang coastline that has been divided into zones to illustrate how monitoring was segmented and then used to adjust the planting strategy. This section of the coast is represented because it is an area where planting was undertaken in all 3 years of the project and some of the highest survival rates were measured. Zones 1 to 5 correspond to eroded coves which are common along the entire length of the eroding coastline. Zone 6 is a more homogeneous section of the coast which also occurs in some other areas along the entire length. Table 3 displays the survival rates corresponding to each zone that resulted from the first two years of planting.

An experiment was designed to test the effectiveness of the three wave attenuation measures with nine 30x15m plots established along part of the Lang Lang coastline (Zone 6 in Figure 28). This part of the coastline was chosen as it is a relatively homogeneous section of coastline with mudflats that are wide enough to fit the plots. The area is also easily accessed, with the main access point used during the project existing at the north end of the site. 400 seedlings were planted in each plot and 200 were randomly assigned a PVC tree guard (see Figure 36). The pile fields and Enviro Rolls were each randomly assigned to three of the plots with the remaining three plots left as controls.

400 seedlings were planted at a 1 plant/0.5m<sup>2</sup> spacing in the middle of cove 1 (see Figure 28). This planting density is twice that of any previously undertaken plantings and the benefits of a higher planting density are discussed in section 4.1. Survival of the 400 seedlings was extremely low (<5%) even though this cove had had good survival rates in the past. Further seedlings that were planted around the rubble in this cove that had provided some protection in 2012 were also showing very low survival rates. A possible explanation for the low survival could be the windy weather that may have resulted in stronger waves. This explanation is strengthened by the fact that the seedlings that were killed appear to have been defoliated (see figure 37).

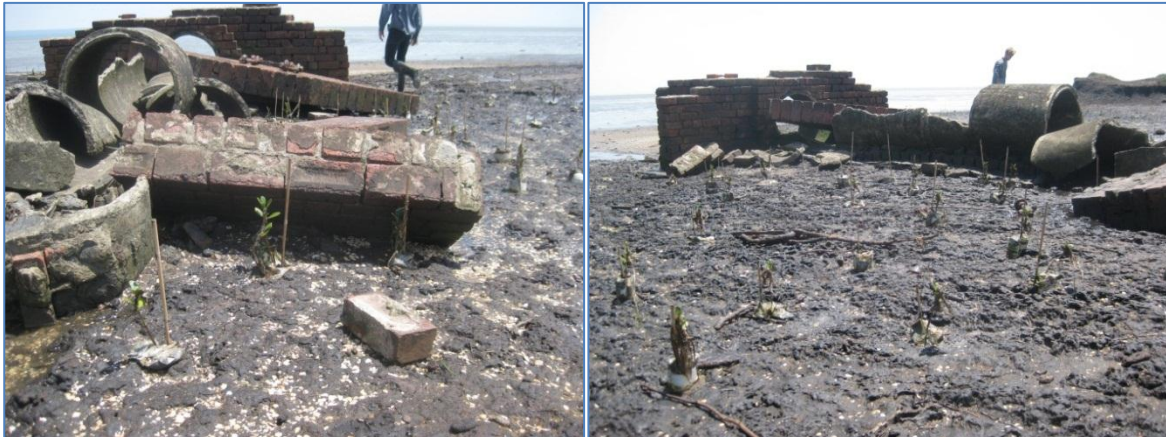
**Figure 29: Healthy seedlings planted behind pipe outlet rubble**

(see Figure 29). These observations were also supported by the experimental plantings that were established near Grantville and Corinella (see Box 2 below).

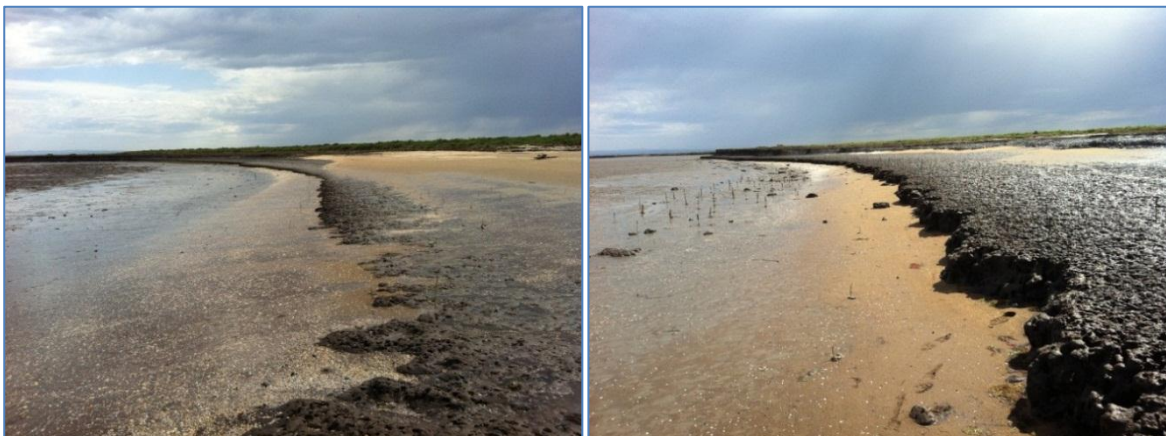
**Figure 30: Low survival coves – zone 3 (left) and zone 2 (right)**

It's important to note that seedling survival rates were not high in every cove. For example, the coves represented by zone 2 and 3 in Figure 22 had low survival rates for both 2011 and 2012. Factors that may have reduced survival include the steepness of the shore at the rear of the cove causing higher turbulence as waves are reflected into in the planting zone, as well as the presence of a fairly pronounced shelf below the bench in the cove (see Figure 30) which may increase turbulence around the seedlings which are planted near the shelf. Evidence of higher wave energy in these coves is demonstrated by the presence of dynamic sand banks visible in Figure 30. Some seedlings were also killed when buried by these sand banks.

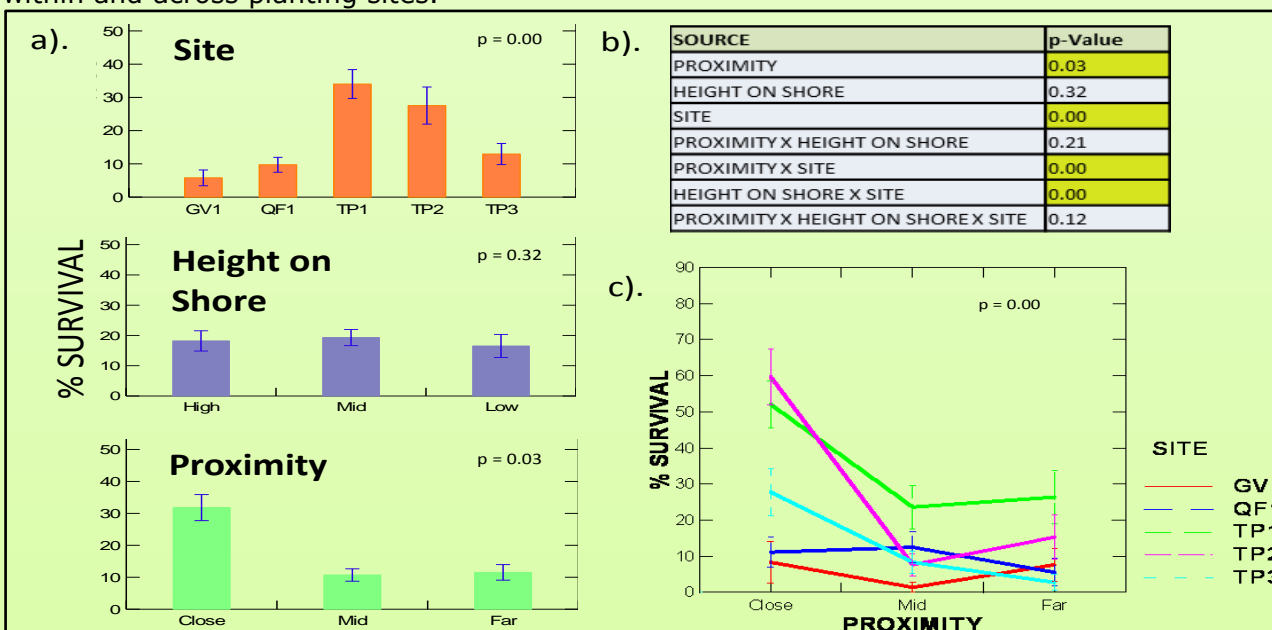
**Figure 32: Survival after 24 months. a) Survival across site, height on shore and proximity treatments, b) Output p-values from 3-way ANOVA (significant results highlighted) and c) Proximity x site interaction plot.**

After 24 months of monitoring, survival of seedlings planted close to remnant forests was three times as high as survival at the other proximities (Figure 32, a)). Additionally, survival varied across sites with the highest survivals found at north facing sites which are more protected from the prevailing westerly weather. High survival at the close proximity was not consistent across sites (c) with the more protected sites mainly responsible for the high survival shown in a). Growth rates were also higher at the north facing sites but height on shore played a greater role in growth than proximity at a site scale. Seedlings are still being monitored but initial analyses indicate that protection is important for the growth and survival of planted mangrove seedlings within and across planting sites.

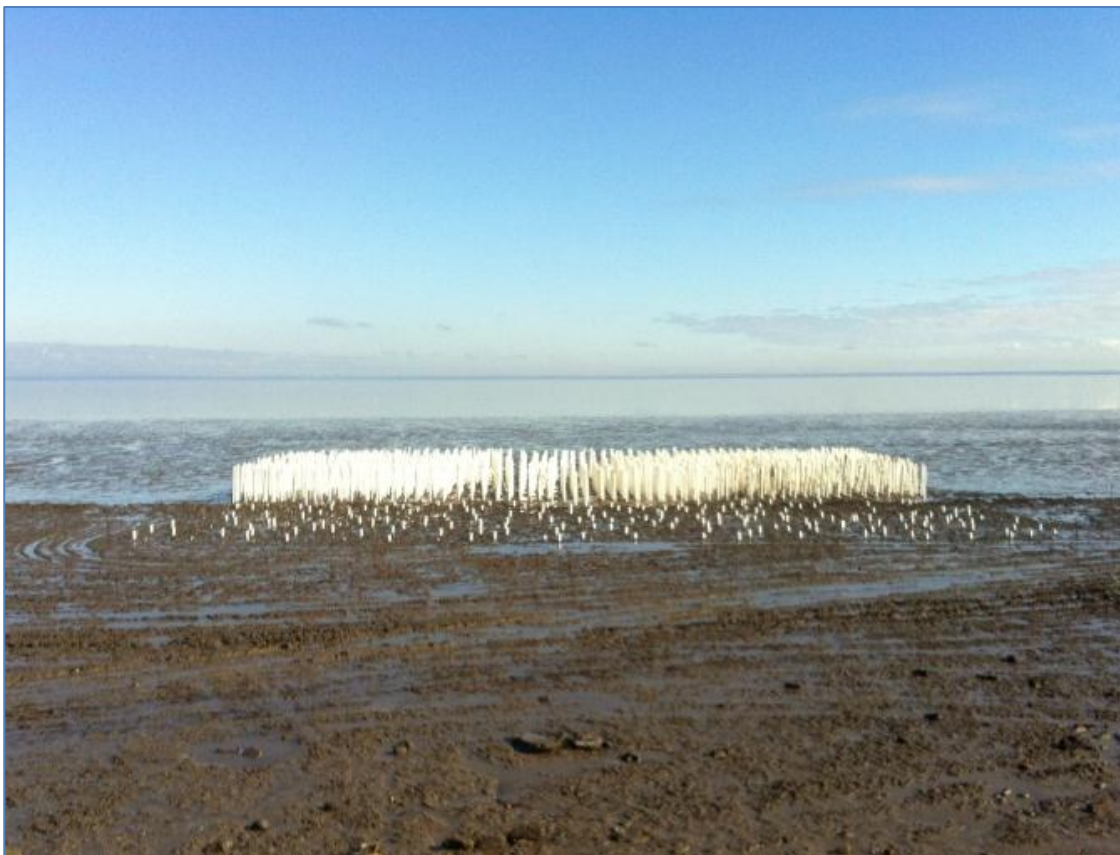
**Figure 33: PVC pipe pile field (with experimental plantings in foreground)**

The pile field wave attenuator is based upon a study which designed an optimal arrangement of vertically driven bamboo piles into the mudflats to reduce incoming wave energy (Halide, Brinkman, & Ridd, 2004). The study found that a pile field that was 30m wide consisting of 80mm piles spaced at

4/m<sup>2</sup> would be effective at attenuating 50% of incoming wave energy. The study also suggested that a minimum of 600mm of each pile should be embedded into the mud. This design was implemented at the Lang Lang coast where three 30m x 15m pile fields were constructed in winter 2013 using 2m lengths of 90mm PVC pipe pushed around one third of their length into the mud (see figure 33). PVC pipe was used as it was the cheapest and most readily available material for pile field construction. Bamboo poles of suitable length and diameter need to be shipped from overseas at a great expense and local natural materials (i.e. tea-tree poles) are not available in the correct dimensions.

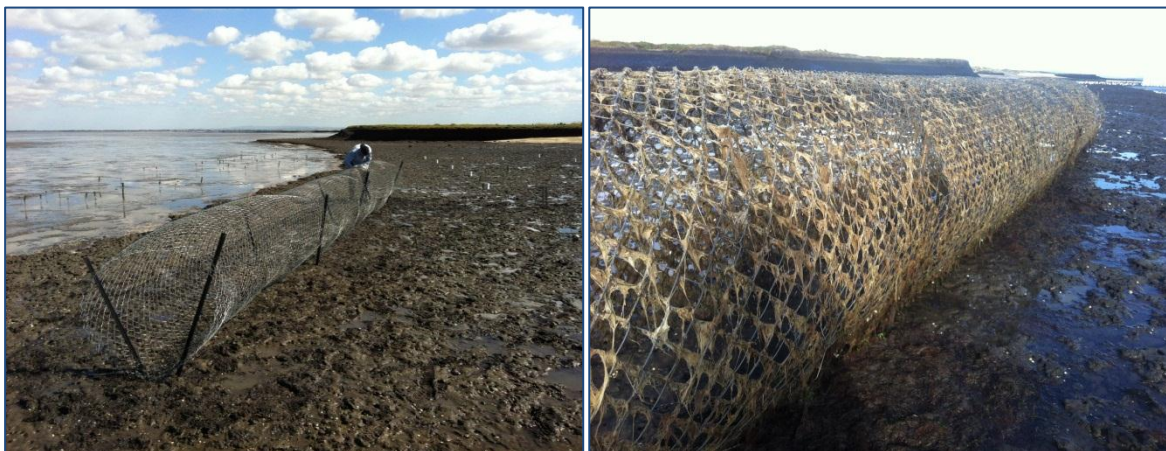
**Figure 34: Enviro roll when constructed (left) and 4 months after construction (right) showing significant build-up of algae and other debris.**

up so that it becomes less 'porous' over time and more effective at attenuating hydrodynamic forces. Three 30m (3 x 10m lengths) Enviro-rolls were constructed in winter 2013 as part of the trial which is described below.

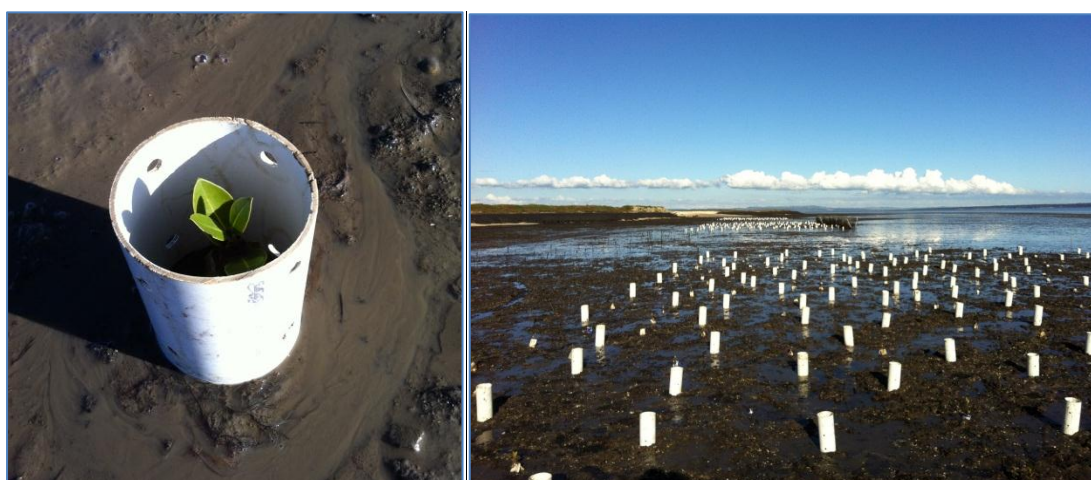
**Figure 35: PVC pipe tree guard (left) randomly placed in experimental plots (right)**

The final wave attenuation measure that was trialled was PVC pipe tree-guards. This technique is a modified version of the Riley-Encasement Method (REM) where a single mangrove seedling is raised in a length of PVC pipe which provides stem protection and promotes growth through phototropism (stimulation of growth towards light source) (Riley & Kent, 1999). The PVC pipe tree guard method aims to provide similar protective properties to REM but differs in that a 400mm piece of 100mm diameter pipe is fitted over an already planted seedling. The guard is pushed 100-200mm in the mud around the seedling and has been pre drilled to allow water to drain from the guard at low tide (see Figure 35).

The tree-guard aims to provide protection for the seedling in its early growth phases and may also help to reduce local erosion around the plants which has been undermining some seedlings at Lang Lang. It is not anticipated that trees will outgrow the guards for many years but they should be monitored to determine when the guards need to be removed. A biodegradable version of these guards made of rice husks has been developed and are being used for mangrove revegetation in Singapore and may be suitable for use in Western Port (Anon, 2013).
