# Enhancing the Ecological Health of Western Port

Mangrove Planting for Coastal Stabilisation 2010-2013  
Final Report

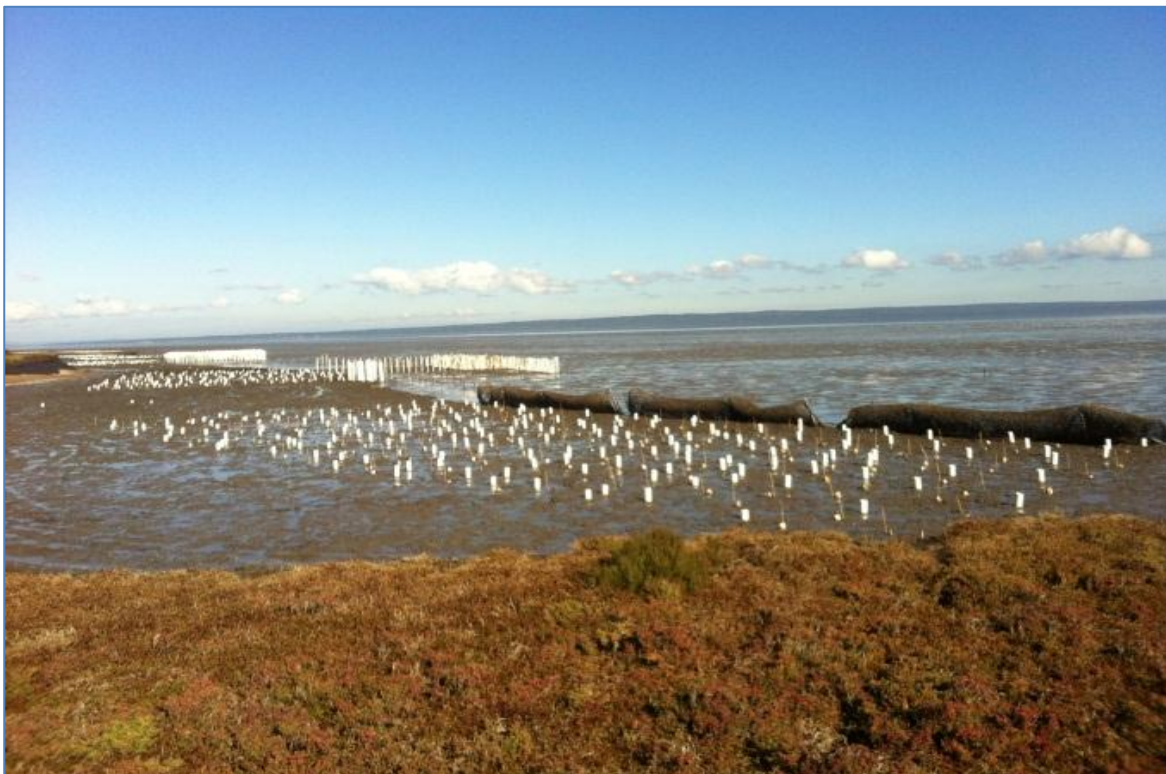
**Figure 36: Experimental site viewed from north end. Enviro rolls in the foreground with two pile fields visible (one under construction) in the background. Planting plots with PVC pipe tree guards visible in lee of structures.**

An experiment was designed to test the effectiveness of the three wave attenuation measures with nine 30x15m plots established along part of the Lang Lang coastline (Zone 6 in Figure 28). This part of the coastline was chosen as it is a relatively homogeneous section of coastline with mudflats that are wide enough to fit the plots. The area is also easily accessed, with the main access point used during the project existing at the north end of the site. 400 seedlings were planted in each plot and 200 were randomly assigned a PVC tree guard (see Figure 36). The pile fields and Enviro Rolls were each randomly assigned to three of the plots with the remaining three plots left as controls.

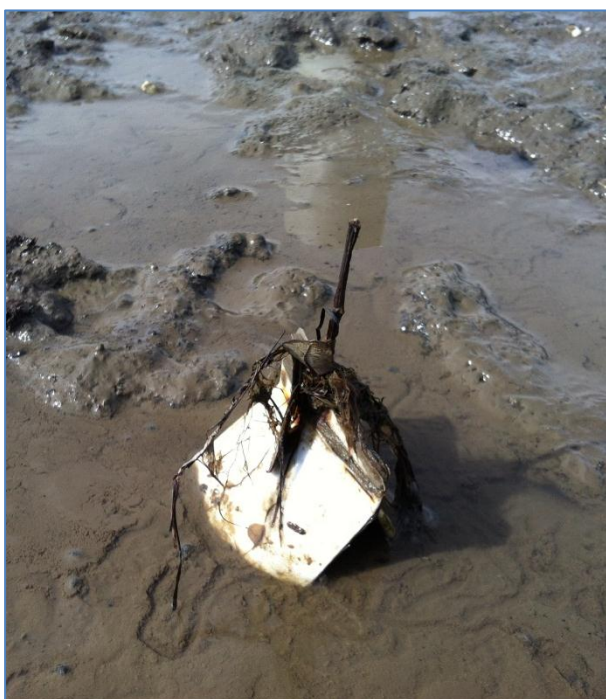
**Figure 37: Defoliated seedling observed in October 2013.**

400 seedlings were planted at a 1 plant/0.5m<sup>2</sup> spacing in the middle of cove 1 (see Figure 28). This planting density is twice that of any previously undertaken plantings and the benefits of a higher planting density are discussed in section 4.1. Survival of the 400 seedlings was extremely low (<5%) even though this cove had had good survival rates in the past. Further seedlings that were planted around the rubble in this cove that had provided some protection in 2012 were also showing very low survival rates. A possible explanation for the low survival could be the windy weather that may have resulted in stronger waves. This explanation is strengthened by the fact that the seedlings that were killed appear to have been defoliated (see figure 37).

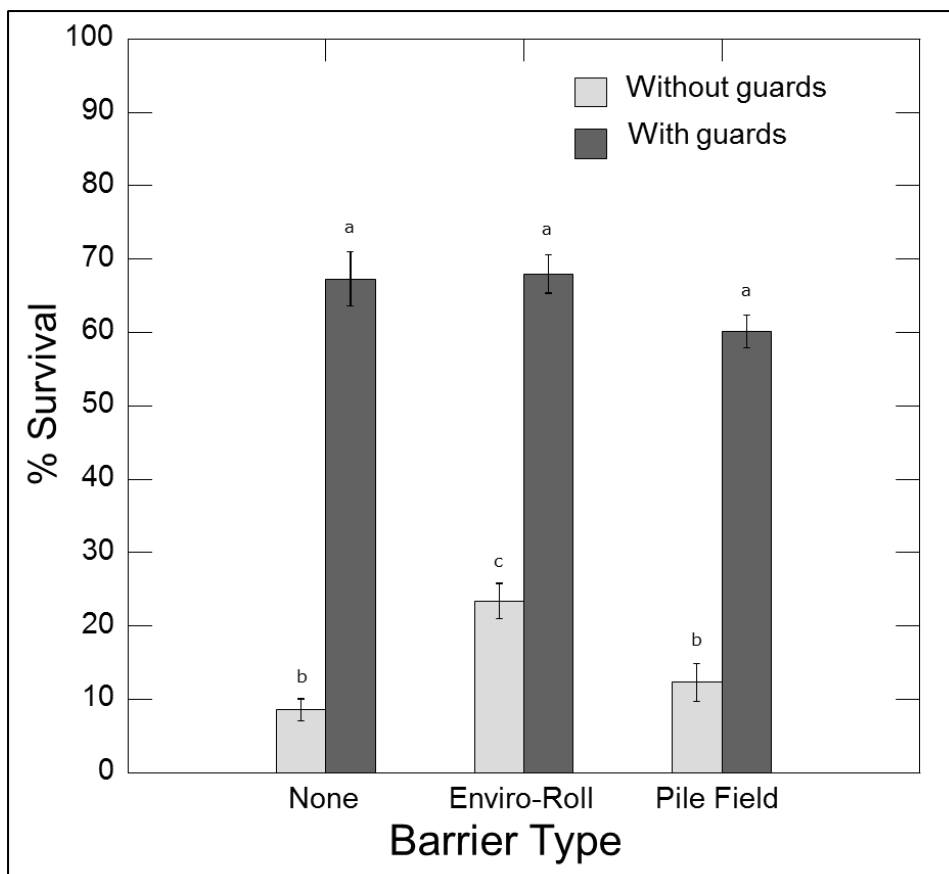
**Figure 38: Seedling survival by barrier type and presence of PVC tree-guards.** Error bars shown are  $\pm 1$  SE. Treatments with same letter are not significantly different.

Five months after planting, seedlings which had been protected with a PVC tree guard displayed an average 65% survival rate (no barrier 67%, Enviro-Roll 68%, Pile Field 60%) whereas an average of only 15% of seedlings that did not have a tree-guard were surviving (no barrier 8%, Enviro-Roll 23%, Pile Field 12%). Guarded seedling survival was not significantly different between barrier type, however it was slightly lower for the pile fields. This may have been caused by the disturbance to the planting plots that was a
