## Nation Partners

## Northern pipeline

## Construction Impact Report

Thursday 23<sup>rd</sup> March 2023

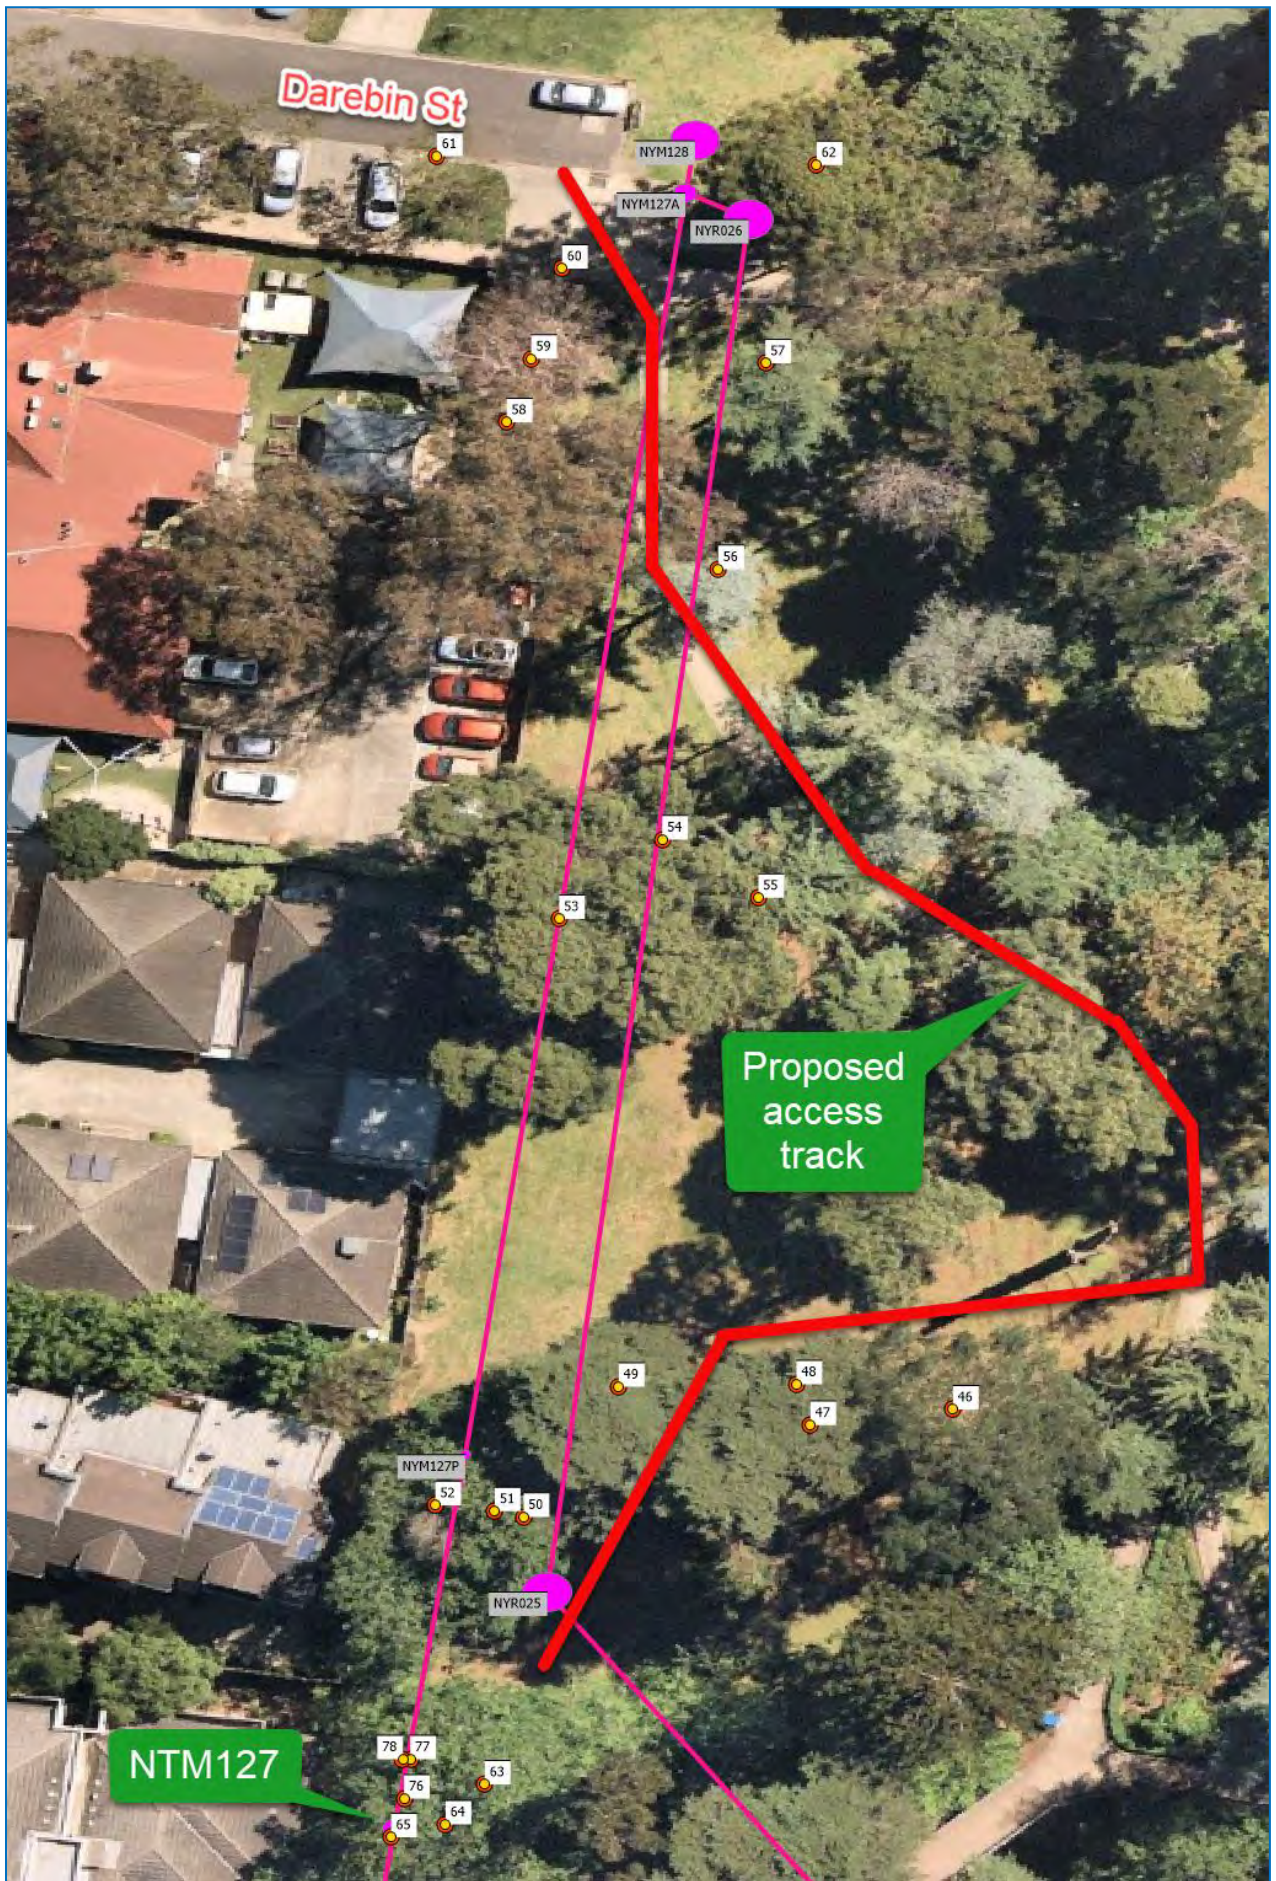
Figure 4 NYM 127, NYM127P, NYM127A & NYM128 (Trees 46 – 65 & 76 – 78)

The construction of a small work platform is required around NYM127 and this could impact the trees closest to the manhole. The construction of the manhole should be supervised by the project arborist.

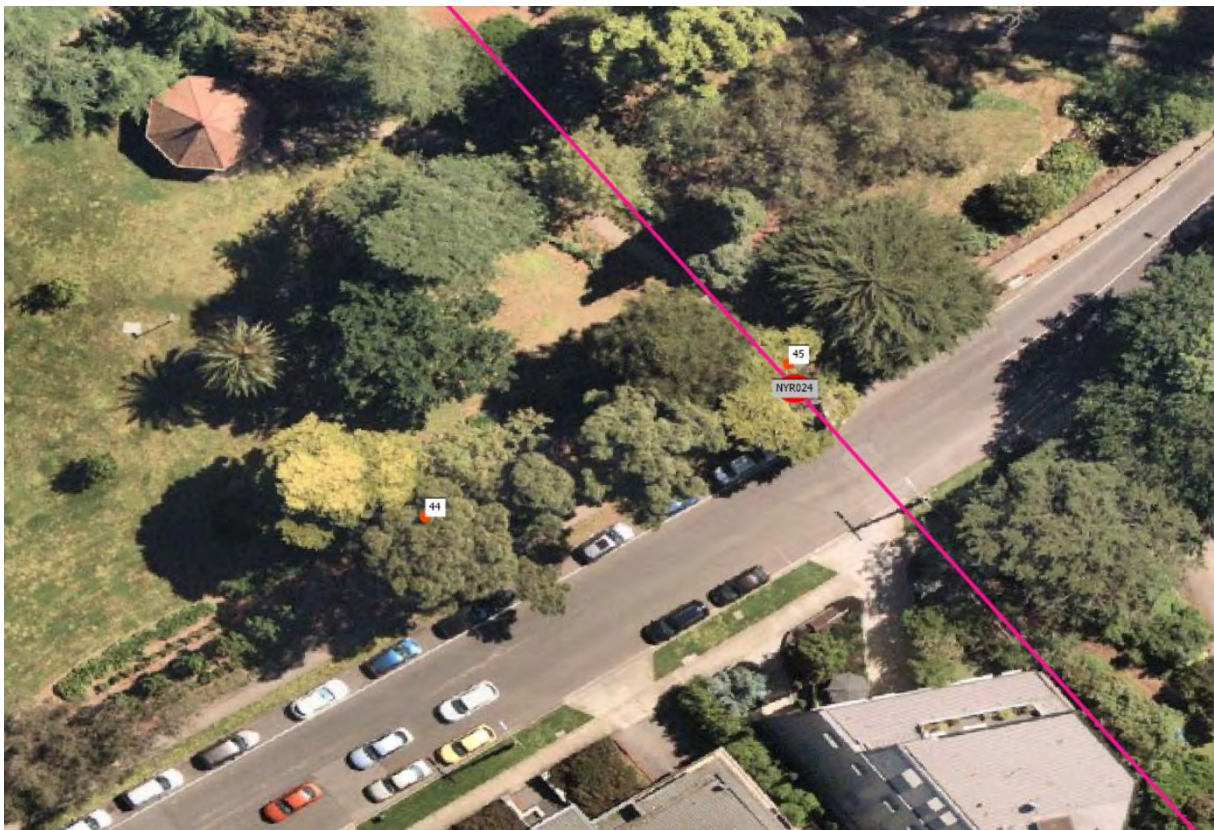
Figure 6 Heidelberg Park set down and parking area (Burgundy Street) (Tree 44 and Tree 45)

Tree 44 and Tree 45 require pruning to provide clearance:

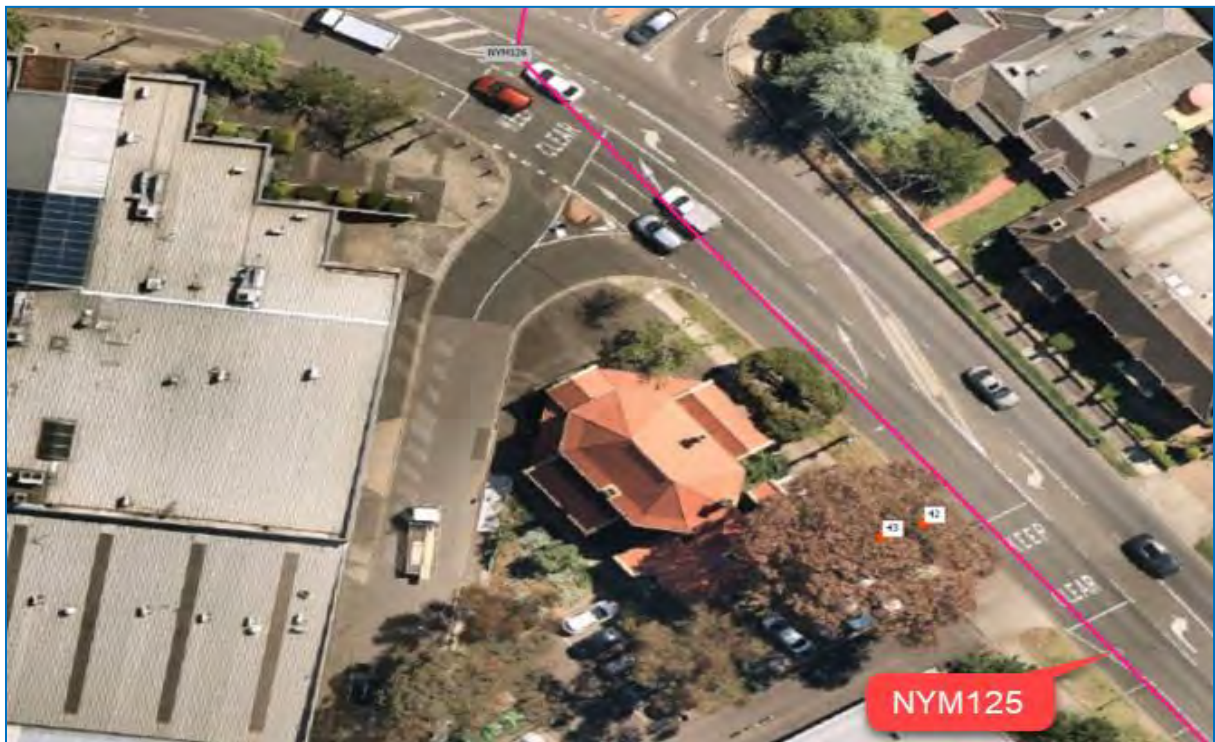
Figure 8 Trees 42 & 43 NYM125 (Trees 42 & 43)

Access to NYM125 is on Jika Street, Heidelberg. Two trees (Tree 42 and 43) were assessed adjacent to this manhole (Figure 8). Tree 42 is a street tree.

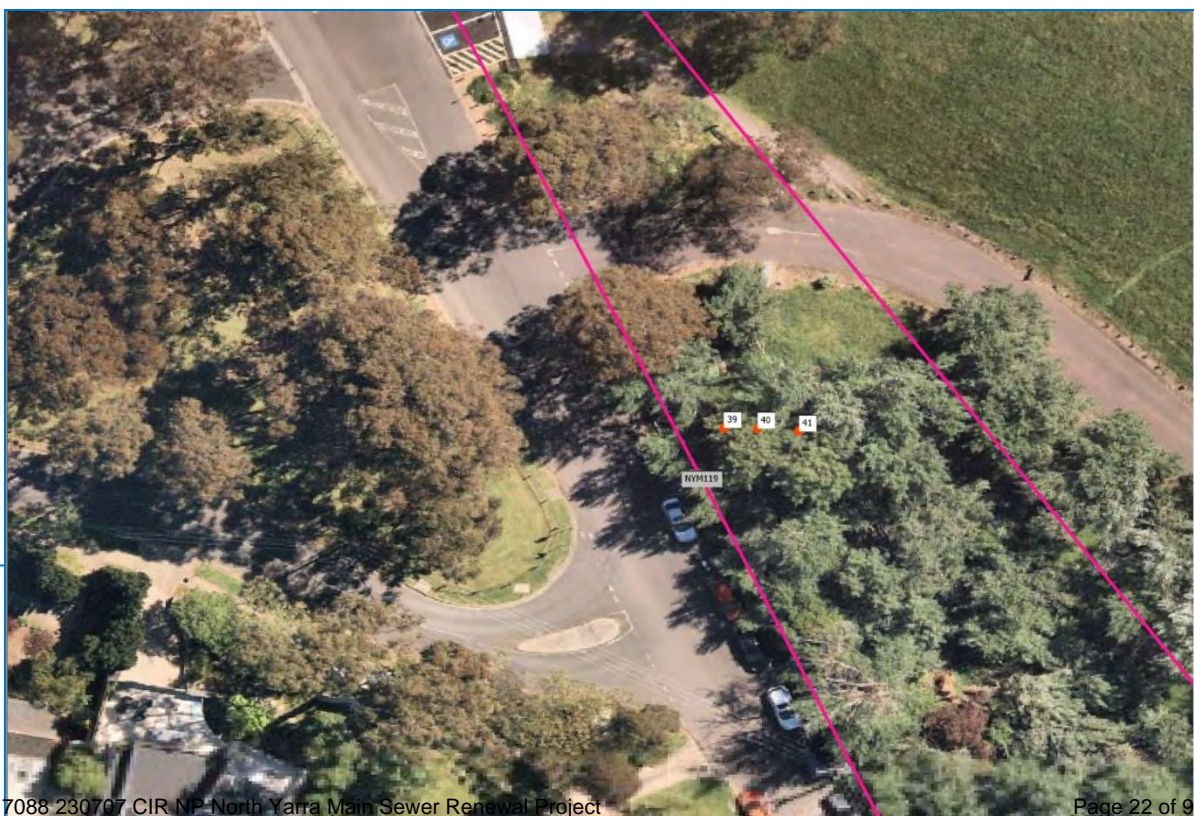
Tree 39 (*Populus alba*), Tree 40 (*Ligustrum lucidum*) and Tree 41 (*Cotoneaster glaucophyllus*)

are species recognised in the 2006 *'Banyule Weed Management Strategy'* as a weed species. Therefore, a planning permit would not be required for the pruning or removal of any of these three trees.

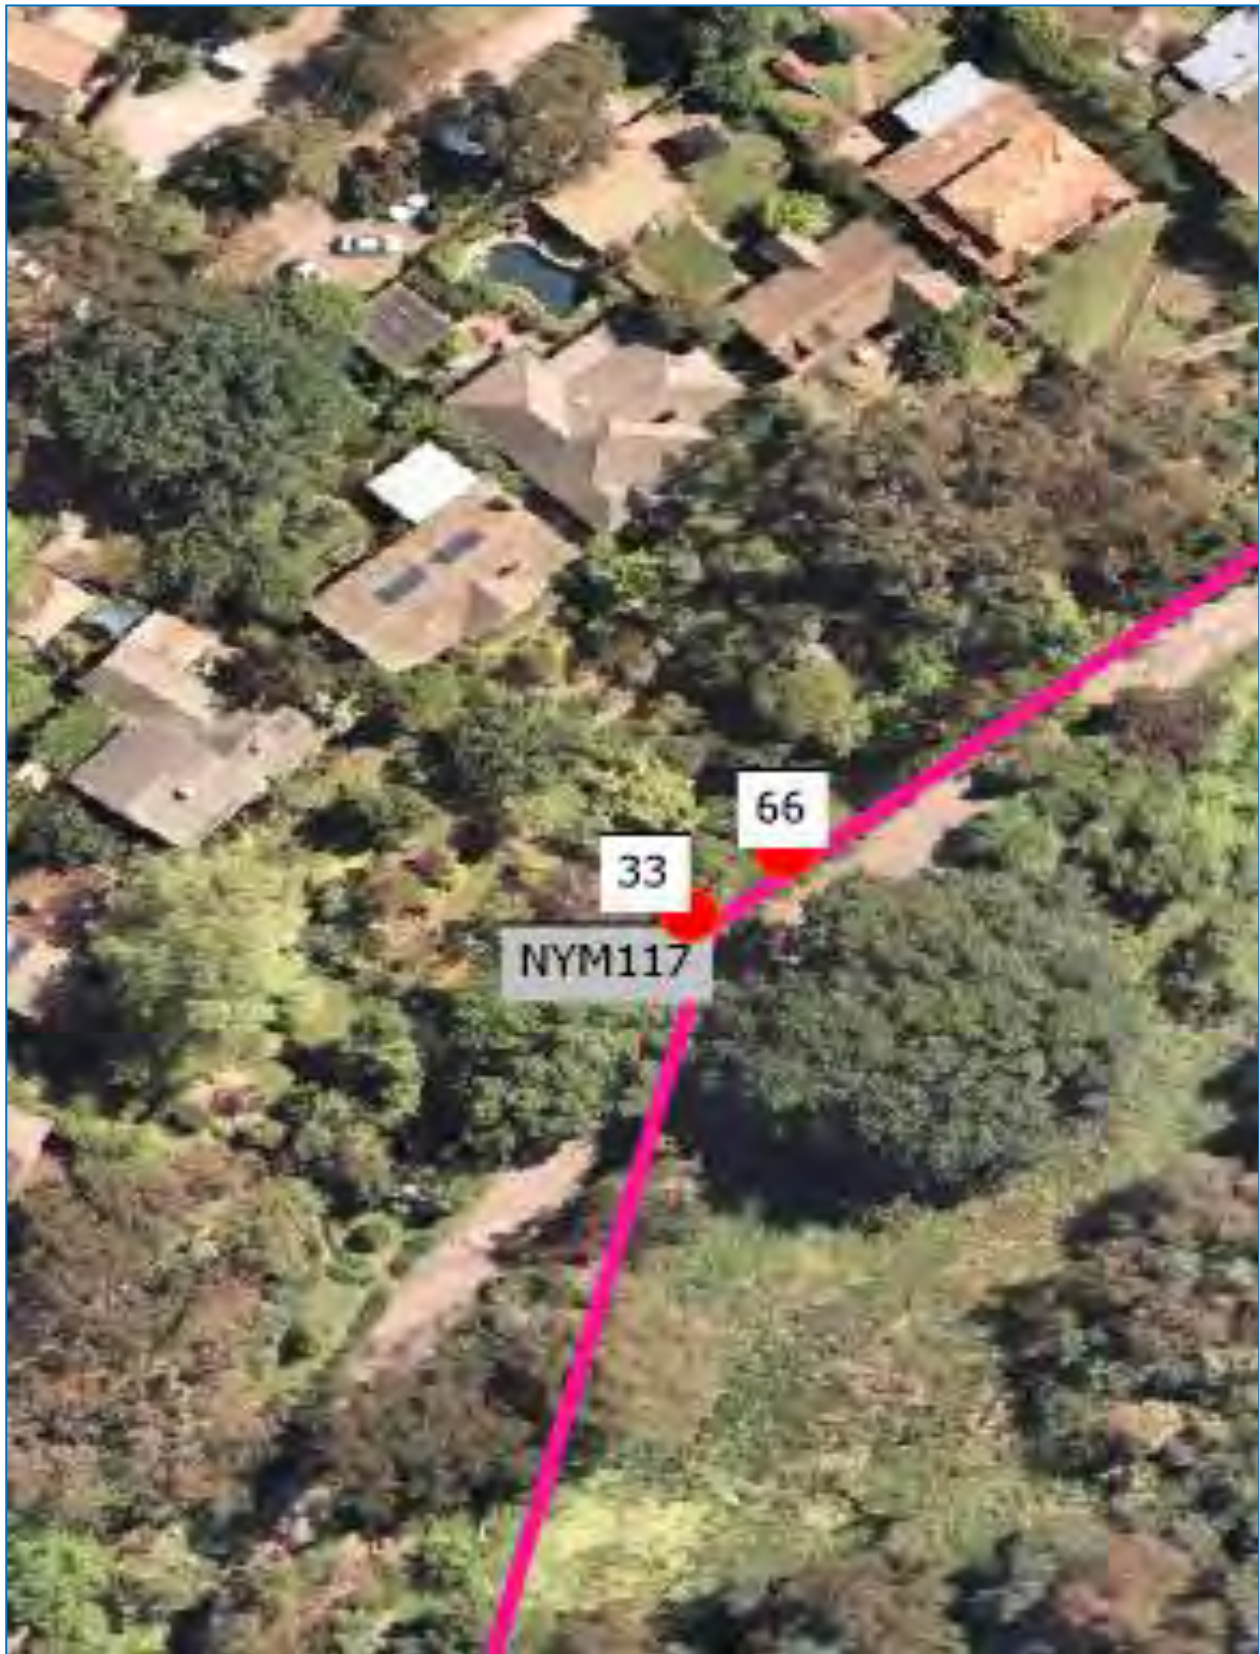
Figure 18 NYM117 Trees 33 & 66

Tree 66 (a *Melia azedarach* with low retention value) (Figure 17) is understood to be required to be removed to facilitate the proposed works. It is understood that the contractors regard this tree as a self seeded specimen although this would seem unlikely.

While this tree is very small and could be readily replaced, it would be preferable that it be preserved at the site.

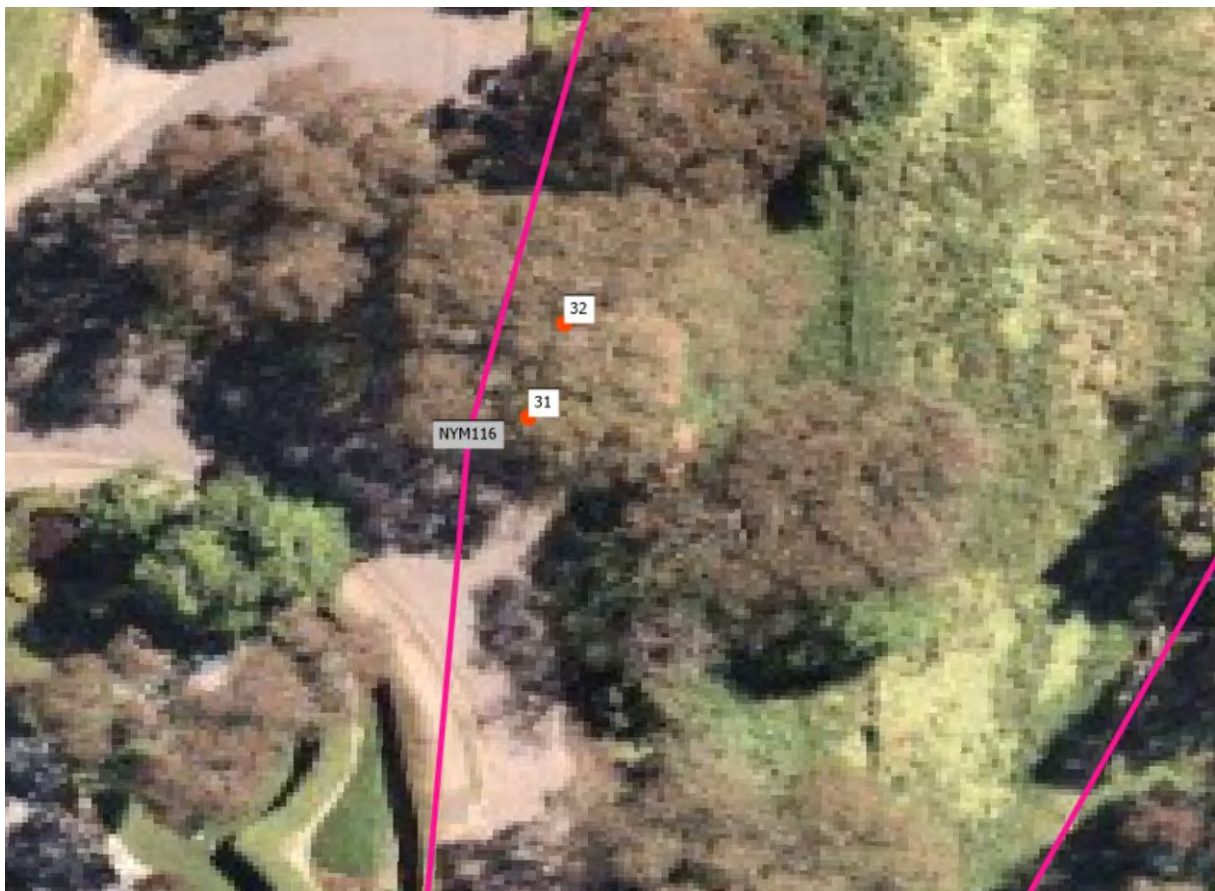
**Figure 20 NYM116 (Tree 31 and Tree 32)**

No pruning or tree removal is required in this location.

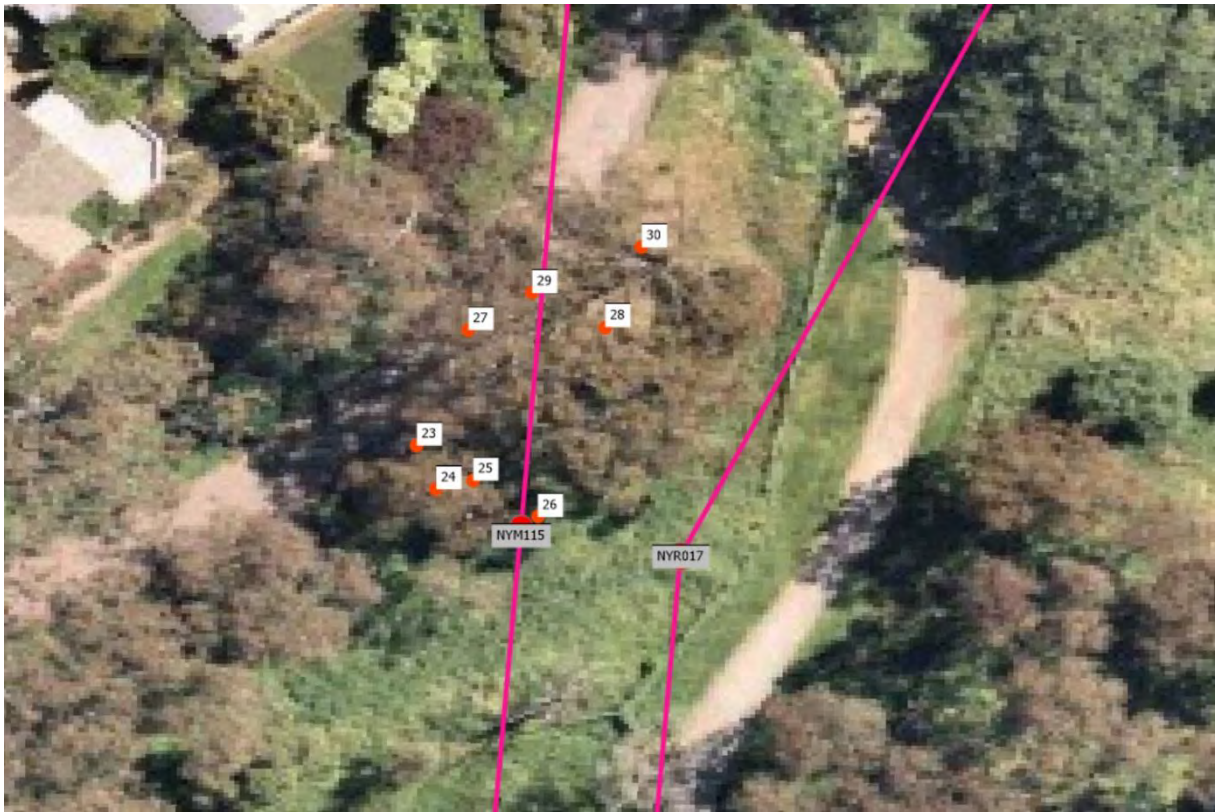
Figure 22 NYM115 (Trees 23 to 30)

Trees 24 & 27 will likely require pruning to provide clearance (Figure 22 and Figure 23).

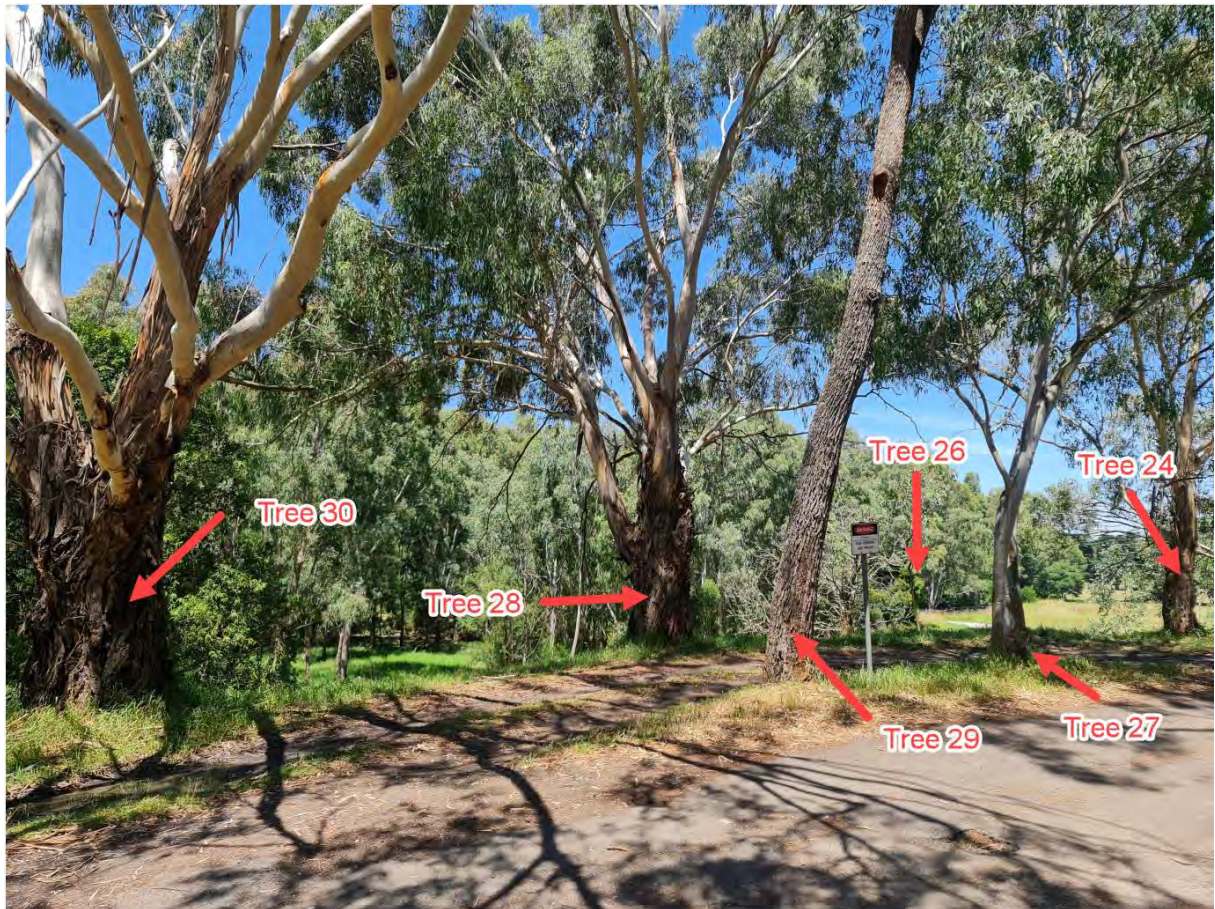
Figure 23 NYM115 Access arrangements (view from The Boulevard, Ivanhoe East to south-west)

It is understood that the proposed works will require the pruning of Trees 24 & 27 at NYM115.

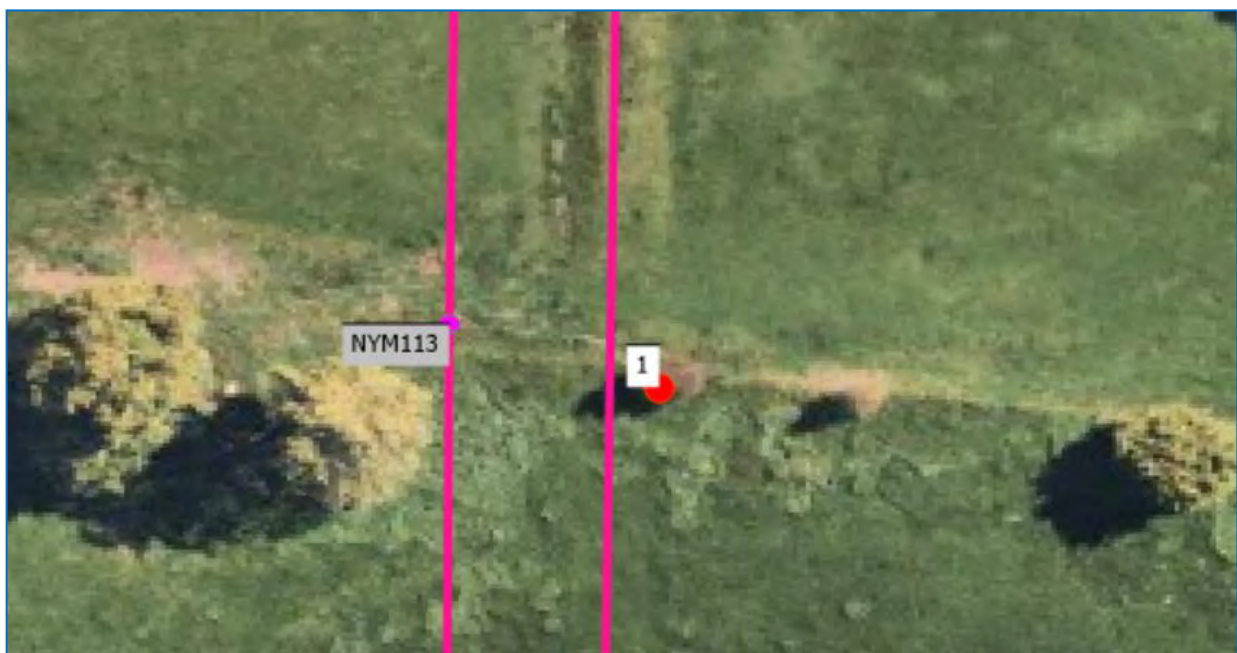
**Figure 37 NYM113 (Tree 1)**

No pruning or tree removal is required.

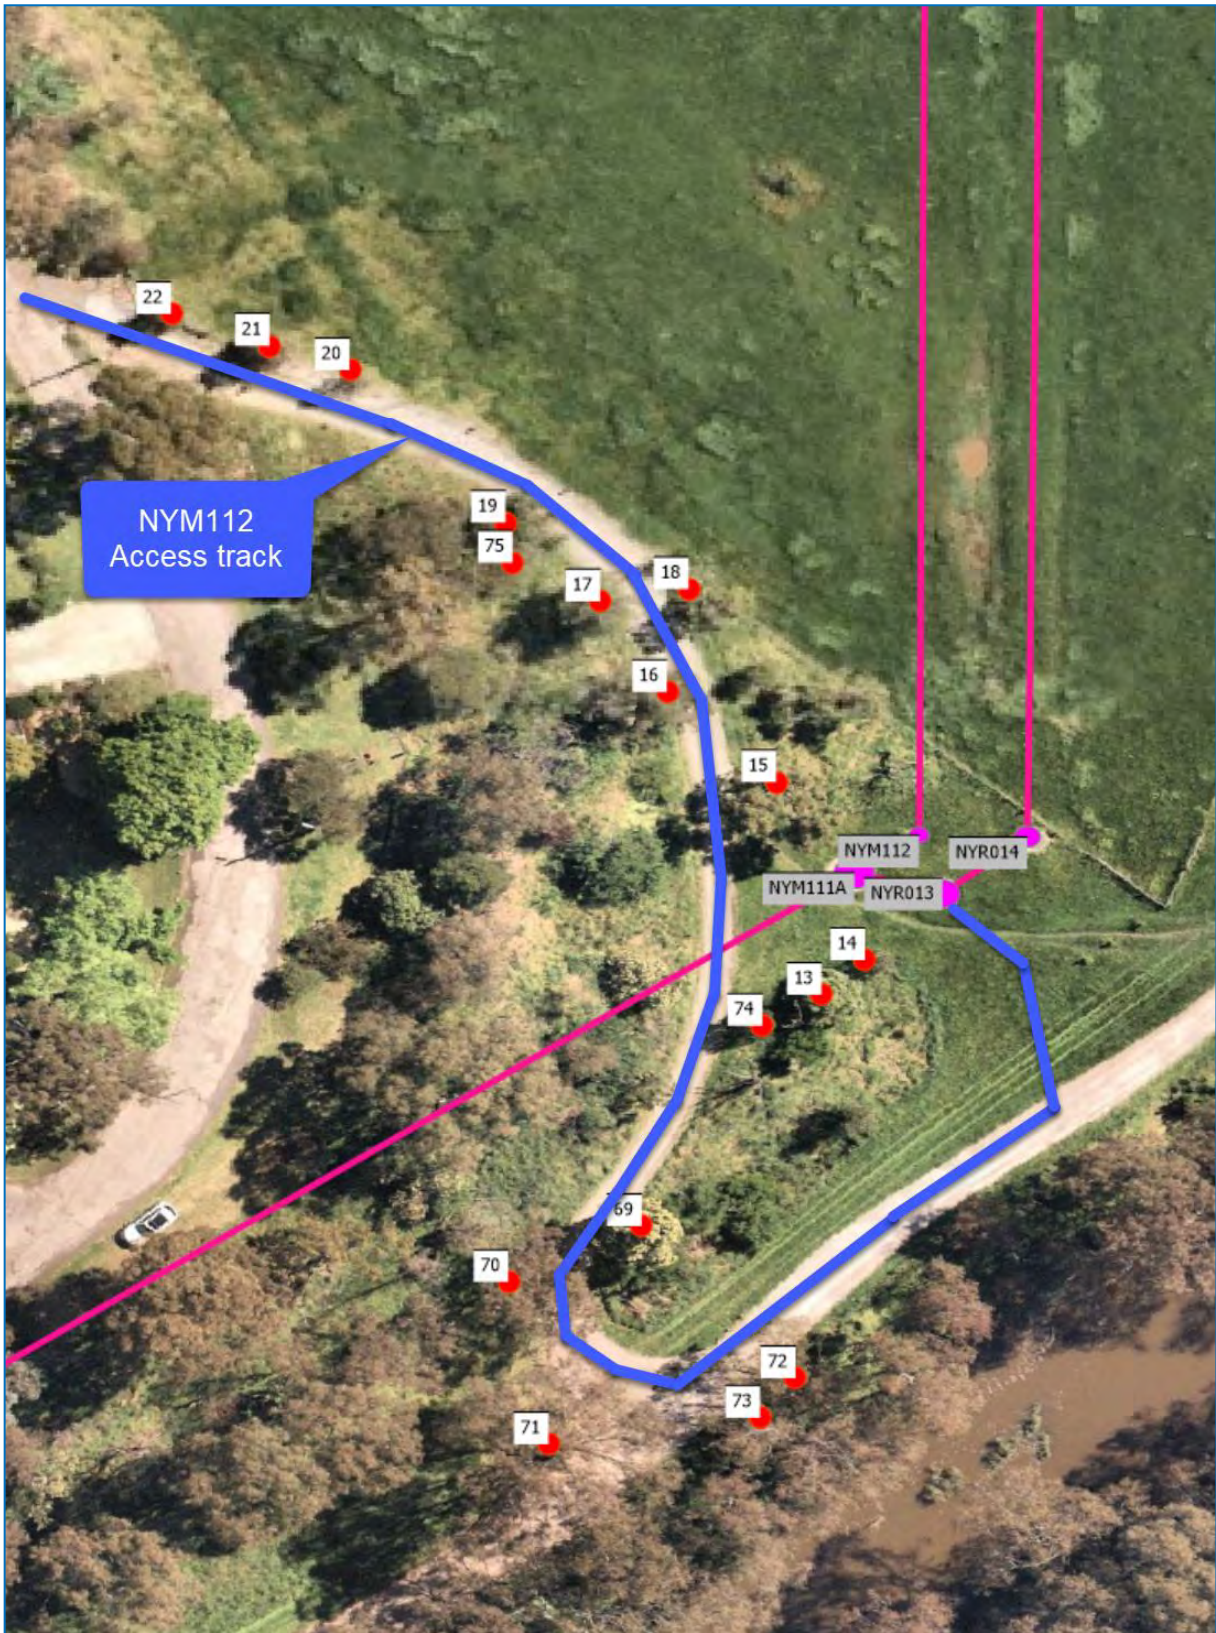
Figure 39 NYM112 (Trees 15, 16, 17, 18, 19, 20, 21, 22, 69, 70., 71, 72 & 730)

Three trees (Tree 13, 14 and Tree 15) are located within approximately 10m of NYM111a. If additional clearance is required around the manholes, we recommend the retention of tree 15 (a *Corymbia citriodora* with a moderate retention value), and the removal of Tree 13 (an *Acacia melanoxylon* with a low retention value) and Tree 14 (a *Casuarina cunninghamiana* with a low retention value). Tree 15 is a mature 10 metre tall tree with an estimated ULE of 30 to 60 year; while Tree 13 and 14 are both under 6 metres tall. In comparison Trees 13 and 14 provides less amenity value. Refer to Figure 39 Figure 40.

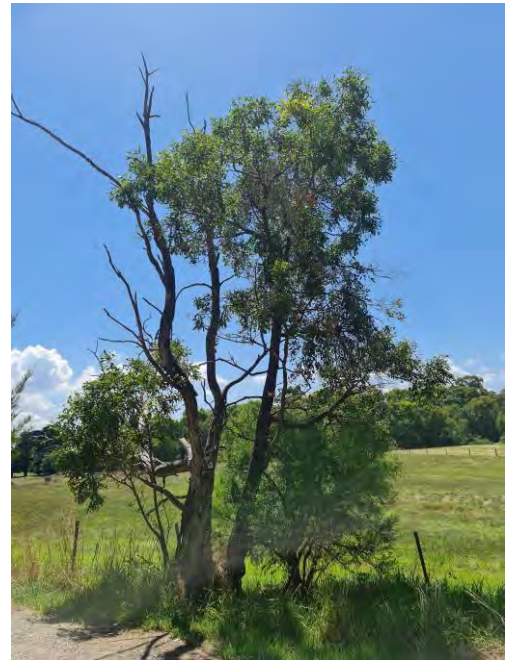
**Tree ID: 18**

**Genus / species:** *Acacia melanoxylon*  
Evergreen Blackwood  
**Height (m):** 7 **Structure:** Fair  
**Width (m):** 5 **Health:** Fair  
**DBH (cm):** 39 Measured **Maturity:** Over mature  
**Origin:** Melbourne **ULE (years):** 5 - 15  
**Form:** Fair  
**Retention value:** Low  
**Removal / retention reason:** N/A.  
**Amenity value:** Low  
**Works Required:** **Works priority:** N/A  
N/A.

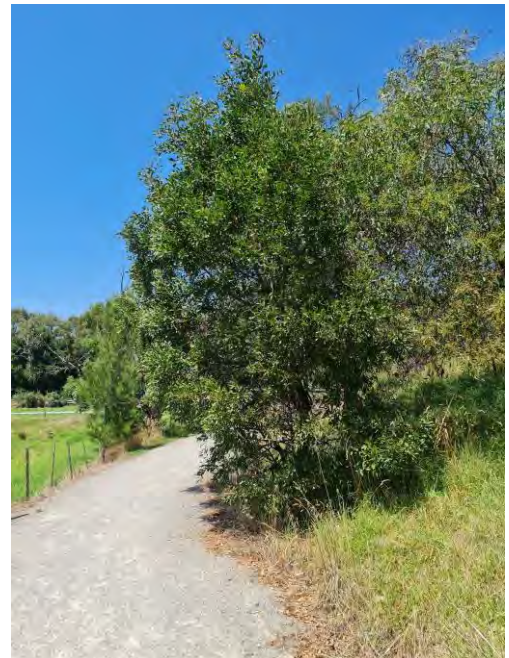
**Tree ID: 19**

**Genus / species:** *Acacia melanoxylon*  
Evergreen Blackwood  
**Height (m):** 6 **Structure:** Good  
**Width (m):** 5 **Health:** Good  
**DBH (cm):** 15 Estimated **Maturity:** Young  
**Origin:** Melbourne **ULE (years):** 30 - 60  
**Form:** Good  
**Retention value:** Remove.  
**Removal / retention reason:** N/A.  
**Amenity value:** Low  
**Works Required:** **Works priority:** Very low  
Remove.

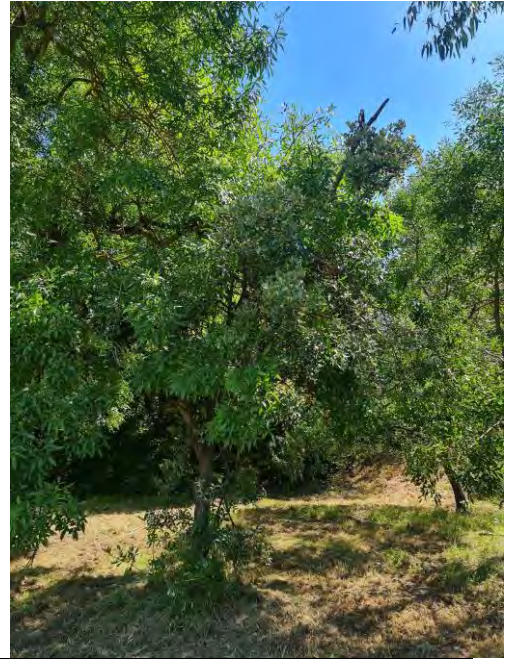
**Tree ID:** 37

**Genus / species:** *Pittosporum crassifolium*  
Evergreen Karo  
**Height (m):** 4 **Structure:** Poor  
**Width (m):** 2 **Health:** Fair  
**DBH (cm):** 15 Measured **Maturity:** Mature  
**Origin:** Australian **ULE (years):** 1 - 5  
**Form:** Poor  
**Retention value:** Remove.  
**Removal / retention reason:** N/A.  
**Amenity value:** Very low  
**Works Required:** **Works priority:** Very low  
Remove.

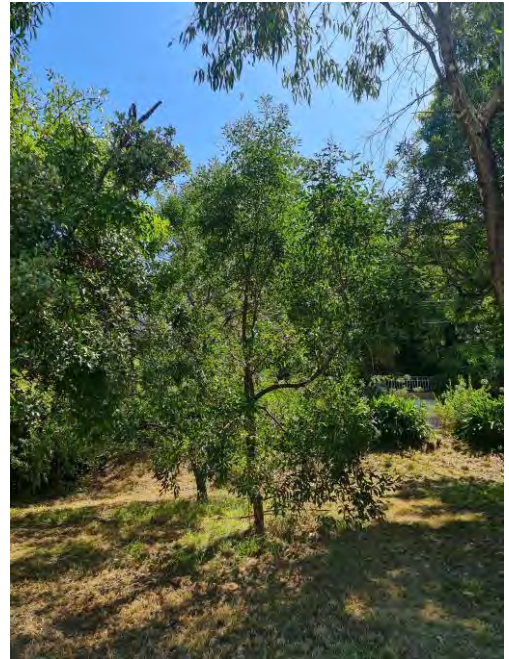
**Tree ID:** 38

**Genus / species:** *Acacia melanoxylon*  
Evergreen Blackwood  
**Height (m):** 5 **Structure:** Good  
**Width (m):** 2 **Health:** Good  
**DBH (cm):** 15 Estimated **Maturity:** Immature  
**Origin:** Melbourne **ULE (years):** 30 - 60  
**Form:** Good  
**Retention value:** Low  
**Removal / retention reason:** N/A.  
**Amenity value:** Low  
**Works Required:** **Works priority:** N/A  
N/A.

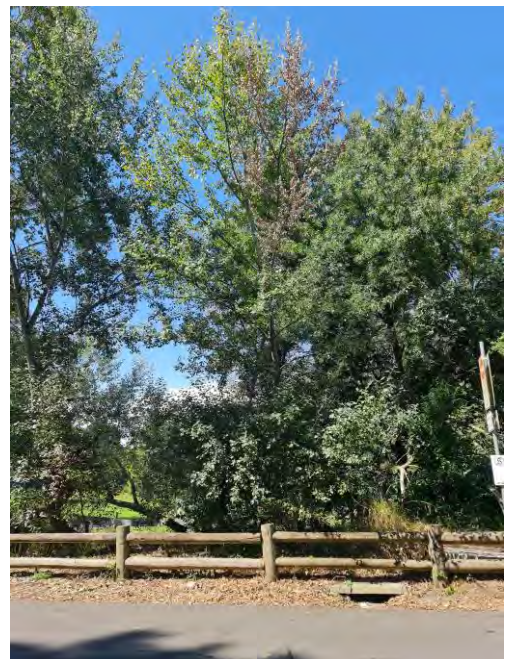
**Tree ID:** 39

**Genus / species:** *Populus alba*  
Deciduous White Poplar  
**Height (m):** 9 **Structure:** Fair  
**Width (m):** 4 **Health:** Good  
**DBH (cm):** 16 Measured **Maturity:** Mature  
**Origin:** Exotic **ULE (years):** 15 - 30  
**Form:** Fair  
**Retention value:** Low  
**Removal / retention reason:** N/A.  
**Amenity value:** Low  
**Works Required:** **Works priority:** Very low  
Prune.

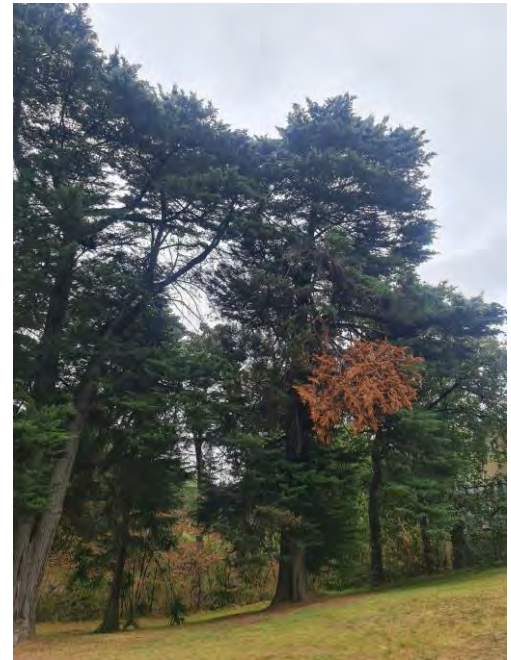
**Tree ID:** 49

**Genus / species:** *Hesperocyparis arizonica*  
Evergreen Arizona Cypress  
**Height (m):** 25 **Structure:** Fair  
**Width (m):** 18 **Health:** Good  
**DBH (cm):** 87 Measured **Maturity:** Mature  
**Origin:** Exotic **ULE (years):** 30 - 60  
**Form:** Fair  
**Retention value:** High  
**Removal / retention reason:** N/A.  
**Amenity value:** High  
**Works Required:** **Works priority:** Very low  
Broken branch/s.

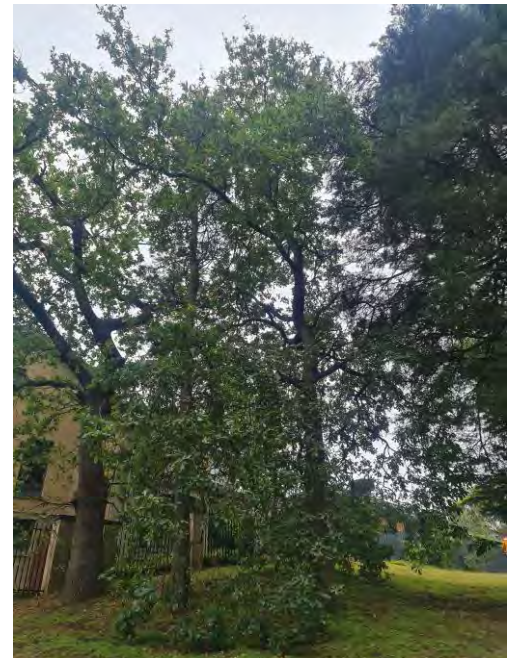
**Tree ID:** 50

**Genus / species:** *Quercus petraea*  
Deciduous Durmast Oak  
**Height (m):** 18 **Structure:** Fair  
**Width (m):** 12 **Health:** Fair  
**DBH (cm):** 87 Measured **Maturity:** Mature  
**Origin:** Exotic **ULE (years):** 30 - 60  
**Form:** Fair  
**Retention value:** Remove.  
**Removal / retention reason:** N/A.  
**Amenity value:** High  
**Works Required:** **Works priority:** N/A  
N/A.

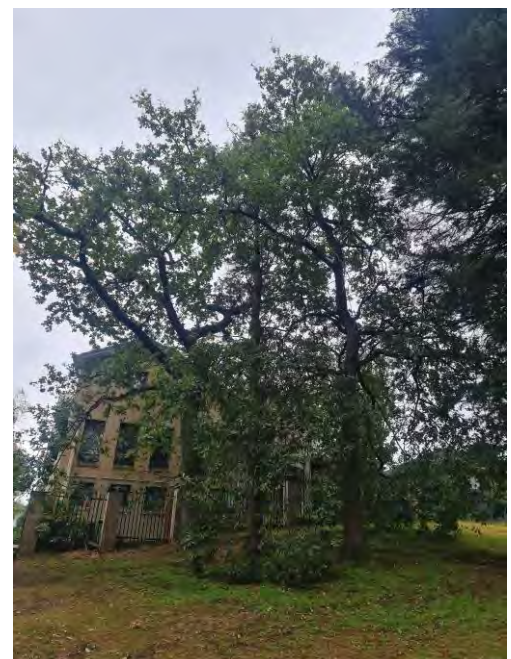
**Tree ID:** 51

**Genus / species:** *Hesperocyparis arizonica*  
Evergreen Arizona Cypress  
**Height (m):** 17 **Structure:** Fair  
**Width (m):** 6 **Health:** Poor  
**DBH (cm):** 38 Measured **Maturity:** Mature  
**Origin:** Exotic **ULE (years):** 5 - 15  
**Form:** Fair  
**Retention value:** Remove.  
**Removal / retention reason:** N/A.  
**Amenity value:** Moderate  
**Works Required:** **Works priority:** N/A  
N/A.

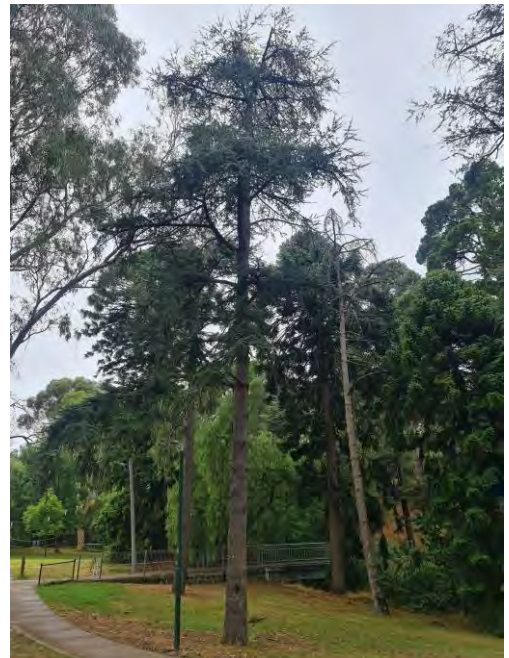
**Tree ID:** 57

**Genus / species:** *Cedrus sp.*  
Evergreen Cedar

**Retention value:** High  
**Removal / retention reason:** N/A.  
**Amenity value:** High  
**Works Required:**      **Works priority:** N/A  
N/A.

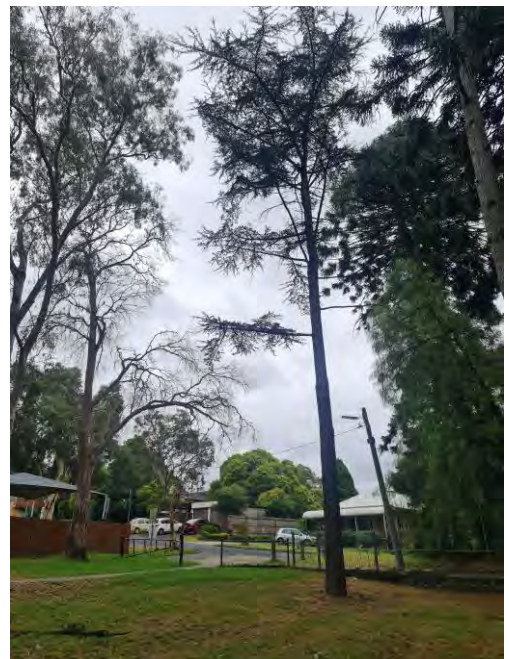
**Tree ID:** 58

**Genus / species:** *Eucalyptus sp.*  
Evergreen Gum  
**Height (m):** 20                      **Structure:** Fair  
**Width (m):** 15                      **Health:** Good  
**DBH (cm):** 121 Measured      **Maturity:** Mature  
**Origin:** Australian              **ULE (years):** 30 - 60  
**Form:** Fair  
**Retention value:** High  
**Removal / retention reason:** N/A.  
**Amenity value:** High  
**Works Required:**              **Works priority:** N/A  
N/A.

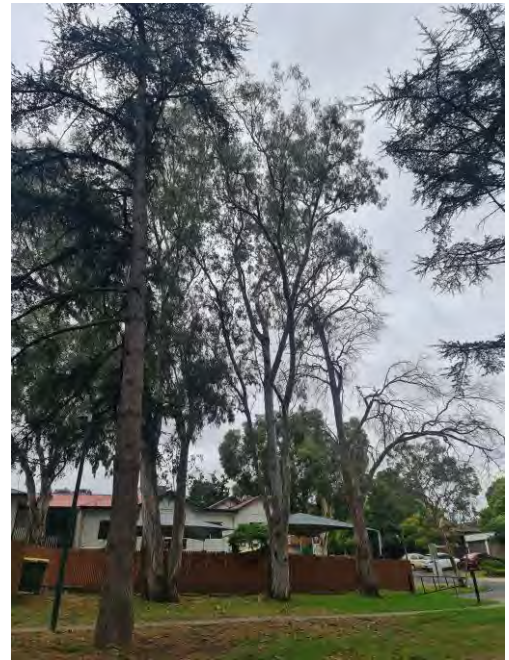
**Tree ID:** 59

**Genus / species:** *Eucalyptus sp.*  
Evergreen Gum  
**Height (m):** 20                      **Structure:** Fair  
**Width (m):** 15                      **Health:** Fair  
**DBH (cm):** 107 Measured      **Maturity:** Mature  
**Origin:** Australian              **ULE (years):** 30 - 60  
**Form:** Fair  
**Retention value:** High  
**Removal / retention reason:** N/A.  
**Amenity value:** High  
**Works Required:**              **Works priority:** N/A  
N/A.

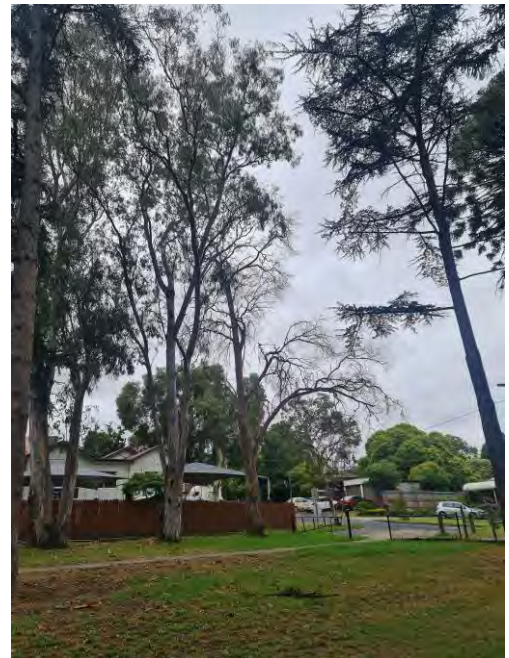
**Tree ID:** 60

**Genus / species:** *Eucalyptus sp.*  
Evergreen Gum  
**Height (m):** 20                      **Structure:** Fair  
**Width (m):** 15                      **Health:** Poor  
**DBH (cm):** 71 Measured      **Maturity:** Mature  
**Origin:** Australian              **ULE (years):** 0  
**Form:** Poor  
**Retention value:** Remove.  
**Removal / retention reason:** N/A.  
**Amenity value:** Moderate  
**Works Required:**              **Works priority:** N/A  
N/A.

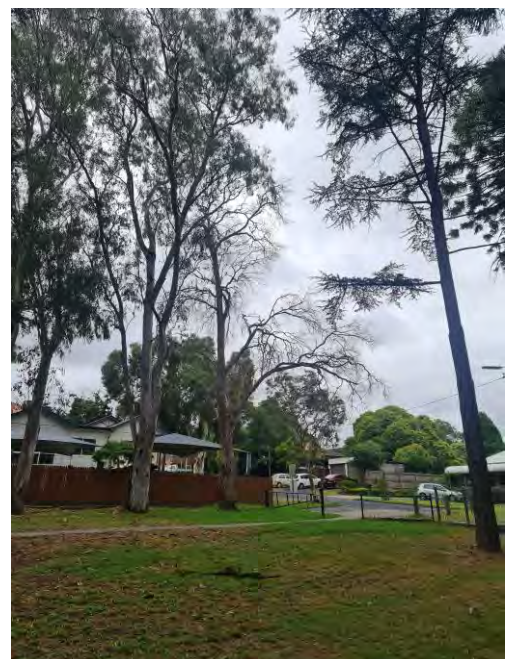
**Tree ID:** 61

**Genus / species:** *Eucalyptus sp.*  
Evergreen Gum  
**Height (m):** 7 **Structure:** Fair  
**Width (m):** 5 **Health:** Fair  
**DBH (cm):** 24 Measured **Maturity:** Young  
**Origin:** Australian **ULE (years):** 15 - 30  
**Form:** Fair  
**Retention value:** Low  
**Removal / retention reason:** N/A.  
**Amenity value:** Low  
**Works Required:** **Works priority:** N/A  
N/A.

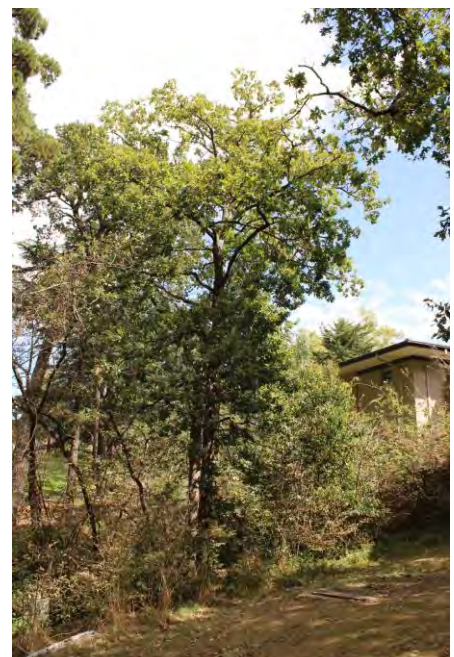
**Tree ID:** 64

**Genus / species:** *Quercus petraea*  
Deciduous Durmast Oak

**Retention value:** High  
**Removal / retention reason:** N/A.  
**Amenity value:** High  
**Works Required:**      **Works priority:** Very low  
Prune

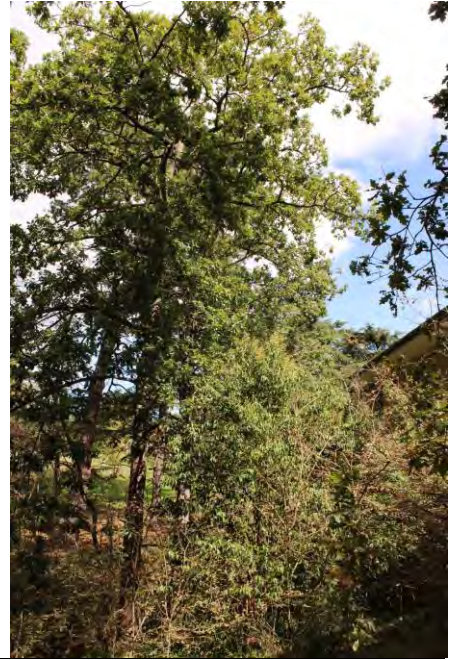
**Tree ID:** 65

**Genus / species:** *Quercus petraea*  
Deciduous Durmast Oak

**Retention value:** High  
**Removal / retention reason:** N/A.  
**Amenity value:** High  
**Works Required:**      **Works priority:** Very low  
Prune

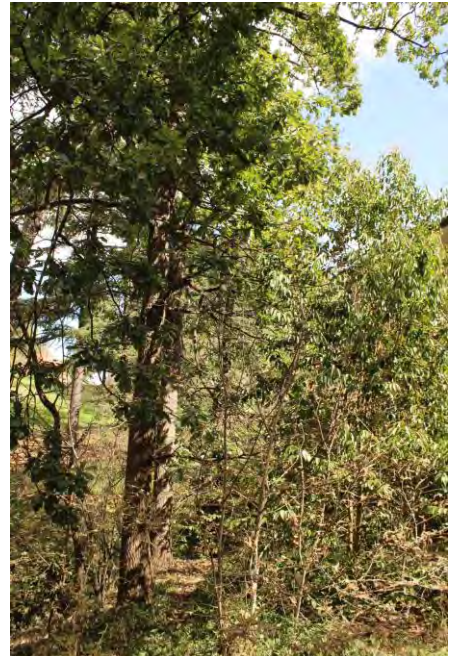
**Tree ID:** 66

**Genus / species:** *Melia azedarach*  
Deciduous White Cedar

**Retention value:** Low  
**Removal / retention reason:** N/A.  
**Amenity value:** Very low  
**Works Required:**      **Works priority:** N/A  
N/A.

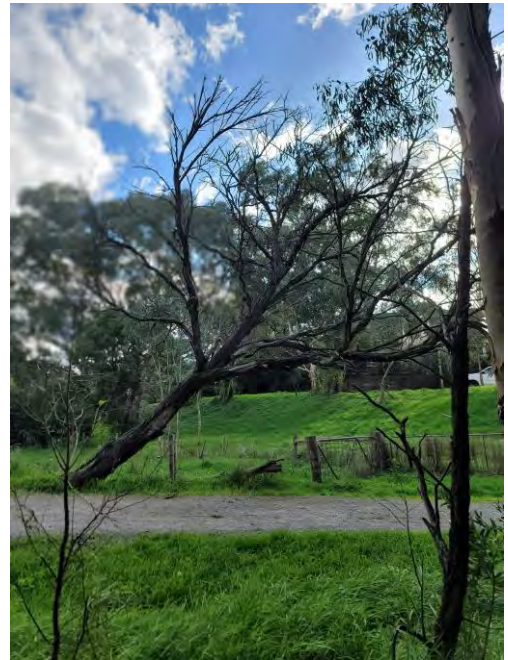
**Tree ID:** 68

**Genus / species:** *Acacia dealbata*  
Evergreen Silver Wattle

**Retention value:** Very low  
**Removal / retention reason:** N/A.  
**Amenity value:** Very low  
**Works Required:**            **Works priority:** N/A  
N/A.

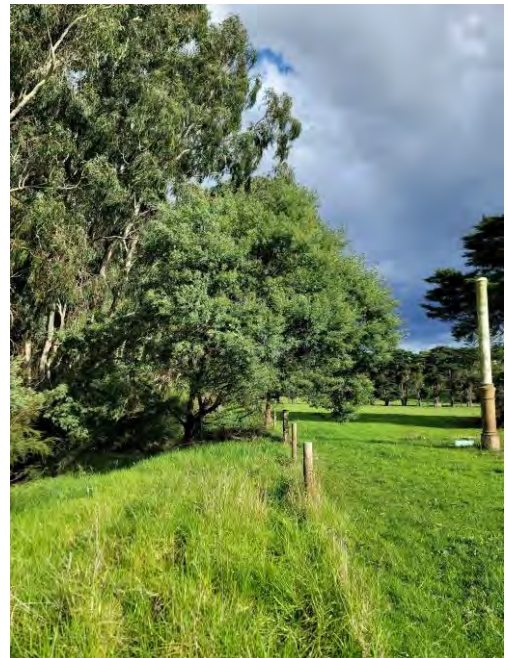
**Tree ID:** 69

**Genus / species:** *Acacia mearnsii*  
Evergreen Black Wattle

**Retention value:** Low  
**Removal / retention reason:** N/A.  
**Amenity value:** Moderate  
**Works Required:**            **Works priority:** Very low  
A Prune.

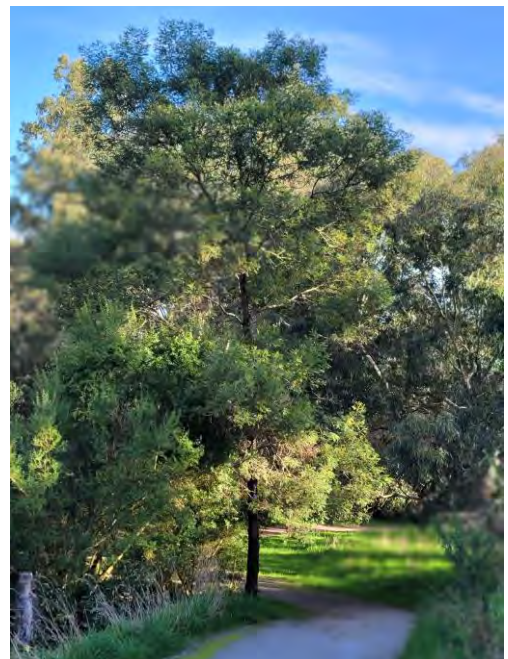
**Tree ID:** 70

**Genus / species:** *Eucalyptus camaldulensis*  
Evergreen River Red Gum

**Retention value:** High  
**Removal / retention reason:** N/A.  
**Amenity value:** Moderate  
**Works Required:**              **Works priority:** Very low  
A Prune.

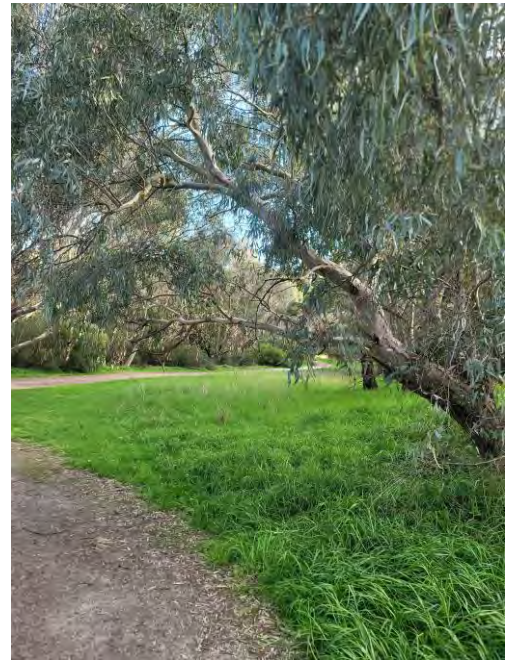
**Tree ID:** 71

**Genus / species:** *Eucalyptus camaldulensis*  
Evergreen River Red Gum

**Retention value:** High  
**Removal / retention reason:** N/A.  
**Amenity value:** High  
**Works Required:**              **Works priority:** Very low  
A Prune.

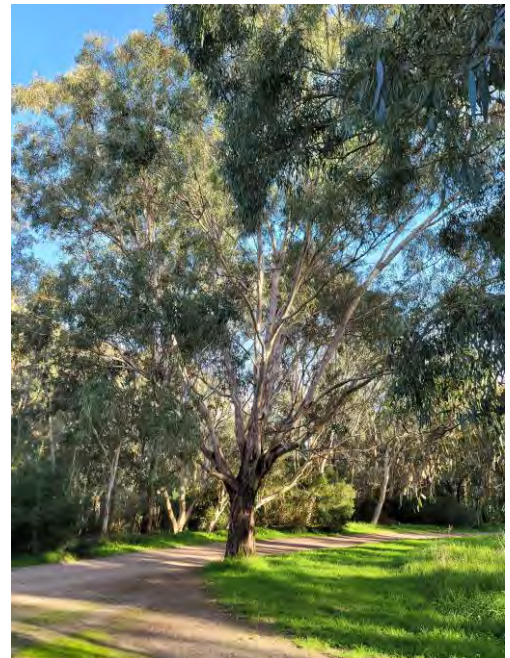
**Tree ID:** 72

**Genus / species:** *Eucalyptus camaldulensis*  
Evergreen River Red Gum

**Retention value:** High  
**Removal / retention reason:** N/A.  
**Amenity value:** Moderate  
**Works Required:**              **Works priority:** Very low  
A Prune.
