## Nation Partners

## Northern pipeline

## Construction Impact Report

Thursday 23<sup>rd</sup> March 2023

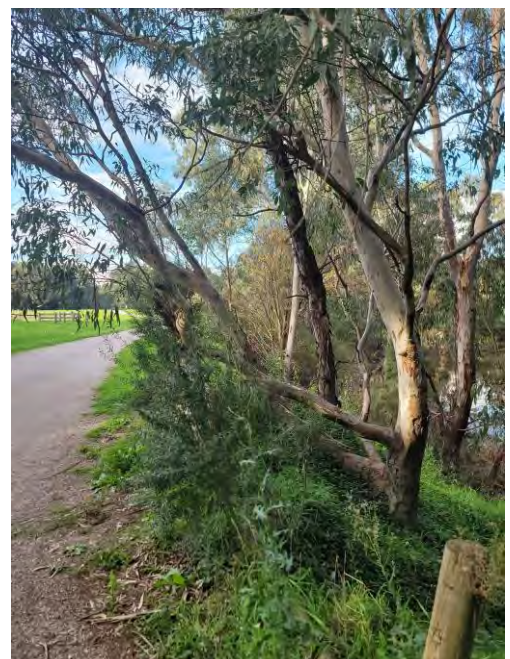
**Tree ID:** 73

**Genus / species:** *Eucalyptus camaldulensis*  
Evergreen River Red Gum

**Retention value:** Low  
**Removal / retention reason:** N/A.  
**Amenity value:** Low  
**Works Required:**            **Works priority:** Very low  
A Prune.

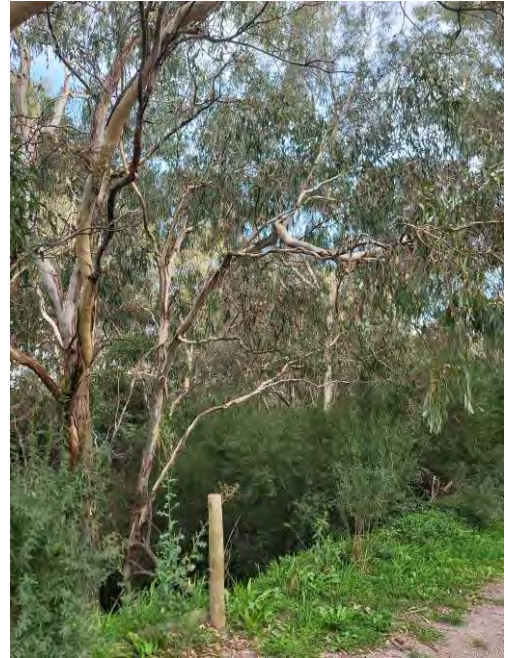
**Tree ID:** 74

**Genus / species:** *Allocasuarina torulosa*  
Evergreen Forest Oak

**Retention value:** Low  
**Removal / retention reason:** N/A.  
**Amenity value:** Low  
**Works Required:**            **Works priority:** N/A  
N/A.

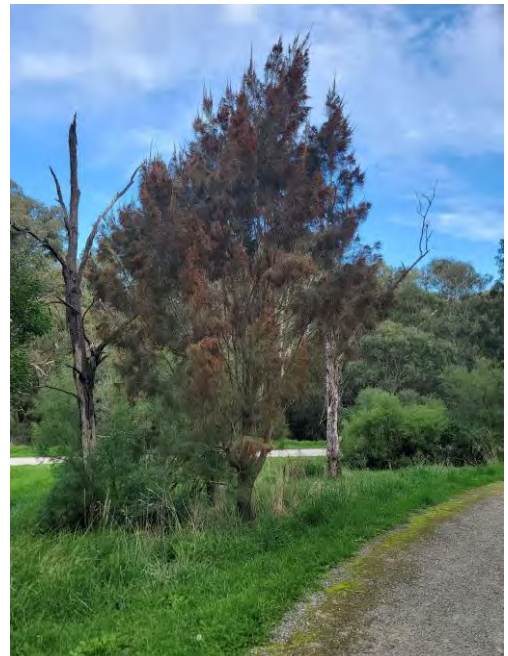
**Tree ID:** 75

**Genus / species:** *Acacia melanoxylon*  
Evergreen Blackwood

**Retention value:** Remove.  
**Removal / retention reason:** N/A.  
**Amenity value:** Very low  
**Works Required:**            **Works priority:** Very low  
Remove.

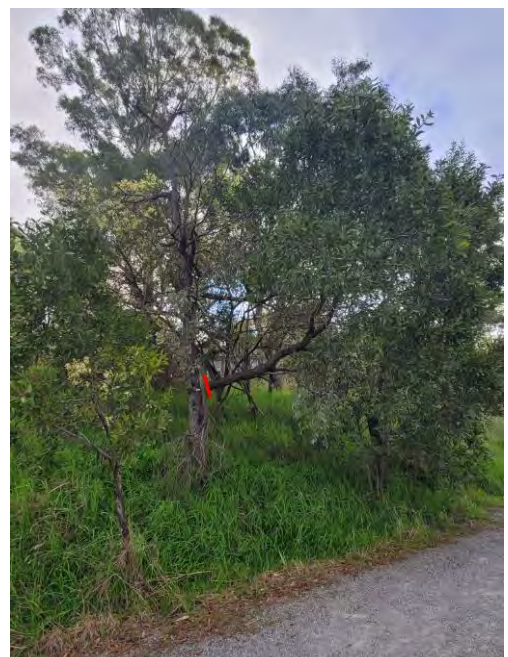
**Tree ID: 76**

**Genus / species:** *Ulmus procera*  
Deciduous English Elm  
**Height (m):** 3                      **Structure:** Good  
**Width (m):** 2                      **Health:** Good  
**DBH (cm):** 3      Estimated      **Maturity:** Young  
**Origin:** Exotic                      **ULE (years):** 5 - 15  
**Form:** Good  
**Retention value:** Very low  
**Removal / retention reason:** N/A.  
**Amenity value:** Very low  
**Works Required:**      **Works priority:** N/A  
N/A.

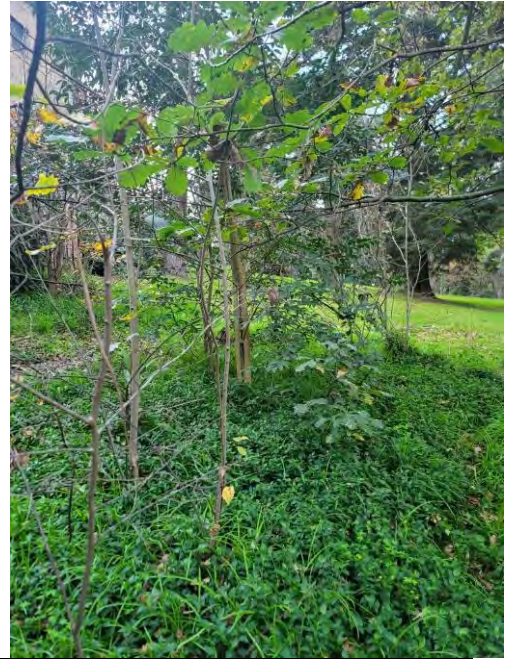
**Tree ID: 77**

**Genus / species:** *Ulmus procera*  
Deciduous English Elm  
**Height (m):** 4                      **Structure:** Good  
**Width (m):** 2                      **Health:** Good  
**DBH (cm):** 5      Estimated      **Maturity:** Young  
**Origin:** Exotic                      **ULE (years):** 5 - 15  
**Form:** Good  
**Retention value:** Very low  
**Removal / retention reason:** N/A.  
**Amenity value:** Very low  
**Works Required:**      **Works priority:** N/A  
N/A.

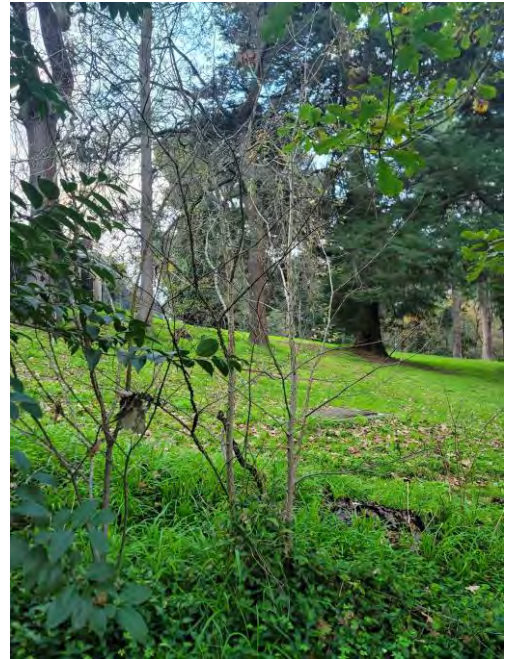
**Tree ID: 78**

**Genus / species:** *Ulmus procera*  
Deciduous English Elm  
**Height (m):** 4                      **Structure:** Good  
**Width (m):** 2                      **Health:** Good  
**DBH (cm):** 4      Estimated      **Maturity:** Young  
**Origin:** Exotic                      **ULE (years):** 5 - 15  
**Form:** Good  
**Retention value:** Very low  
**Removal / retention reason:** N/A.  
**Amenity value:** Very low  
**Works Required:**      **Works priority:** N/A  
N/A.
