## Nation Partners

# Northern Sewers Relining Project Southern Section

## Construction Impact Report

**Wednesday 4<sup>th</sup> December 2024**

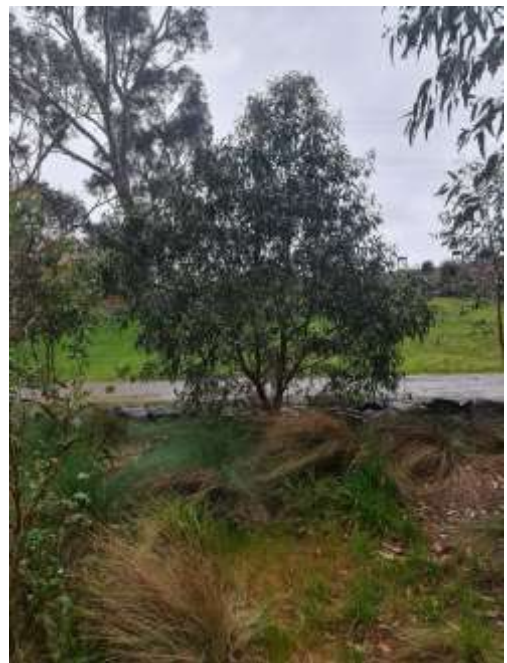
**Tree ID:** 604

**Height (m):** 4                      **Structure:** Good  
**Width (m):** 3                      **Health:** Good  
**DBH (cm):** 8      Estimated **Maturity:** Immature  
**Origin:** Victorian              **ULE (years):** 30 - 60  
**Retained?:** Removed              **Form:** Good  
**Retention Value:** Very low  
**Removal / retention reason:** N/A.  
**Amenity value:** Very low  
**Works Required:** N/A.

**SRZ (m):** 1.6              **Works priority:** N/A  
**TPZ (m):** 2.0              **Construction Proximity:** 0.1  
**mTPZ (m):**

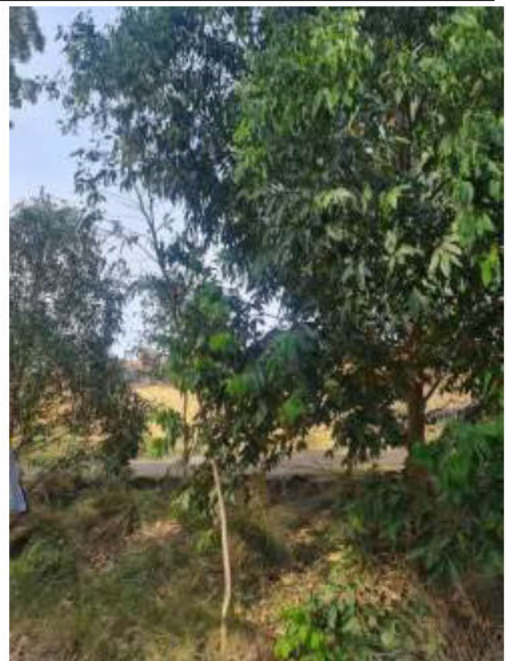
**Tree ID:** 639

<b>Height (m):</b> 3	<b>Structure:</b> Good
<b>Width (m):</b> 2	<b>Health:</b> Good
<b>DBH (cm):</b> 3 Measured	<b>Maturity:</b> Immature
<b>Origin:</b> Australian	<b>ULE (years):</b> 15 - 30
<b>Retained?:</b> Removed	<b>Form:</b> Good
<b>Retention Value:</b>	Very low
<b>Removal / retention reason:</b>	N/A.
<b>Amenity value:</b>	Very low
<b>Works Required:</b>	N/A.

<b>SRZ (m):</b> 1.6	<b>Works priority:</b>	Very low
<b>TPZ (m):</b> 2.0	<b>Construction Proximity:</b>	0.1
<b>mTPZ (m):</b>

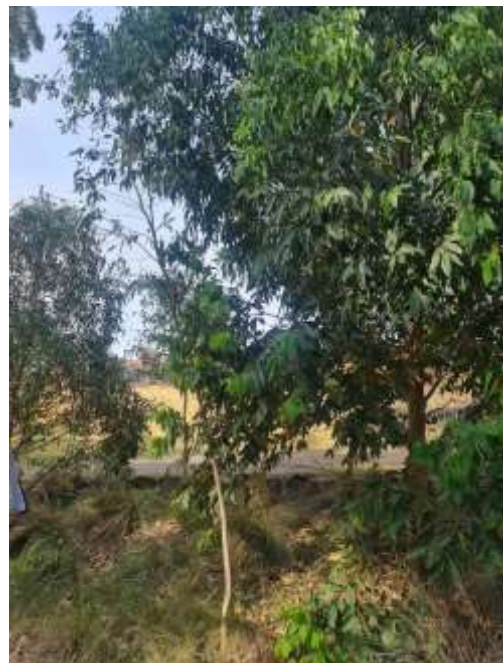
**Tree ID:** 640

<b>Height (m):</b> 3	<b>Structure:</b> Fair
<b>Width (m):</b> 3	<b>Health:</b> Fair
<b>DBH (cm):</b> 5 Estimated	<b>Maturity:</b> Immature
<b>Origin:</b> Australian	<b>ULE (years):</b> 15 - 30
<b>Retained?:</b> Removed	<b>Form:</b> Fair
<b>Retention Value:</b>	Very low
<b>Removal / retention reason:</b>	N/A.
<b>Amenity value:</b>	Very low
<b>Works Required:</b>	N/A.

<b>SRZ (m):</b> 1.6	<b>Works priority:</b>	Very low
<b>TPZ (m):</b> 2.0	<b>Construction Proximity:</b>	0.1
<b>mTPZ (m):</b>

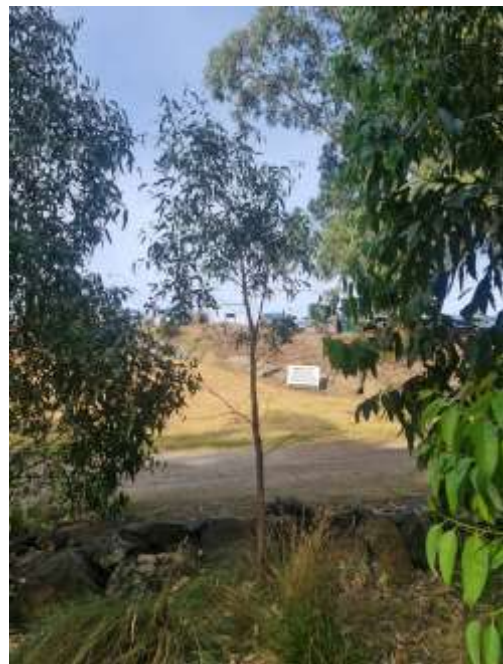
**Tree ID:** 641

<b>Height (m):</b> 3	<b>Structure:</b> Fair
<b>Width (m):</b> 3	<b>Health:</b> Fair
<b>DBH (cm):</b> 5 Measured	<b>Maturity:</b> Immature
<b>Origin:</b> Australian	<b>ULE (years):</b> 15 - 30
<b>Retained?:</b> Removed	<b>Form:</b> Fair
<b>Retention Value:</b>	Very low
<b>Removal / retention reason:</b>	N/A.
<b>Amenity value:</b>	Very low
<b>Works Required:</b>	N/A.

<b>SRZ (m):</b> 1.6	<b>Works priority:</b>	Very low
<b>TPZ (m):</b> 2.0	<b>Construction Proximity:</b>	0.1
<b>mTPZ (m):</b>

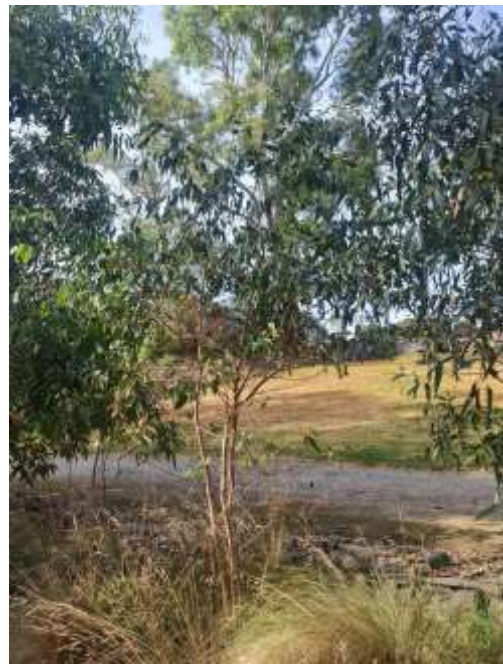
**Tree ID:** 642

<b>Height (m):</b> 3	<b>Structure:</b> Fair
<b>Width (m):</b> 1	<b>Health:</b> Good
<b>DBH (cm):</b> 5 Estimated	<b>Maturity:</b> Immature
<b>Origin:</b> Australian	<b>ULE (years):</b> 15 - 30
<b>Retained?:</b> Removed	<b>Form:</b> Fair
<b>Retention Value:</b>	Very low
<b>Removal / retention reason:</b>	N/A.
<b>Amenity value:</b>	Very low
<b>Works Required:</b>	N/A.

<b>SRZ (m):</b> 1.6	<b>Works priority:</b>	Very low
<b>TPZ (m):</b> 2.0	<b>Construction Proximity:</b>	0.1
<b>mTPZ (m):</b>

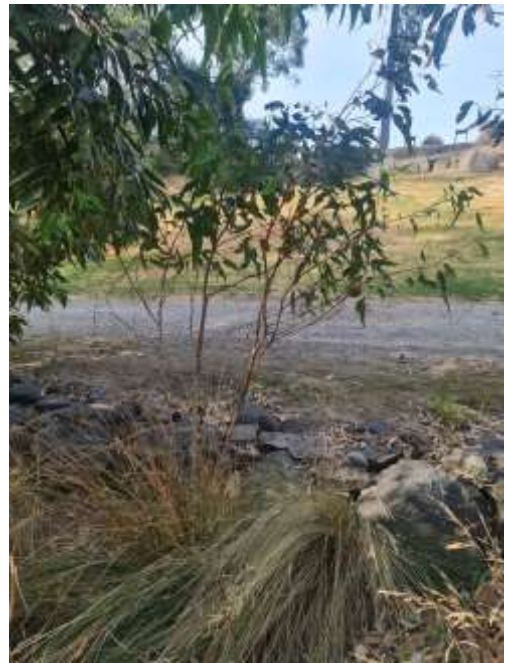
**Tree ID:** 643

<b>Height (m):</b> 2	<b>Structure:</b> Good
<b>Width (m):</b> 1	<b>Health:</b> Good
<b>DBH (cm):</b> 2 Measured	<b>Maturity:</b> Immature
<b>Origin:</b> Australian	<b>ULE (years):</b> 15 - 30
<b>Retained?:</b> Removed	<b>Form:</b> Good
<b>Retention Value:</b>	Very low
<b>Removal / retention reason:</b>	N/A.
<b>Amenity value:</b>	Very low
<b>Works Required:</b>	N/A.

<b>SRZ (m):</b> 1.6	<b>Works priority:</b>	Very low
<b>TPZ (m):</b> 2.0	<b>Construction Proximity:</b>	0.1
<b>mTPZ (m):</b>

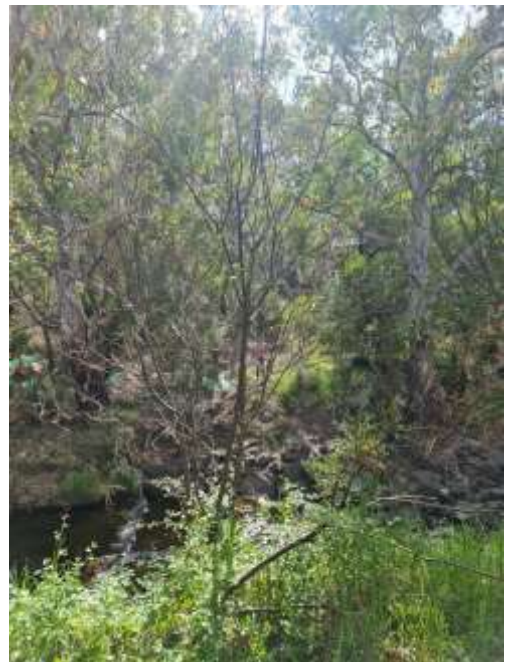
**Tree ID:** 648

**Height (m):** 20                      **Structure:** Good  
**Width (m):** 8                         **Health:** Good  
**DBH (cm):** 45 Measured **Maturity:** Mature  
**Origin:** Australian                **ULE (years):** 30 - 60  
**Retained?:** Retained                **Form:** Good  
**Retention Value:** High  
**Removal / retention reason:** N/A.  
**Amenity value:** High  
**Works Required:** N/A.

**SRZ (m):** 2.5                      **Works priority:** Very low  
**TPZ (m):** 5.4                      **Construction Proximity:** 0.1  
**mTPZ (m):**

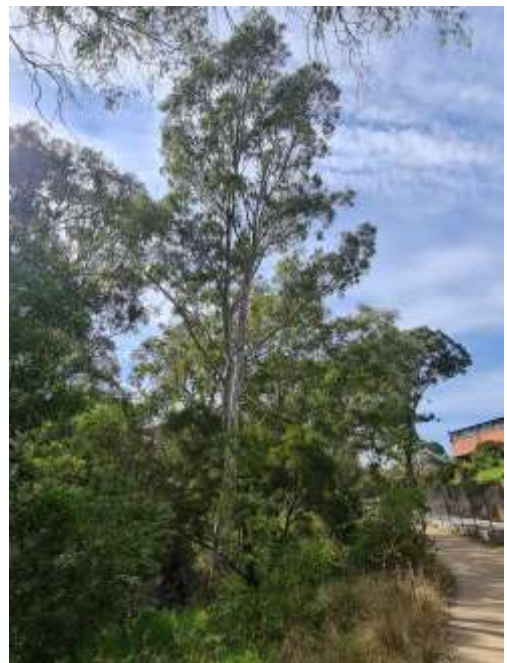
**Tree ID:** 649

**Height (m):** 4                         **Structure:** Good  
**Width (m):** 1                         **Health:** Good  
**DBH (cm):** 5 Measured **Maturity:** Immature  
**Origin:** Melbourne                **ULE (years):** 15 - 30  
**Retained?:** Removed                **Form:** Good  
**Retention Value:** Very low  
**Removal / retention reason:** N/A.  
**Amenity value:** Very low  
**Works Required:** N/A.

**SRZ (m):** 1.6                      **Works priority:** Very low  
**TPZ (m):** 2.0                      **Construction Proximity:** 0.1  
**mTPZ (m):**

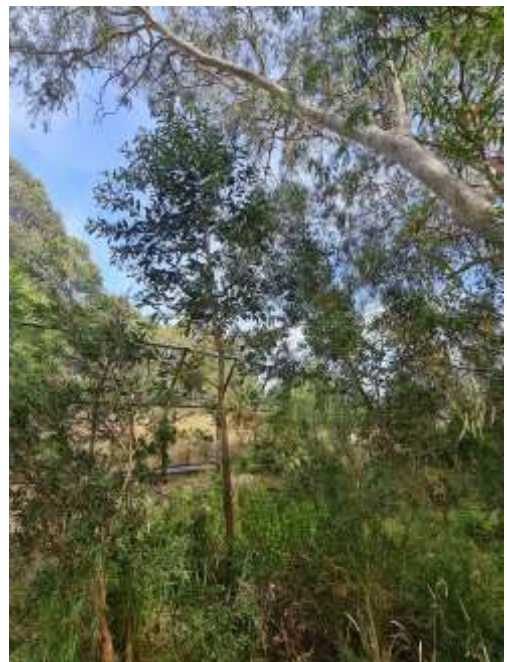
**Tree ID:** 650

**Height (m):** 4                         **Structure:** Good  
**Width (m):** 1                         **Health:** Fair  
**DBH (cm):** 5 Measured **Maturity:** Immature  
**Origin:** Melbourne                **ULE (years):** 15 - 30  
**Retained?:** Removed                **Form:** Good  
**Retention Value:** Very low  
**Removal / retention reason:** N/A.  
**Amenity value:** Very low  
**Works Required:** N/A.

**SRZ (m):** 1.6                      **Works priority:** Very low  
**TPZ (m):** 2.0                      **Construction Proximity:** 0.1  
**mTPZ (m):**
