# AM PLA Power Line Bushfire Mitigation Plan Plan

October 2024

This plan has been specifically designed for the 2.6 km of 11 kV lines (at-risk electric lines) in the Sugarloaf-Winneke area and 64m of 22kV line (at-risk electric lines) in the Bells Portal – Thompson dam area.

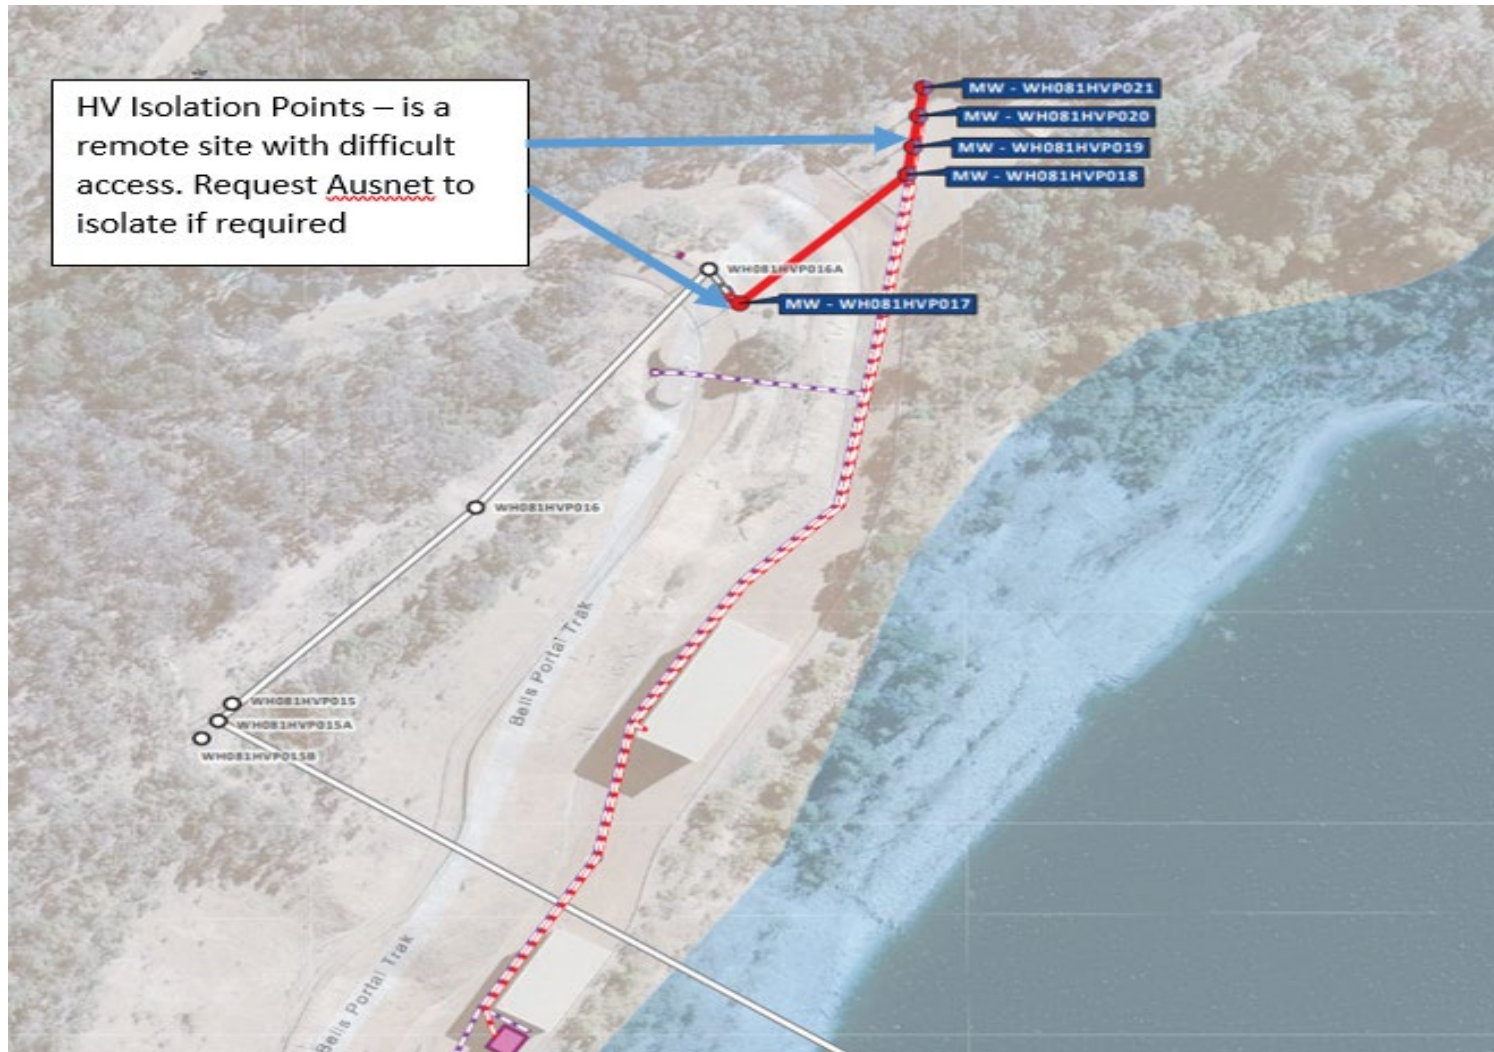
The following diagram shows location of High Voltage Isolation Control Points around **Bells Portal**.
