## Practicalities of rockwork construction

### Toe and Edge Rocks

#### TOE/EDGE ROCKS - Dos and Don'ts

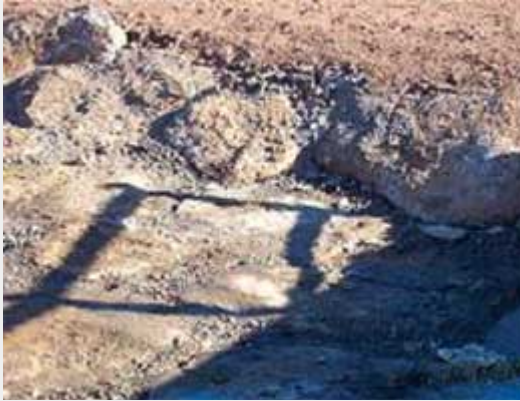
✓ Edge rocks well entrenched into earthen bank. Top soil filled to top of edge rocks.

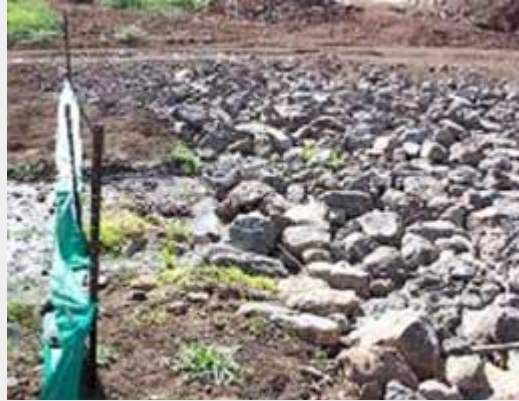
✗ Edge rocks not well defined, poorly entrenched.

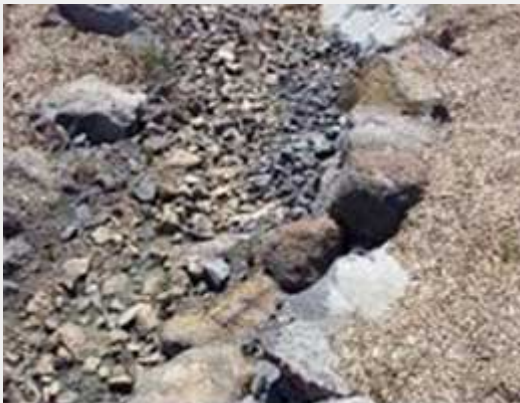
✓ Edge rocks blended into surrounding ground.

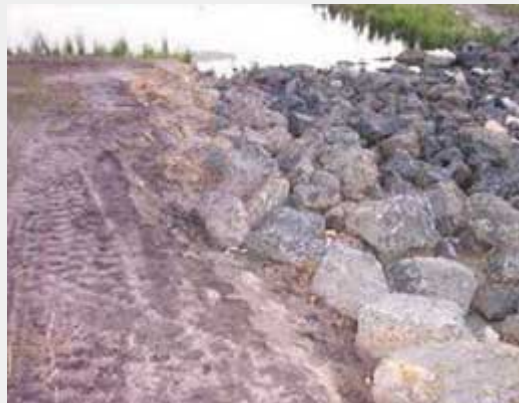
✗ Edge rocks protruding above surrounding ground. Note scouring of ground next to edge rocks.

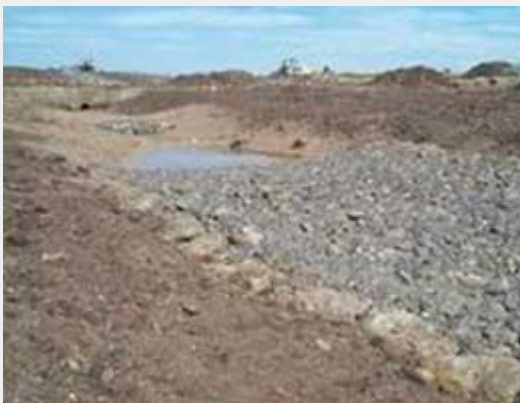
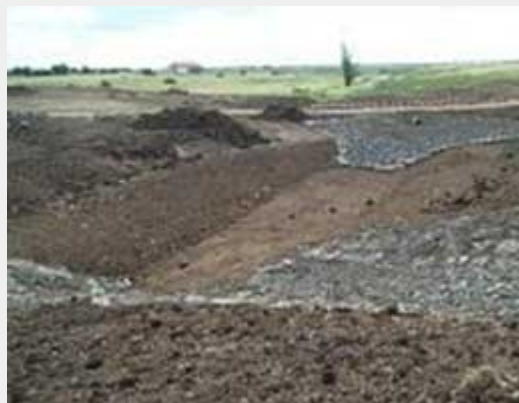
✓ Well defined edge rocks, well integrated with lining rocks.

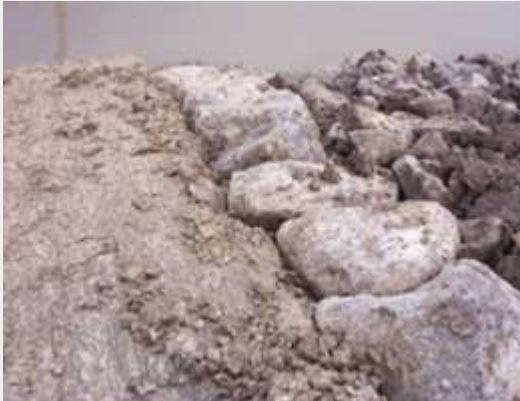
✓ Edge rocks well integrated into topography.

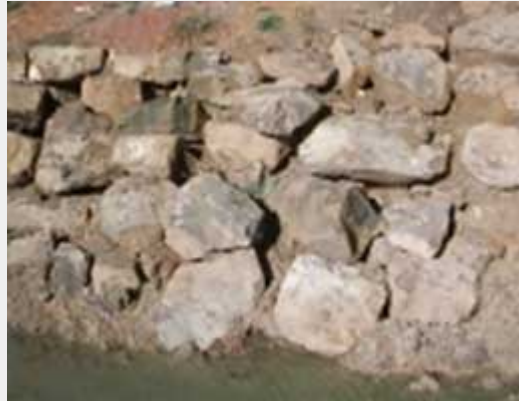
✓ Edge rocks well entrenched into bank.

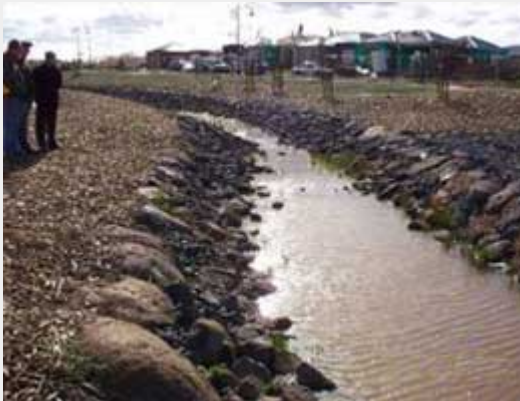
✗ Edge rocks not well defined, poorly entrenched.

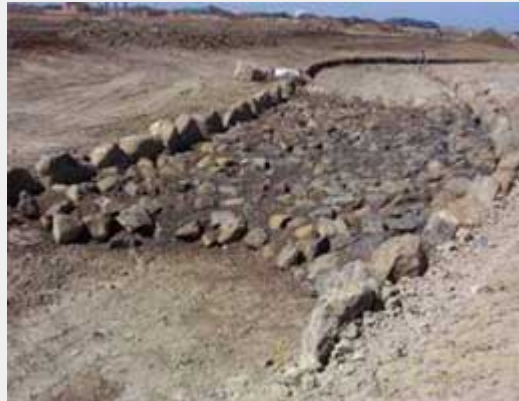
✓ Edge rocks well defined and entrenched into top of bank.

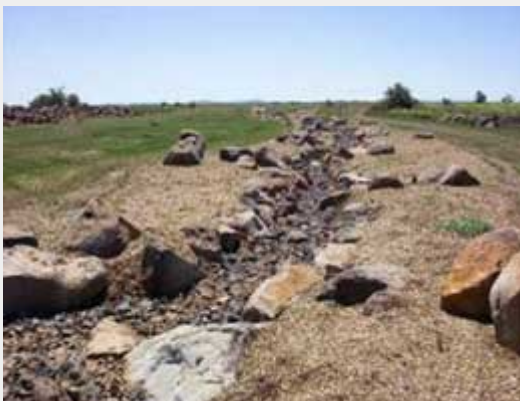
✗ Edge rocks protruding above surrounding ground.

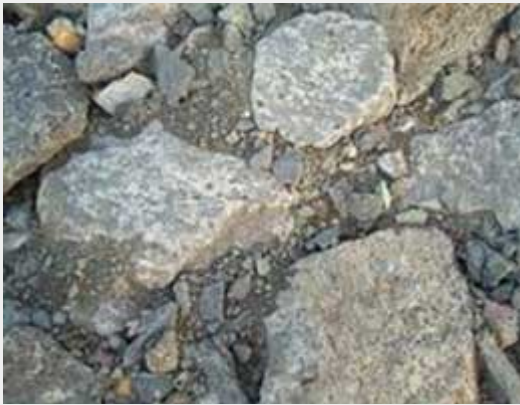
✓ Good use of 0-150mm graded material to seal voids between larger lining rocks.

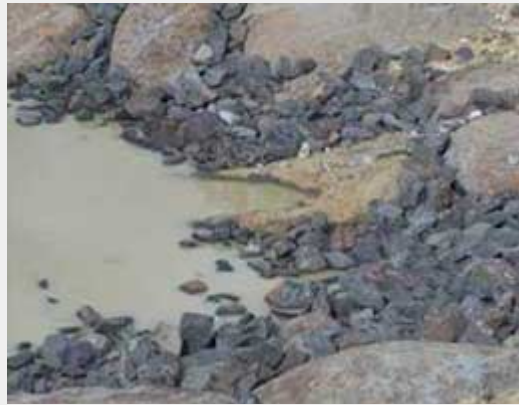
✗ One size ballast material used to fill voids between larger rocks - will dislodge in high flows.

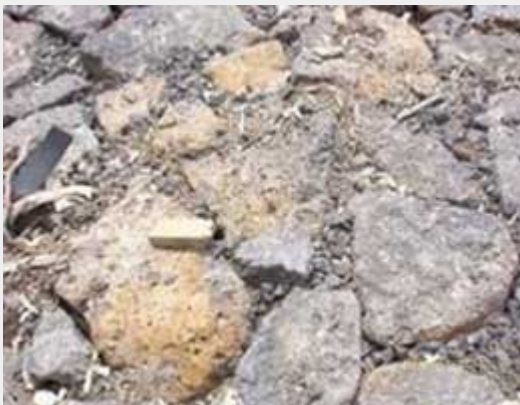
✓ Angled rocks well interlocked, voids well sealed.

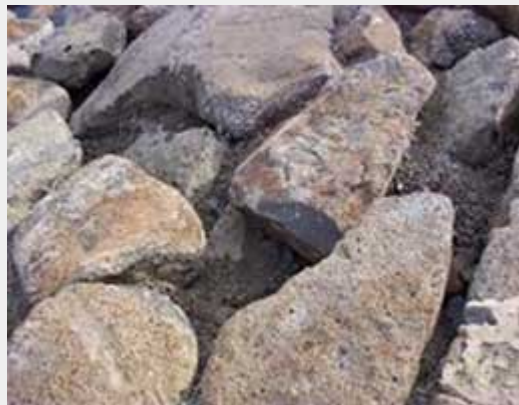
✗ Rocks not interlocked, voids not sealed.

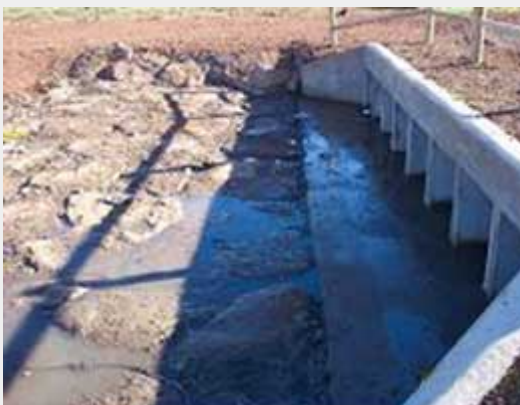
✓ Good use of large lining rocks, neatly interfacing with concrete apron.

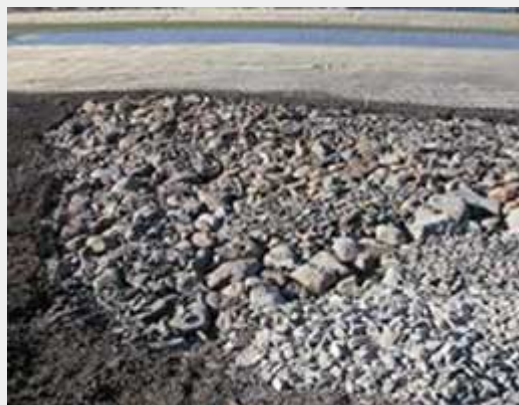
✗ Rockwork too fragmented i.e. too loose, too small in general.

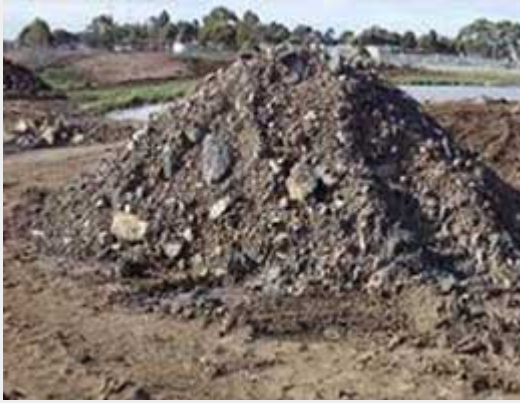
✓ Example of well graded material for filter/embedment layer.

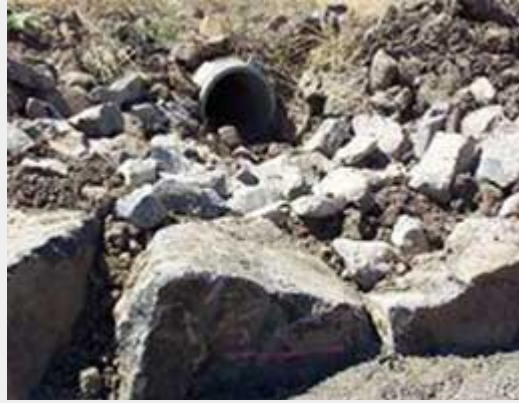
✗ Rocks placed straight on clay without filter/embedment layer.

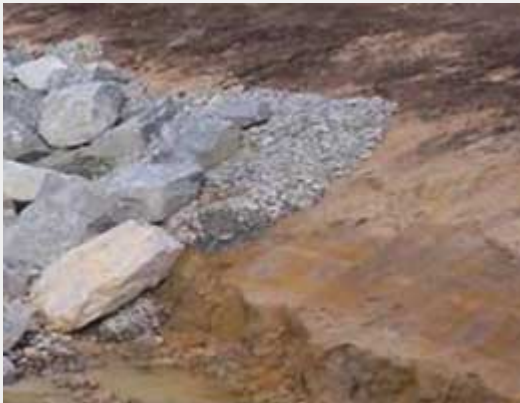
✓ Coarse grade filter/embedment material under lining rocks.

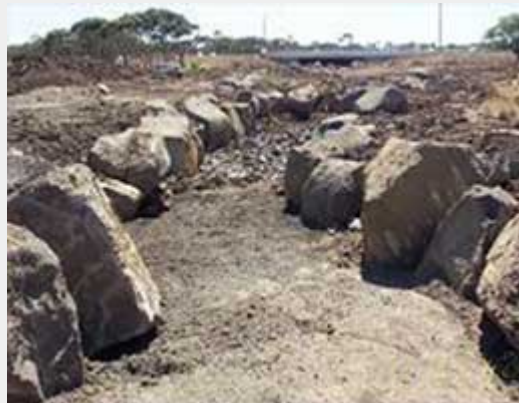
✗ 20mm crushed rock not generally preferred for filter/embedment layer in active waterway.

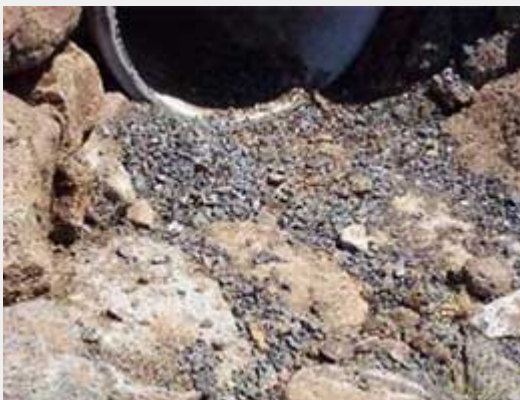
✓ Well interlocked and well sealed rock beaching Refer rockwork in front of pipe.

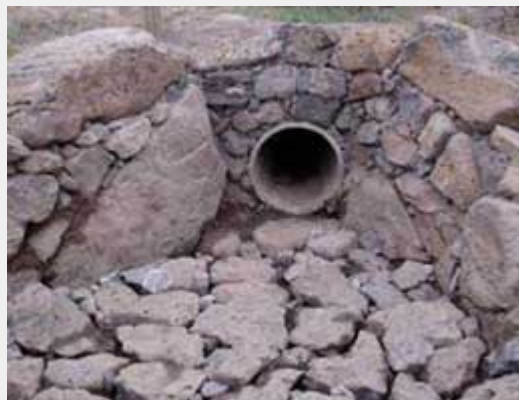
✗ Poor sealing of rockwork.

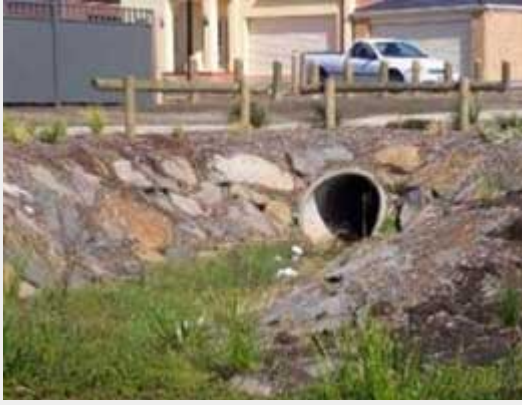
✓ Well embedded rockwork.

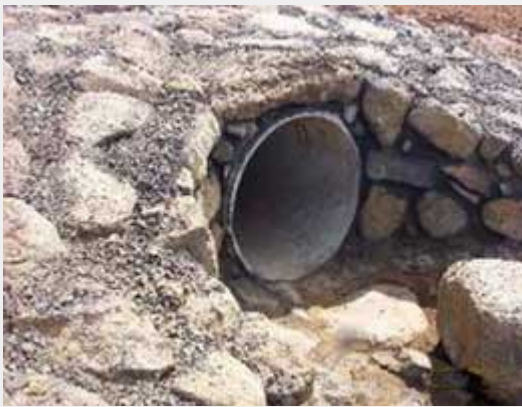
✓ Well interlocked and well sealed, plate rock set on mortar pad. Note use of energy dissipating rock in front of outlet pipe.

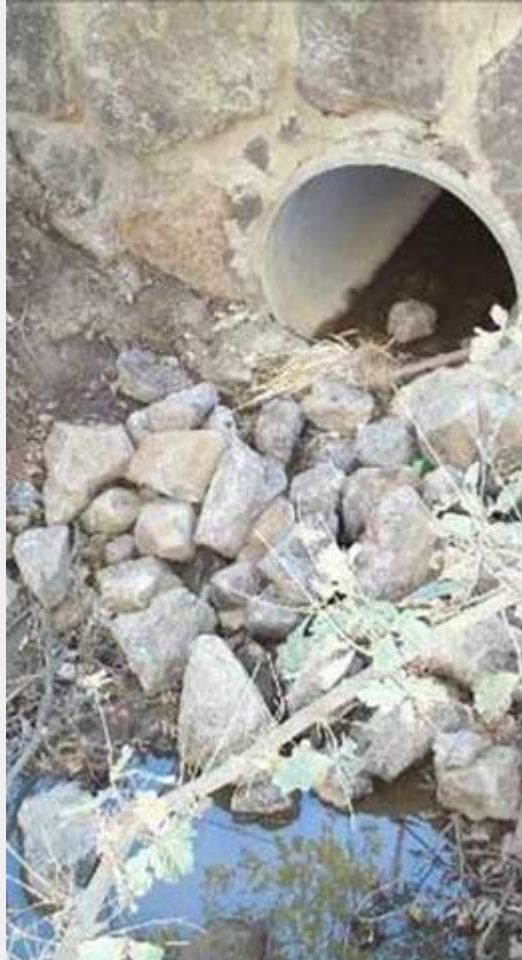
✗ Rocks have simply been dumped in front of outlet pipe - apart from obvious problems with grading, interlocking and sealing of rocks, other problems include rocks projecting above pipe invert, rocks not extended up banks, toe rocks not entrenched into creek bed.
